Journal of the Transportation Research Board, No. 2201

Moving Substrate in an Ephemeral Stream

Case Study in Bridge Survival

George R. Herrmann and Theodore G. Cleveland

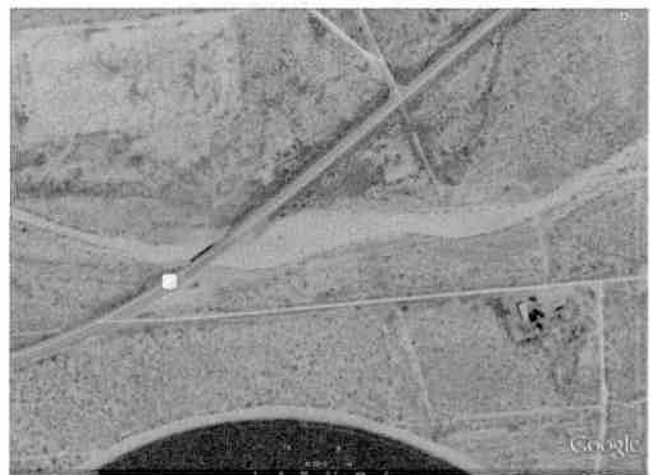
The particular problem at the site has developed as bank erosion along the outside of a gentle meander, adjacent to and threatening the adjacent south abutment of the bridge. An important observation about this site is found in the overhead imagery (by Google Earth). Tracking Guadalupe Creek along all tributaries from origin to destination, the stream reach immediately adjacent to the crossing of US-62-180 stands out as anomalous. The stream exhibits an obvious widening at the crossing, which continues downstream approximately 300 ft (91 m) before disappearing and extends upstream approximately 1,600 ft (488 m). This widening is seen in Figure 2.

The image shows that an already conspicuously wide reach of the stream is further widening to the south. No similar reach is in evidence from imagery along this stream. This widening appears to be associated with the highway crossing. Numerous other sites have been identified in recent years where highway stream crossings have exhibited an adverse impact on stream stability in central and west Texas (1-4), so such an association is not unusual.

FIGURE 2 Current overhead image (note overwidened section upstream of bridge and appearance of shorter meander wavelength).

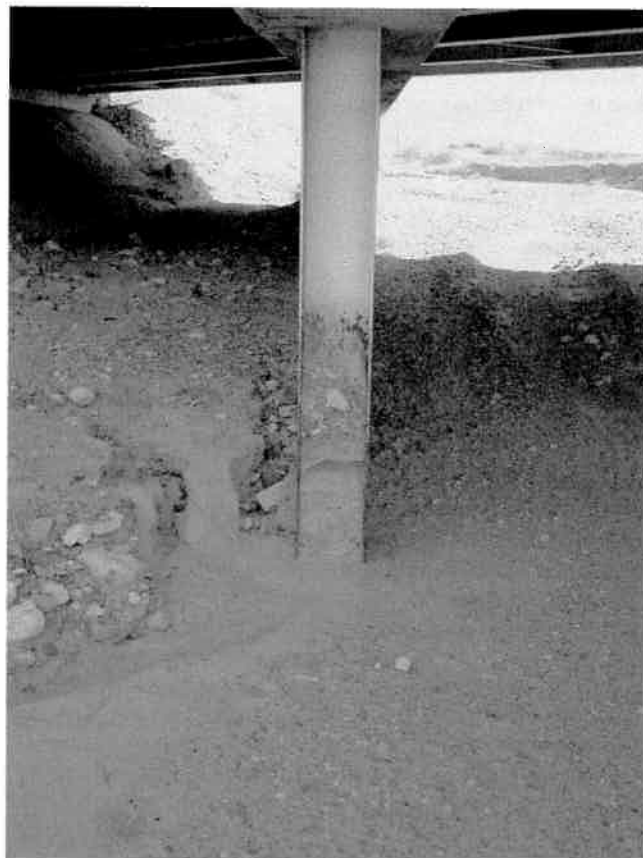
The construction plans for the bridge indicate a general height of the bridge low chord above the streambed at the time of construction of 12 ft (3.6 m). The roadway profile at the bridge is both on a grade and in a superelevated curve, making reference to such a height ambiguous. Thus it is difficult to state with certainty how much the streambed has aggraded. A rough estimate based on observation is that net aggradation at the bridge has been, in the recent past, bed

FIGURE 3 Bridge pile (note evidence that bed material has been at least 4 ft higher than it is under conditions at time of the photograph).

material between 5 and 8 ft (1.5 and 2.4 m) deep, which has been mechanically removed. As the removal of such material has apparently been ongoing for many years, the amount of material that has already passed through the reach cannot be estimated. However, on the basis of this degree of aggradation at the bridge and the distance upstream that the impact is visible, the amount of material remaining in a lens upstream of the bridge is estimated at between 10,000 and 20,000 yd³ (7,650 and 15,300 m³). A minimum of approximately 300 yd³ (230 m³) of bed material per year appears to be the average arriving at the site and being detained since the bridge was constructed in 1959.

The steel H-pilings supporting the bridge bear indications of having been buried numerous times and of damage indicating impacts from boulders. Some time after the original construction, concrete walls were constructed connecting the piling of each bent and semicircular nose elements on the upstream side of the upstream pilings, evidently to prevent damage from boulder impacts or machine impacts during removal operations.

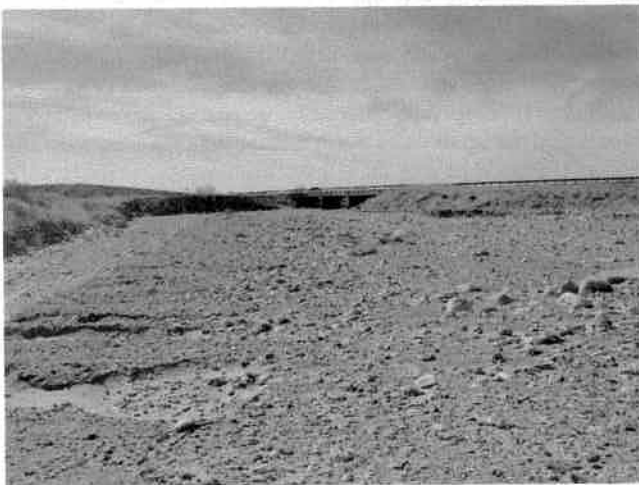
Site reconnaissance demonstrated that the bed material is composed of particles ranging from silt size up to several feet in size (Figures 4 and 5). This gradation is also an indication of the magnitude of the forces driving their movement; such particles are not moved easily. Conditions permitting their movement would necessarily result in the movement of huge quantities of cobbles and gravel as well. By volume, the preponderance of material is fine sand. Larger particles, including a wide range of gravel, cobble, and boulder sizes, appear embedded in a matrix of fine sand. One plausible model is that the apparent extreme throughput of material might be related to some optimal proportion of large particles embedded in a matrix of more easily mobilized sand.

FIGURE 4 Streambed material (view of streambed looking downstream toward bridge).

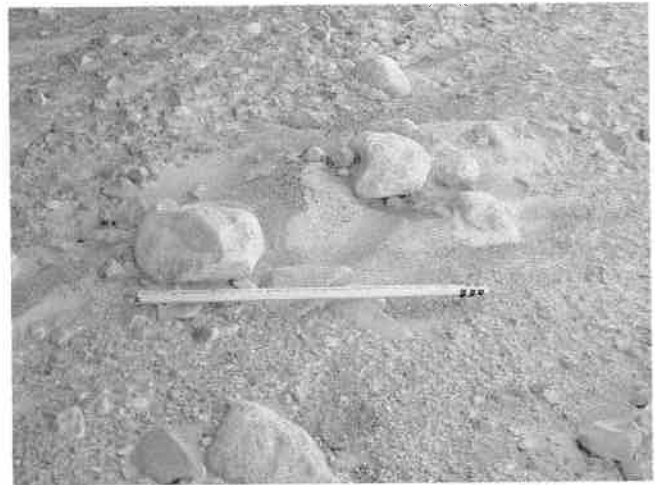
FIGURE 5 Large bed material (Philadelphia level rod for scale).

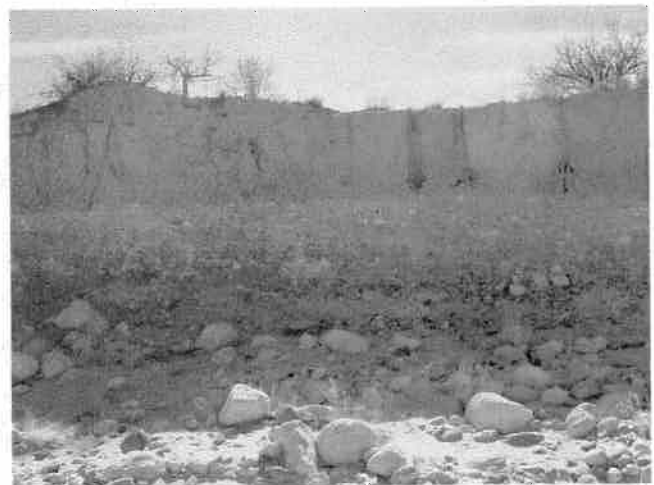
In locations where the undisturbed streambanks that are subject to erosion were visible, the material in them appears to be alluvium consistent with the bed material—sand, gravel, and cobbles. Erosion of the banks results in material indistinguishable from that already in the streambed (Figure 6); thus at least some of the material present at the site is material recently liberated from these banks. However, considerable quantities of material have had to be removed mechanically; this necessity argues in favor of a net positive change in storage of the bed material in this reach over time as opposed to simply liberating it from adjacent alluvial deposits.

FIGURE 6 Undisturbed streambank showing character of bank material.

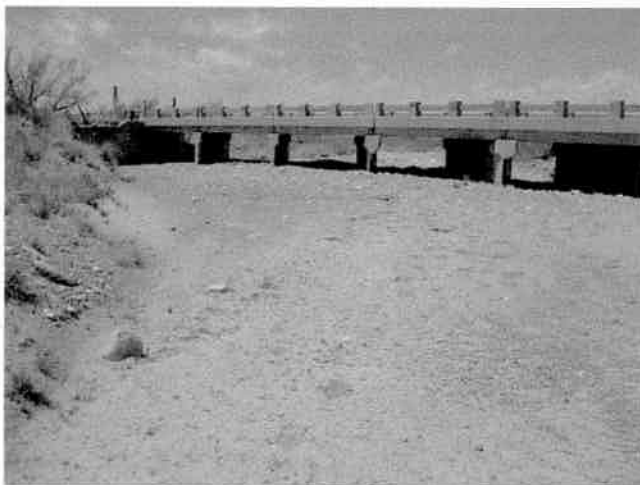
Several miles above the site in question, Guadalupe Arroyo is crossed by Texas State Highway (SH) 54, which ends where it intersects with US-62-180 several miles east of the bridge in question. At this crossing, bed material is predominantly sand-sized. The boulder-sized particles seen at the US-62-180 site are not in evidence in quantities similar to those of the problematic site, although occasional large cobbles do appear (Figure 7).

FIGURE 7 Guadalupe Arroyo at upstream crossing of SH-54, looking downstream (larger material in bridge vicinity; bankfull configuration is evident in stream adjacent to this bridge).

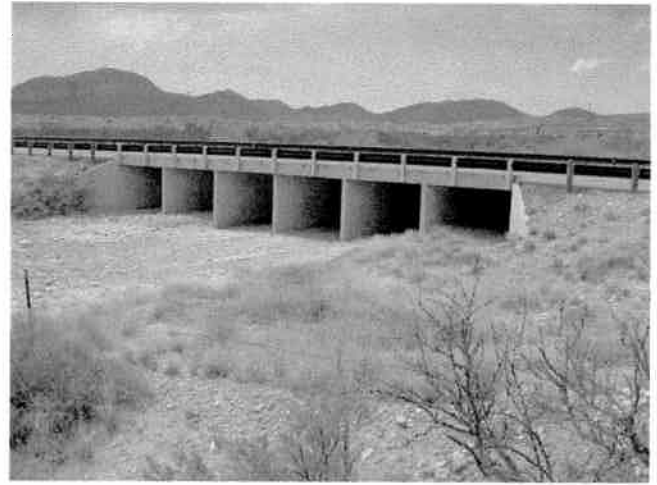
The crossings at SH-54 and of US-62-180 at a tributary to Guadalupe Arroyo present comparisons to the crossing in question. The former is an open-span bridge, similar to the structure of interest but smaller. In that location, the bankfull width is approximately 40 ft (12 m). The latter crossing is a six-barrel 10-ft by 10-ft (3-m by 3-m) box culvert, and the bankfull width is approximately 35 ft (10.7 m) (Figure 8).

FIGURE 8 US-62-180 at a tributary to Guadalupe Arroyo.

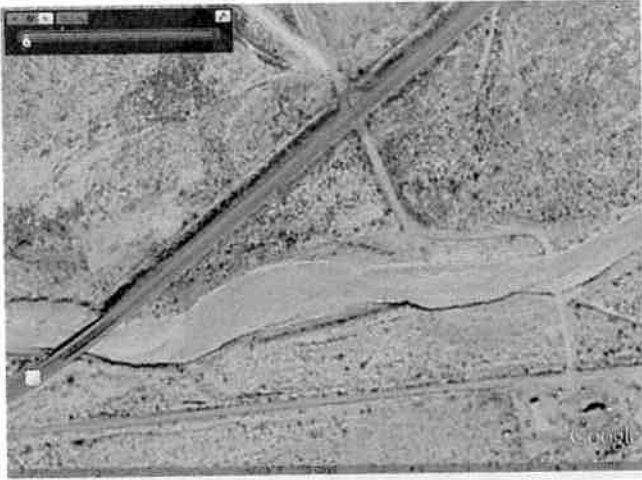
A series of overhead images extending back in time approximately 13 years shows that the stream immediately above the bridge has been exhibiting essentially identical instability at least that long. Imagery from 1996 (Figure 9) indicates that the meander character of the stream immediately upstream of the bridge is in a state of change. Where there had previously been a long, gentle meander, meander reversal has occurred, resulting in the development of a short-wavelength meander anomalous for the stream. The avulsion attendant with this meander change has been seen and interpreted only in the context of bank erosion that threatens the southwest bridge abutment.

FIGURE 9 Image from 1996 (shortening of meander wavelength is evident at this time).

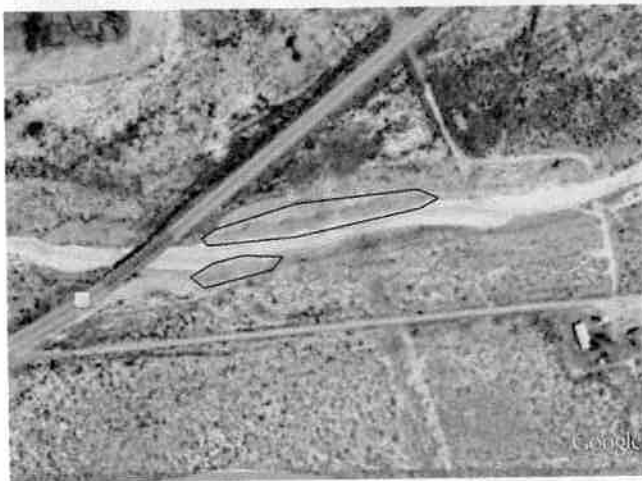
This image and others from the years between 1996 and the present show the signs of repeated and chronic attempts to rebuild and stabilize the streambanks, as well as to remove material from the bridge opening itself. Figure 10 is an image from 2005, which shows bed material piled adjacent to the stream from efforts to deal with the accumulating bed material.

FIGURE 10 Image from 2005 (note bed material piled along stream upstream of bridge location, indicated by closed shapes).

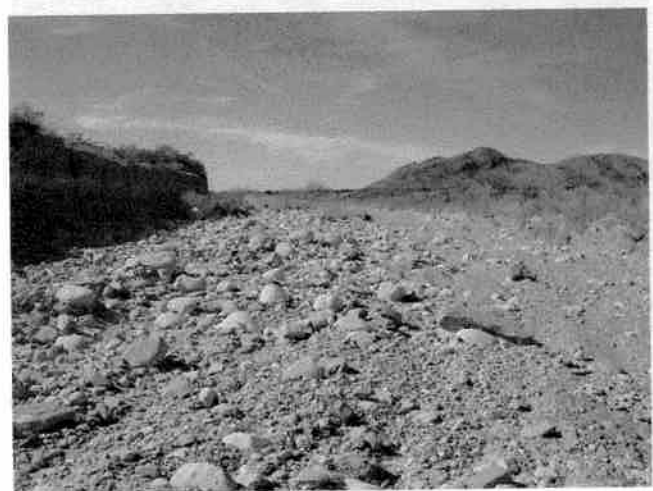
Both hydrology and hydraulic analysis at this site (and others like it) are particularly difficult because of a lack of appropriate data under similar conditions. At this time, a computational approach to stream restoration is severely hampered by those difficulties. However, the "reference reach" approach to stream restoration would be a viable option for addressing this site. The reference reach approach involves locating a similar reach of stream in close proximity and transferring certain physical characteristics from that stream to the stream of interest. In this case, reaches immediately above and below the affected reach were examined for features including bankfull channel and potential riffles. At intervals along the stream in the reaches upstream and downstream of the bridge are features thought to be riffles during flow events. The nature of the material, as well as visibly higher slopes over short distances, is thought to be indicative of riffles. Figure 11 shows one of these locations.

FIGURE 11 Riffle location (looking downstream from a location thought to be head of a riffle).

Nevertheless, it appears that an approach to this problem should be sought through stream restoration. Clearly, the simple armoring of the banks has not solved the problem, and there is no reason to believe that it will in the future. A more thorough solution would involve the manipulation of the stream geometry in a manner that would allow bed material arriving at the site to pass and would encourage bed material accumulated at the site to remobilize and continue downstream.
