Gold King Mine Incident

CASE STUDY IN CRITICAL THINKING

CE 4200

Technical Evaluation of the Gold King Mine Incident

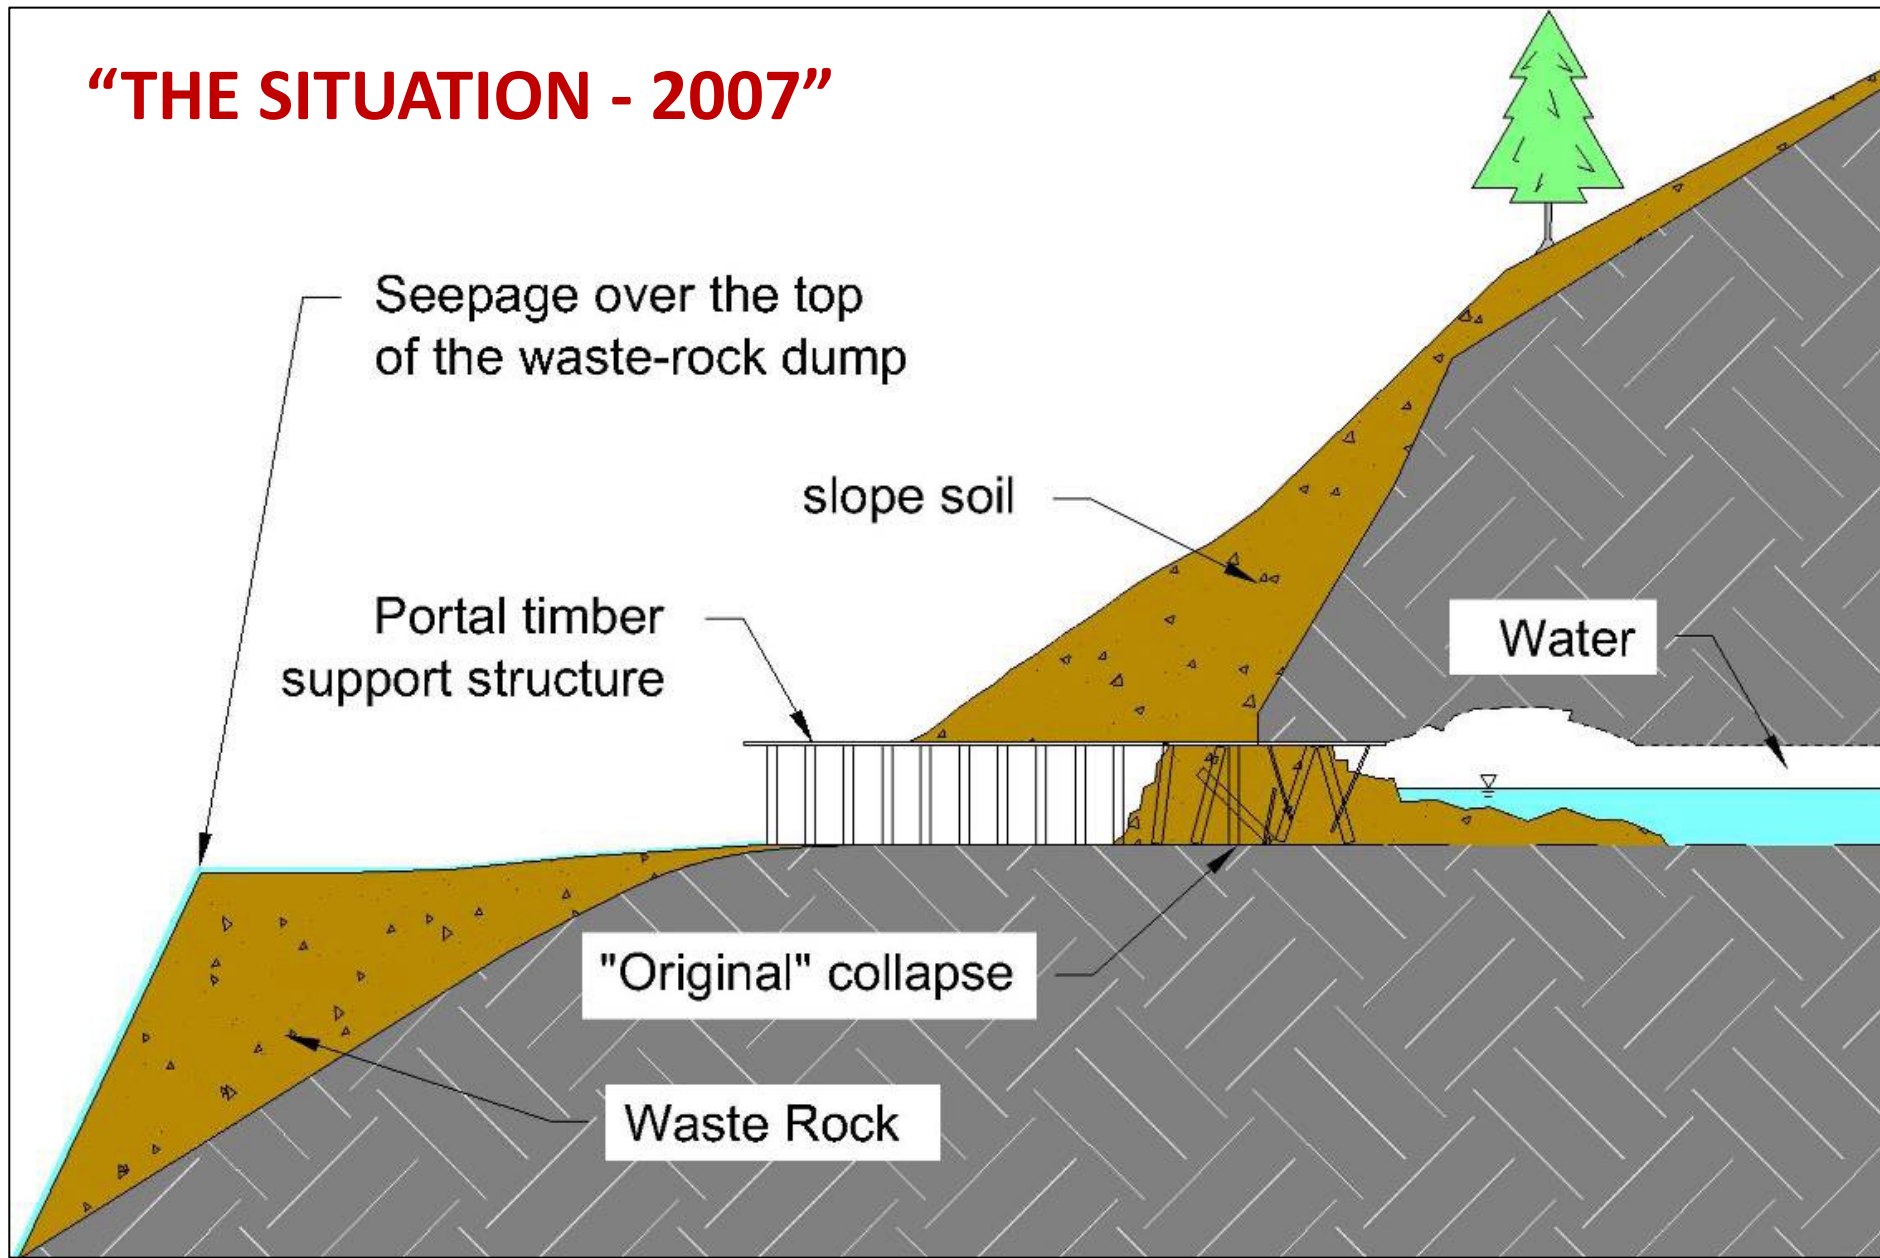
Figure 16.—Cross-section showing the condition of the Gold King Mine Level 7 New Adit in 2007 (not to scale). This shows the water level assumed by DRMS, but it may have been full of water at this time, as was later discovered.

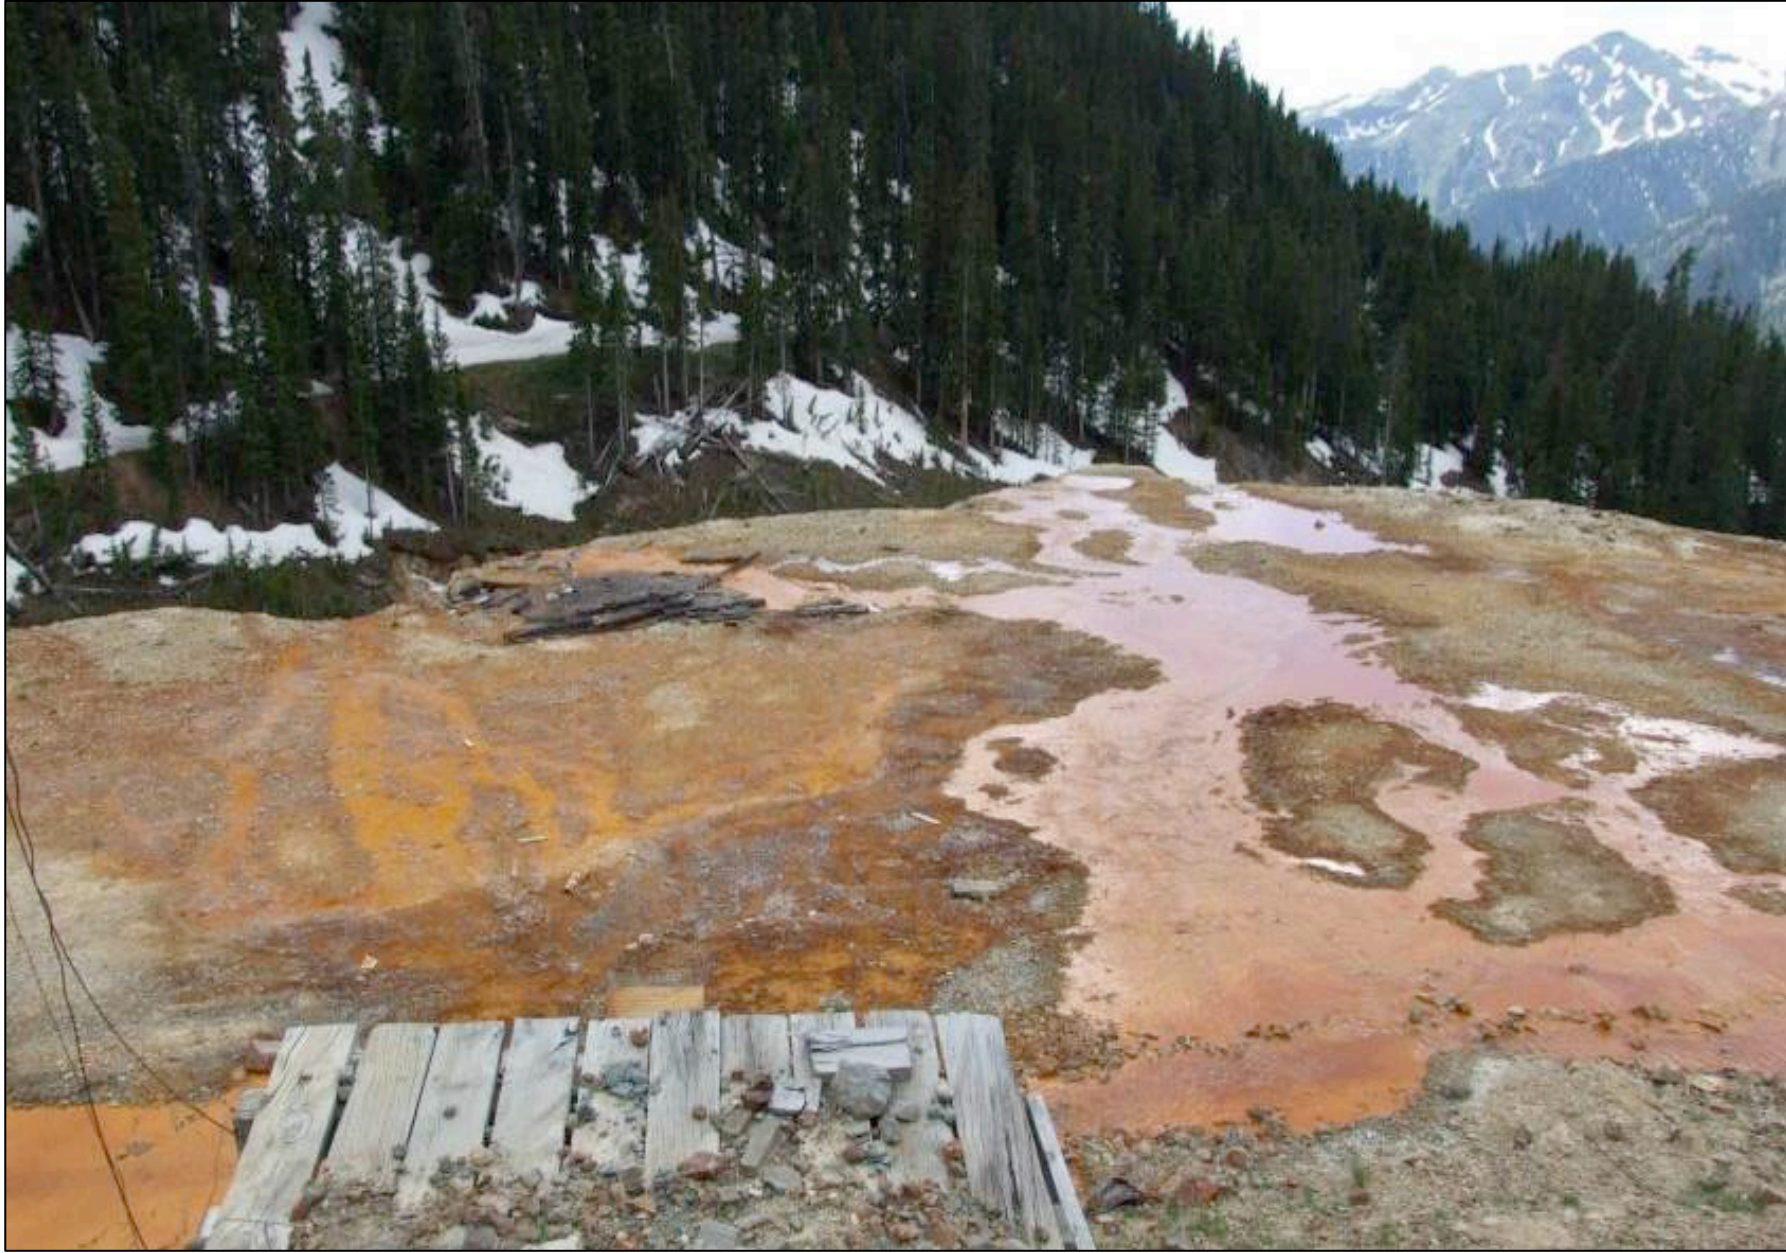
Figure 14.—Photograph showing adit seepage infiltrating into the Gold King Mine Level 7 waste-rock dump in 2007 (from DRMS project files).

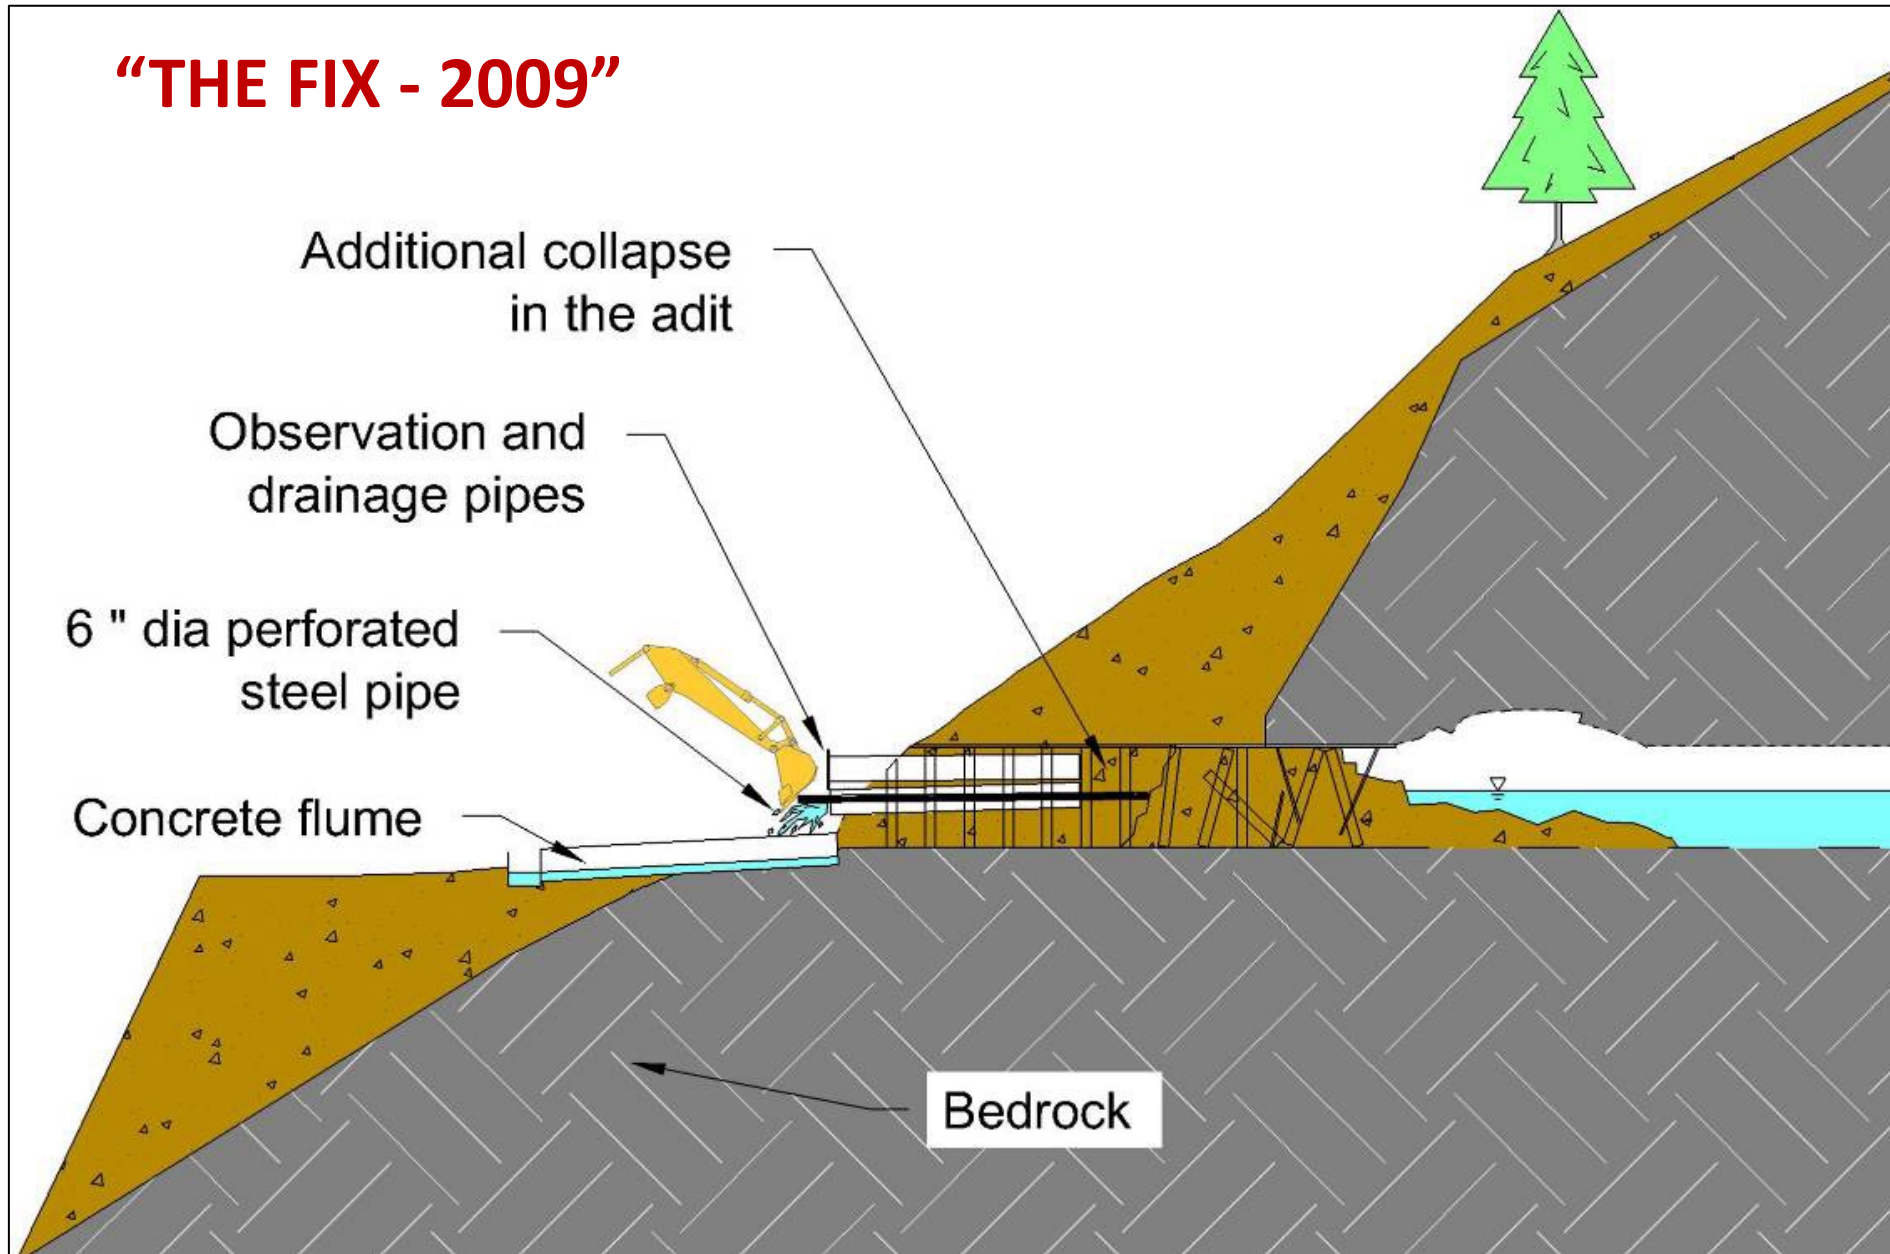
Figure 21.—Cross-section showing the installation of pipes by DRMS at the Gold King Mine Level 7 New Adit in 2009 (water level as assumed by DRMS) (not to scale).

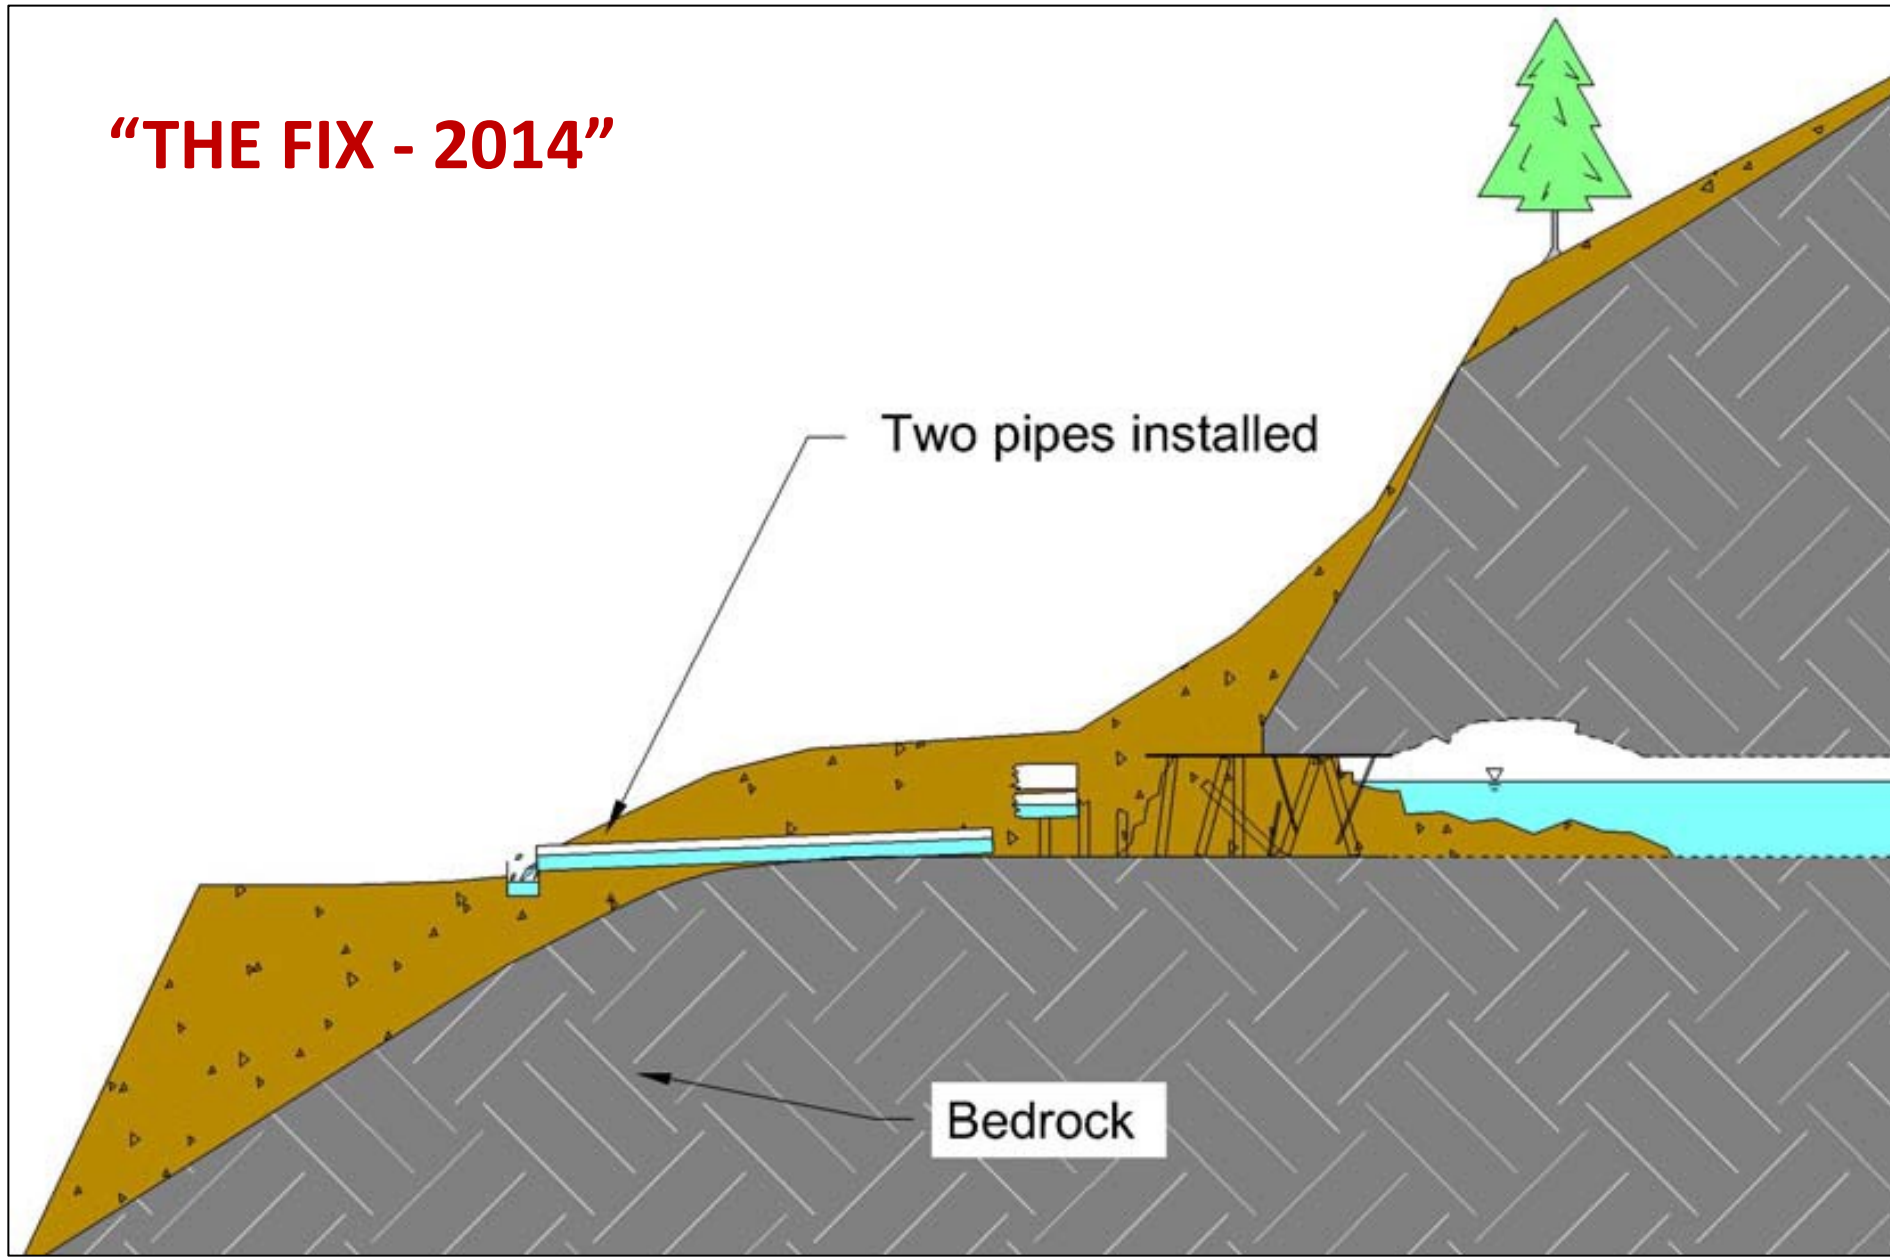
Figure 30.—Cross-section showing the condition of the Gold King Mine Level 7 New Adit in 2014 (water level as assumed by EPA and DRMS), after the installation of the two drain pipes and backfill cover (not to scale).

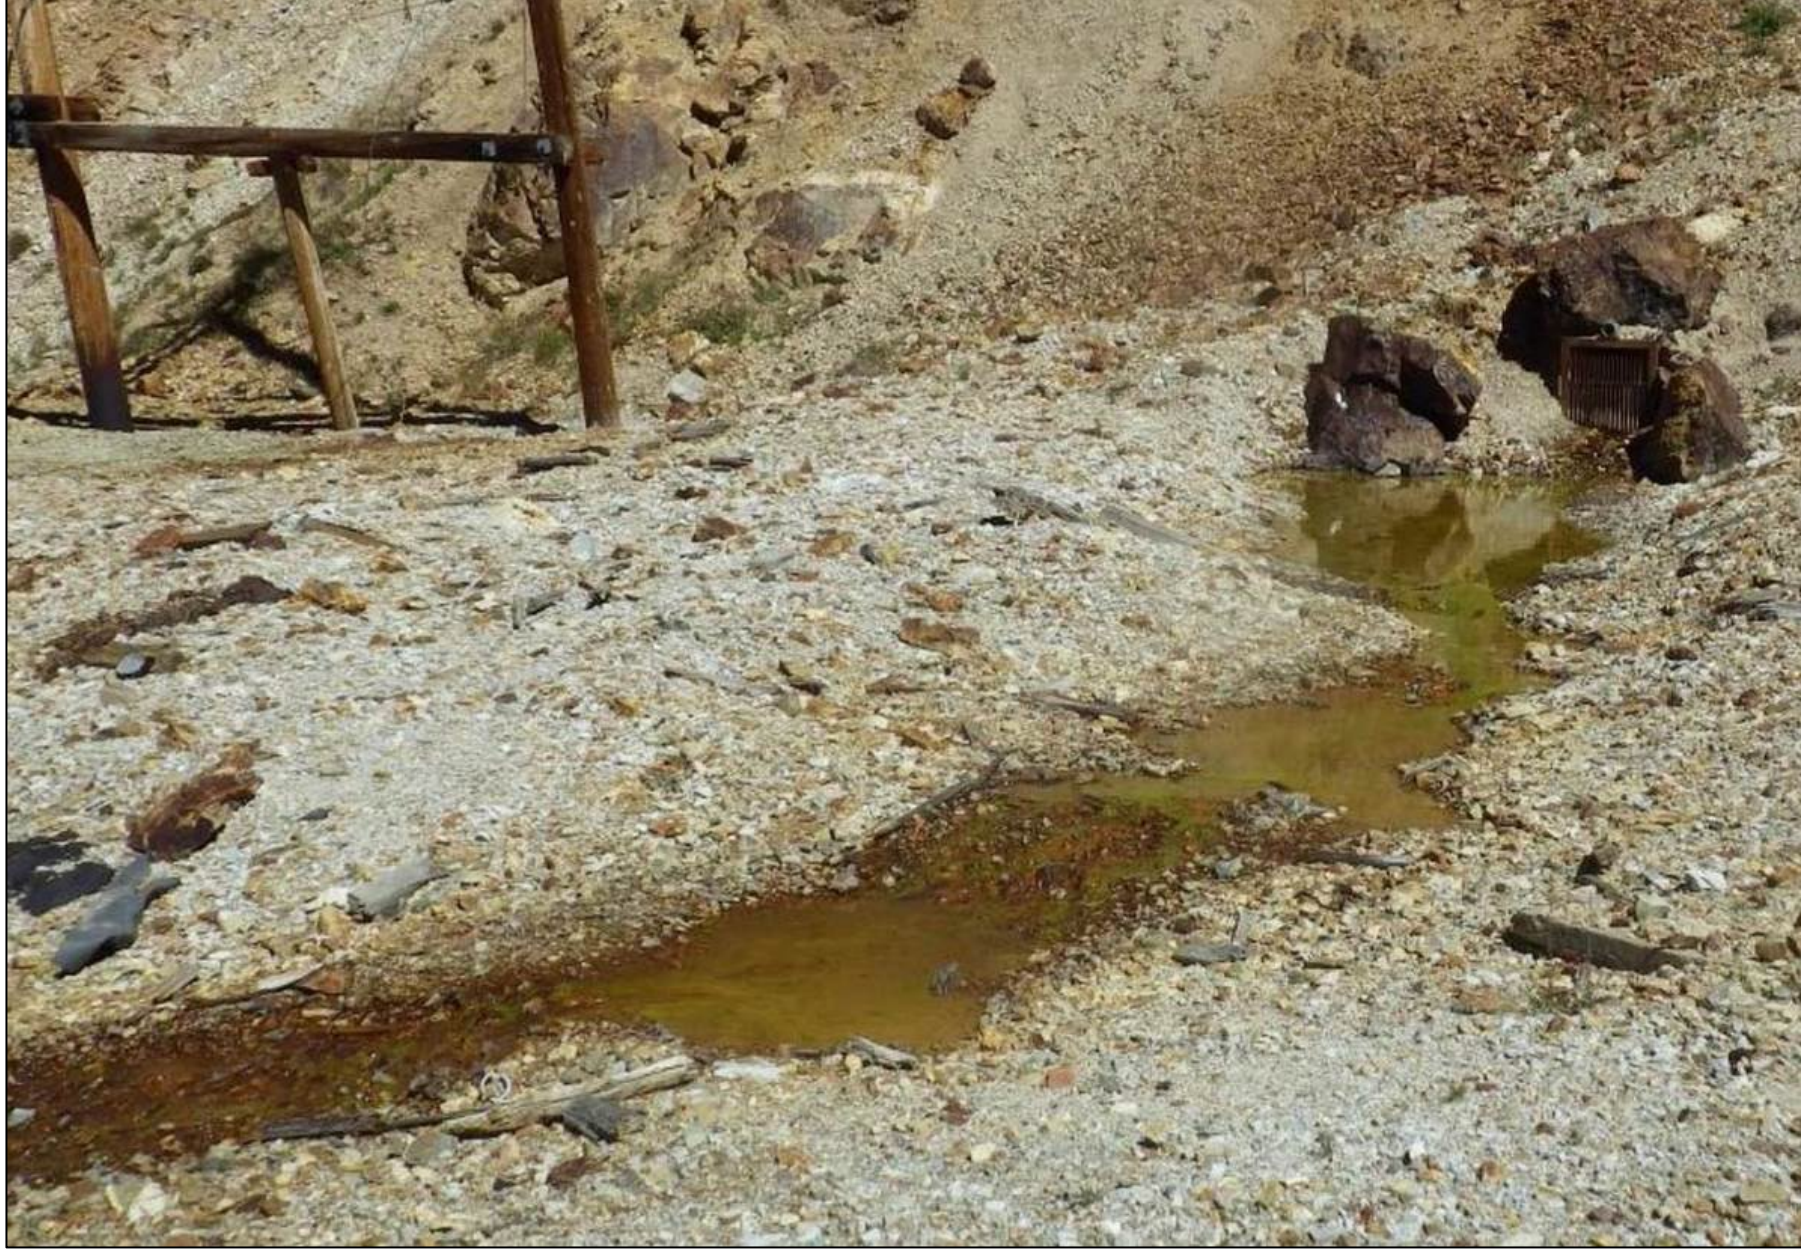
Figure 31.—Gold King Mine Level 7 OLD Adit (upper right) showing a small amount of seepage flow on September 11, 2014. At the portal, the floor of the old adit is approximately 2 feet higher than the floor of the old adit portal (photograph from EPA project files).

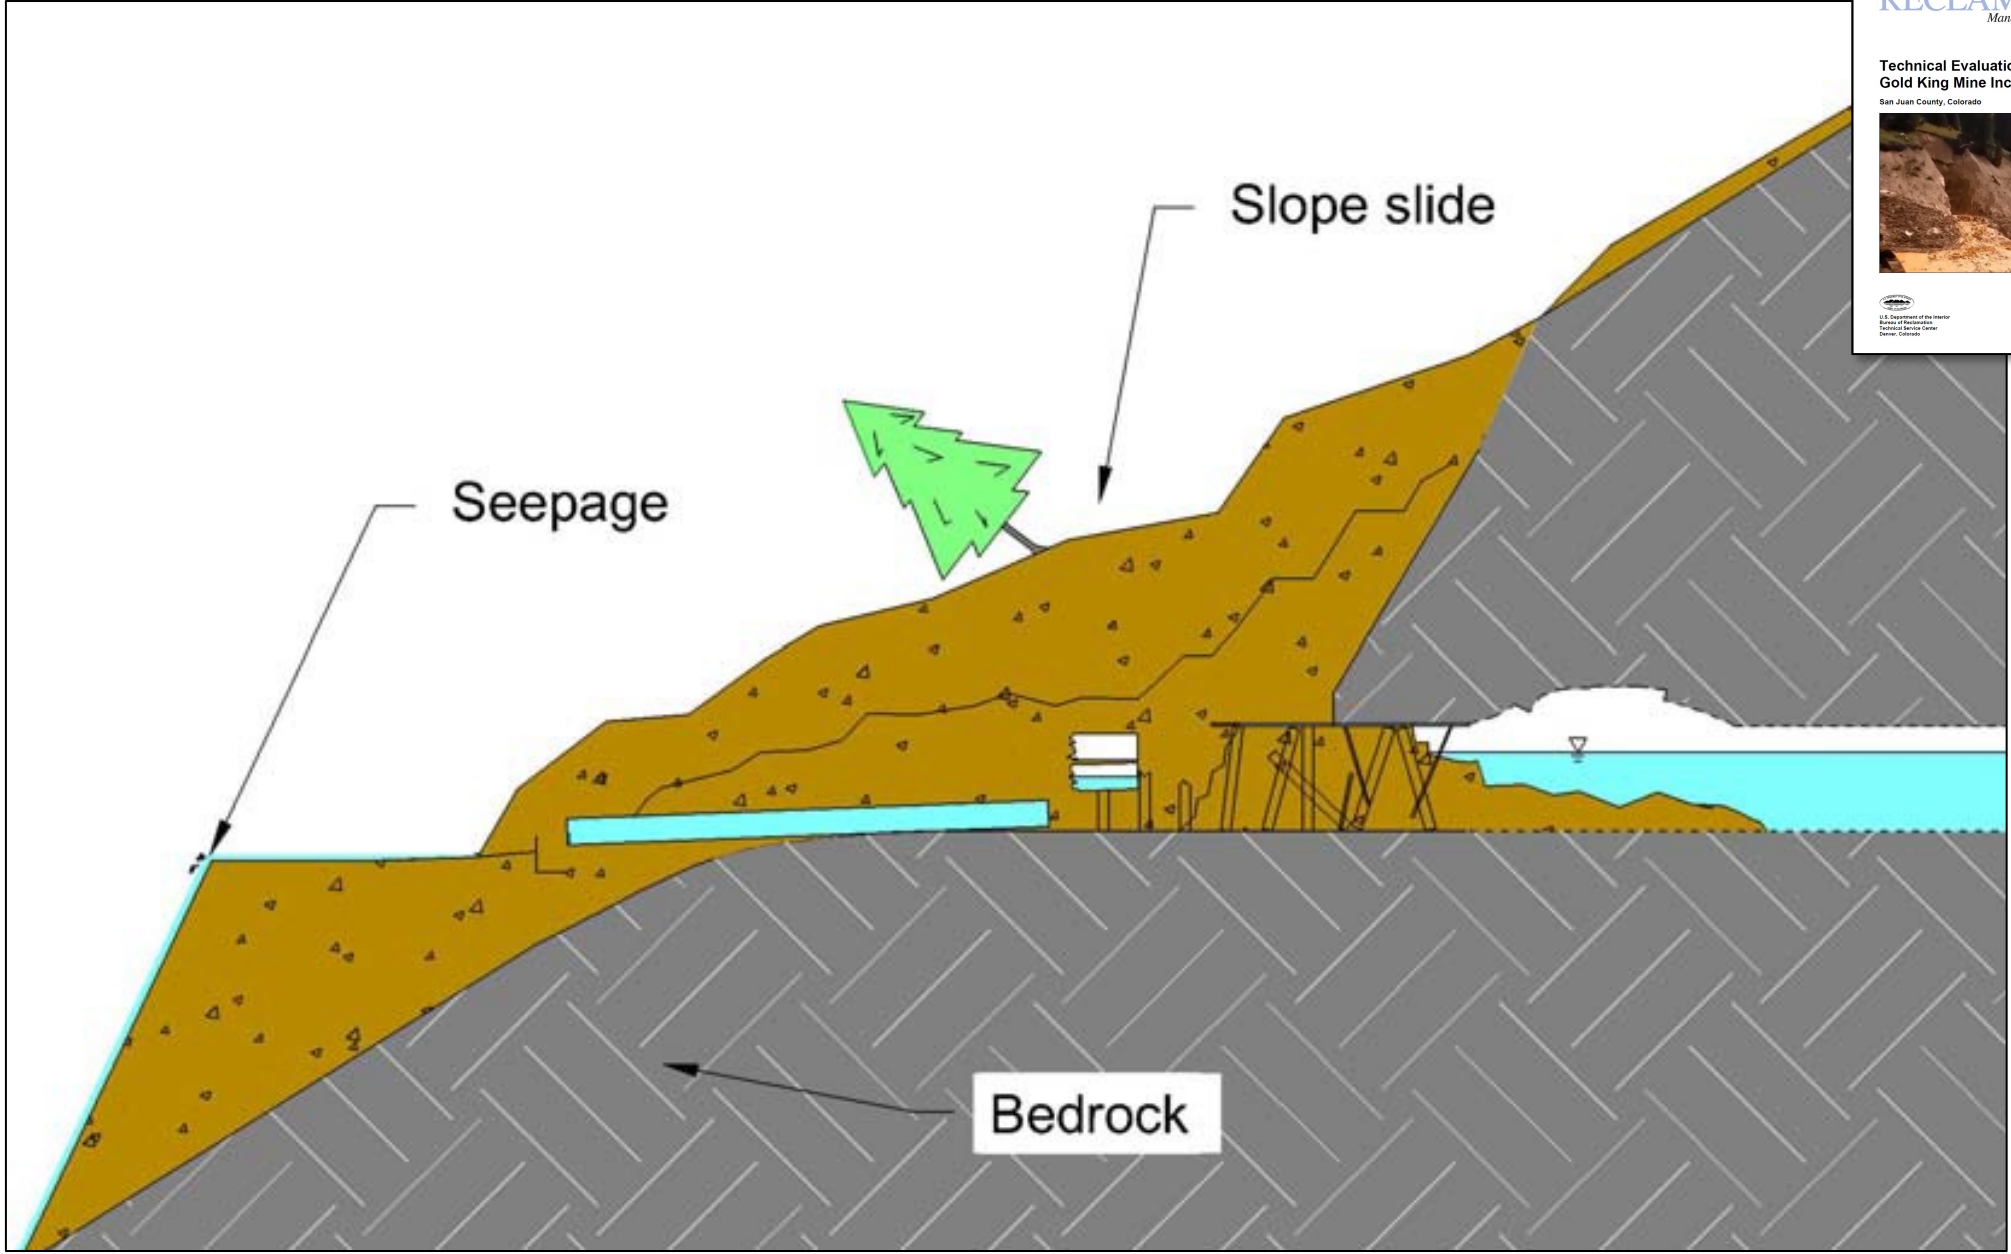
Figure 34.—Cross-section showing the condition of the Gold King Mine Old Adit on July 14, 2015 (water level as assumed by EPA and DRMS), when EPA returned to the site to begin work. More rock and soil and a tree had slid down onto the drains, and seepage was again saturating part of the waste-rock dump (not to scale).

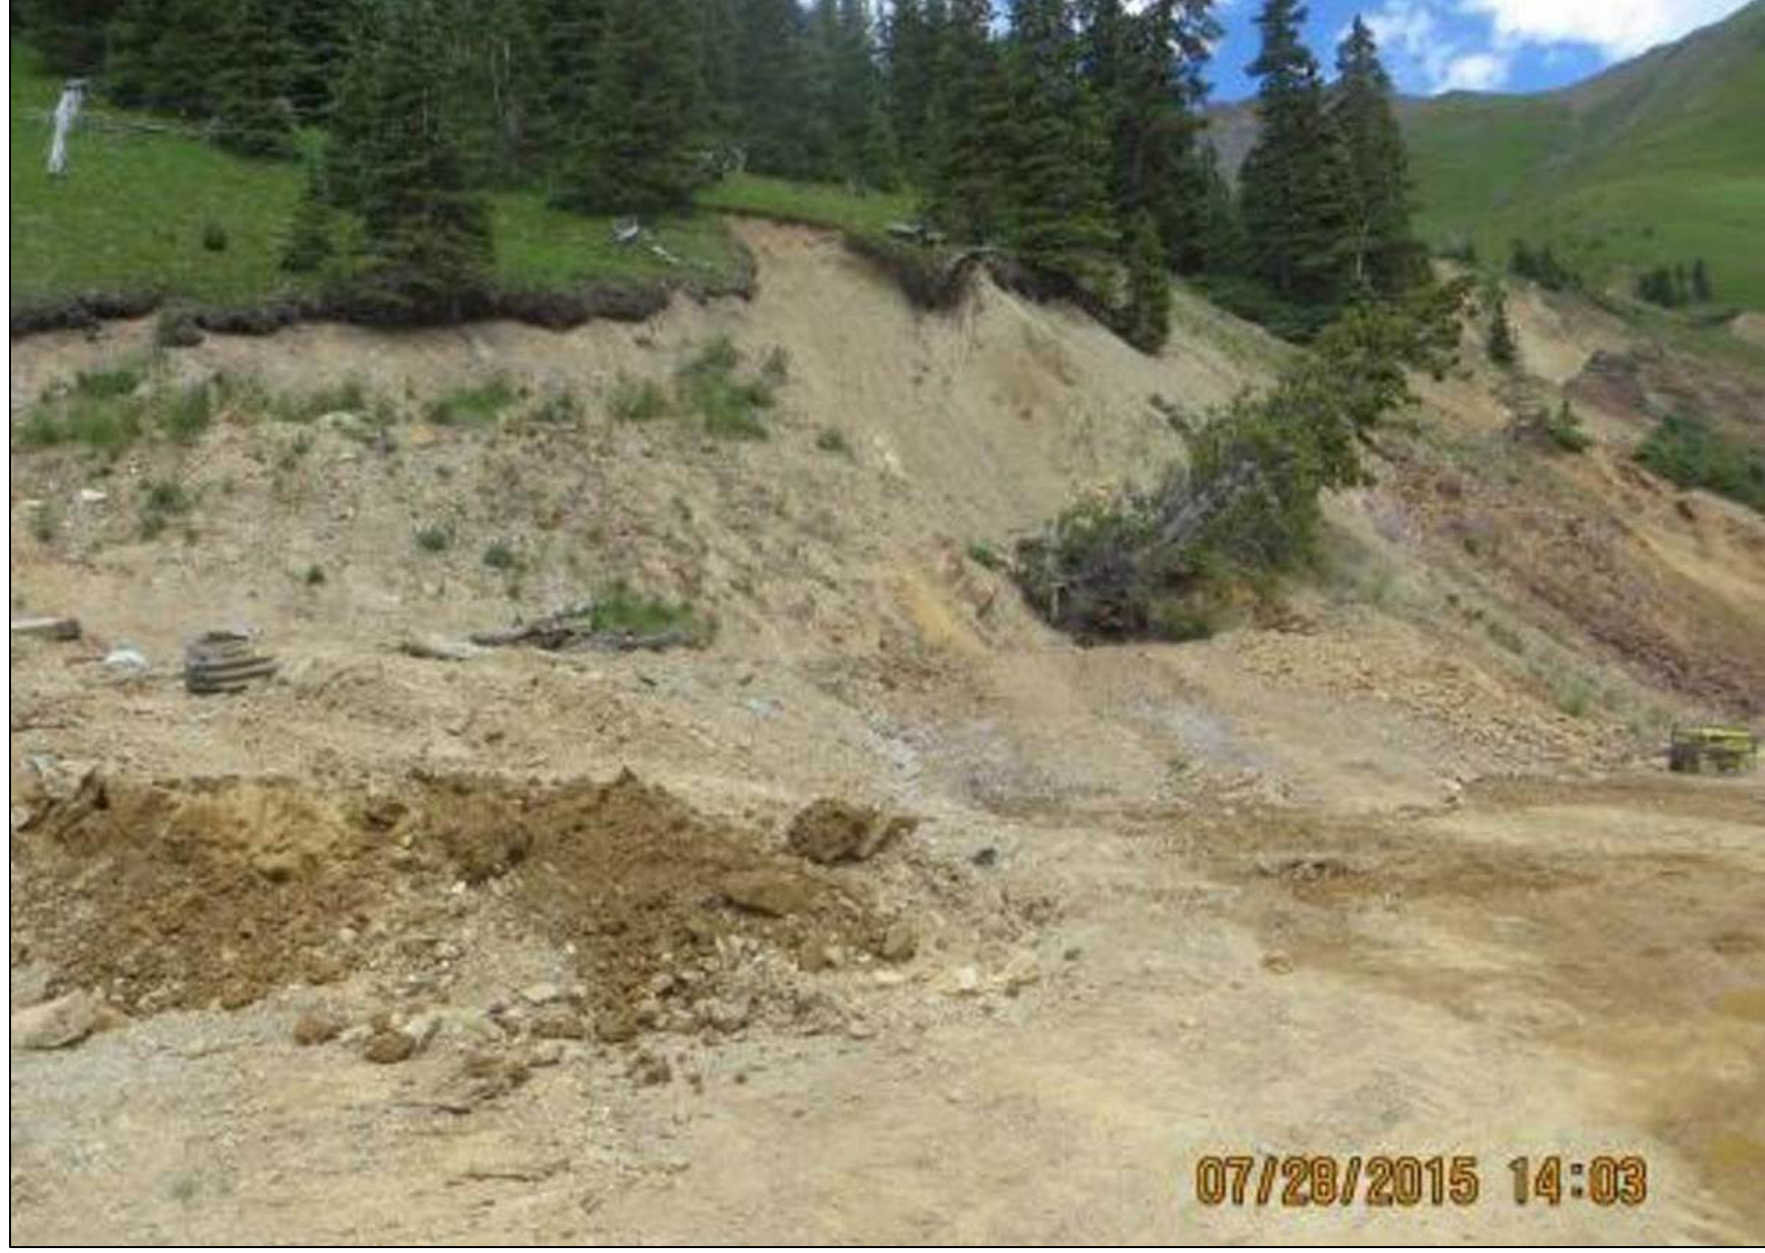
Figure 35.—Photograph showing the condition of the Gold King Mine Level 7 New Adit portal area on July 28, 2015. Note the soil and a tree that has slid downslope onto the portal area; at this time the seepage had been returned to the concrete trough, and the dump was drying out (photograph from EPA project files).

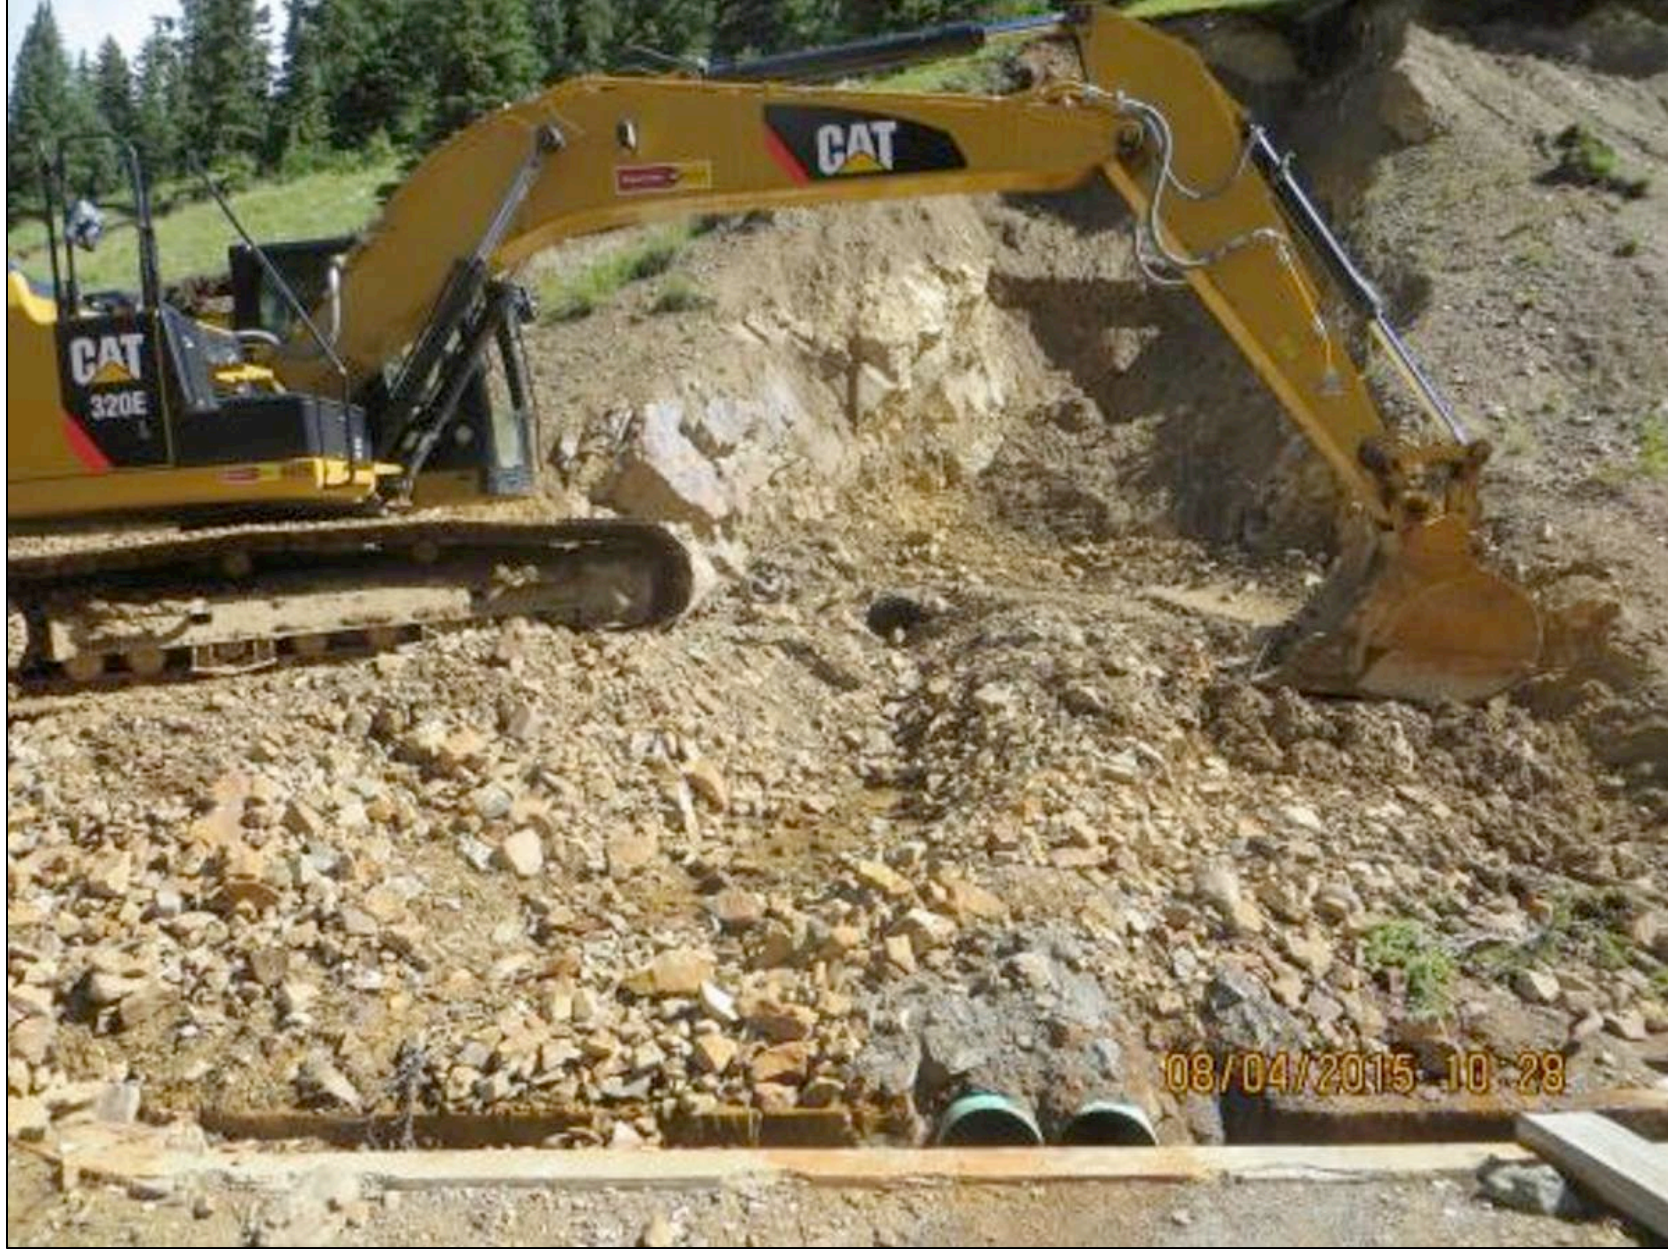
Figure 37.—Photograph showing additional excavation at the Gold King Mine Level 7 New Adit at 10:28 a.m. August 4, 2015 (photograph from EPA project files).

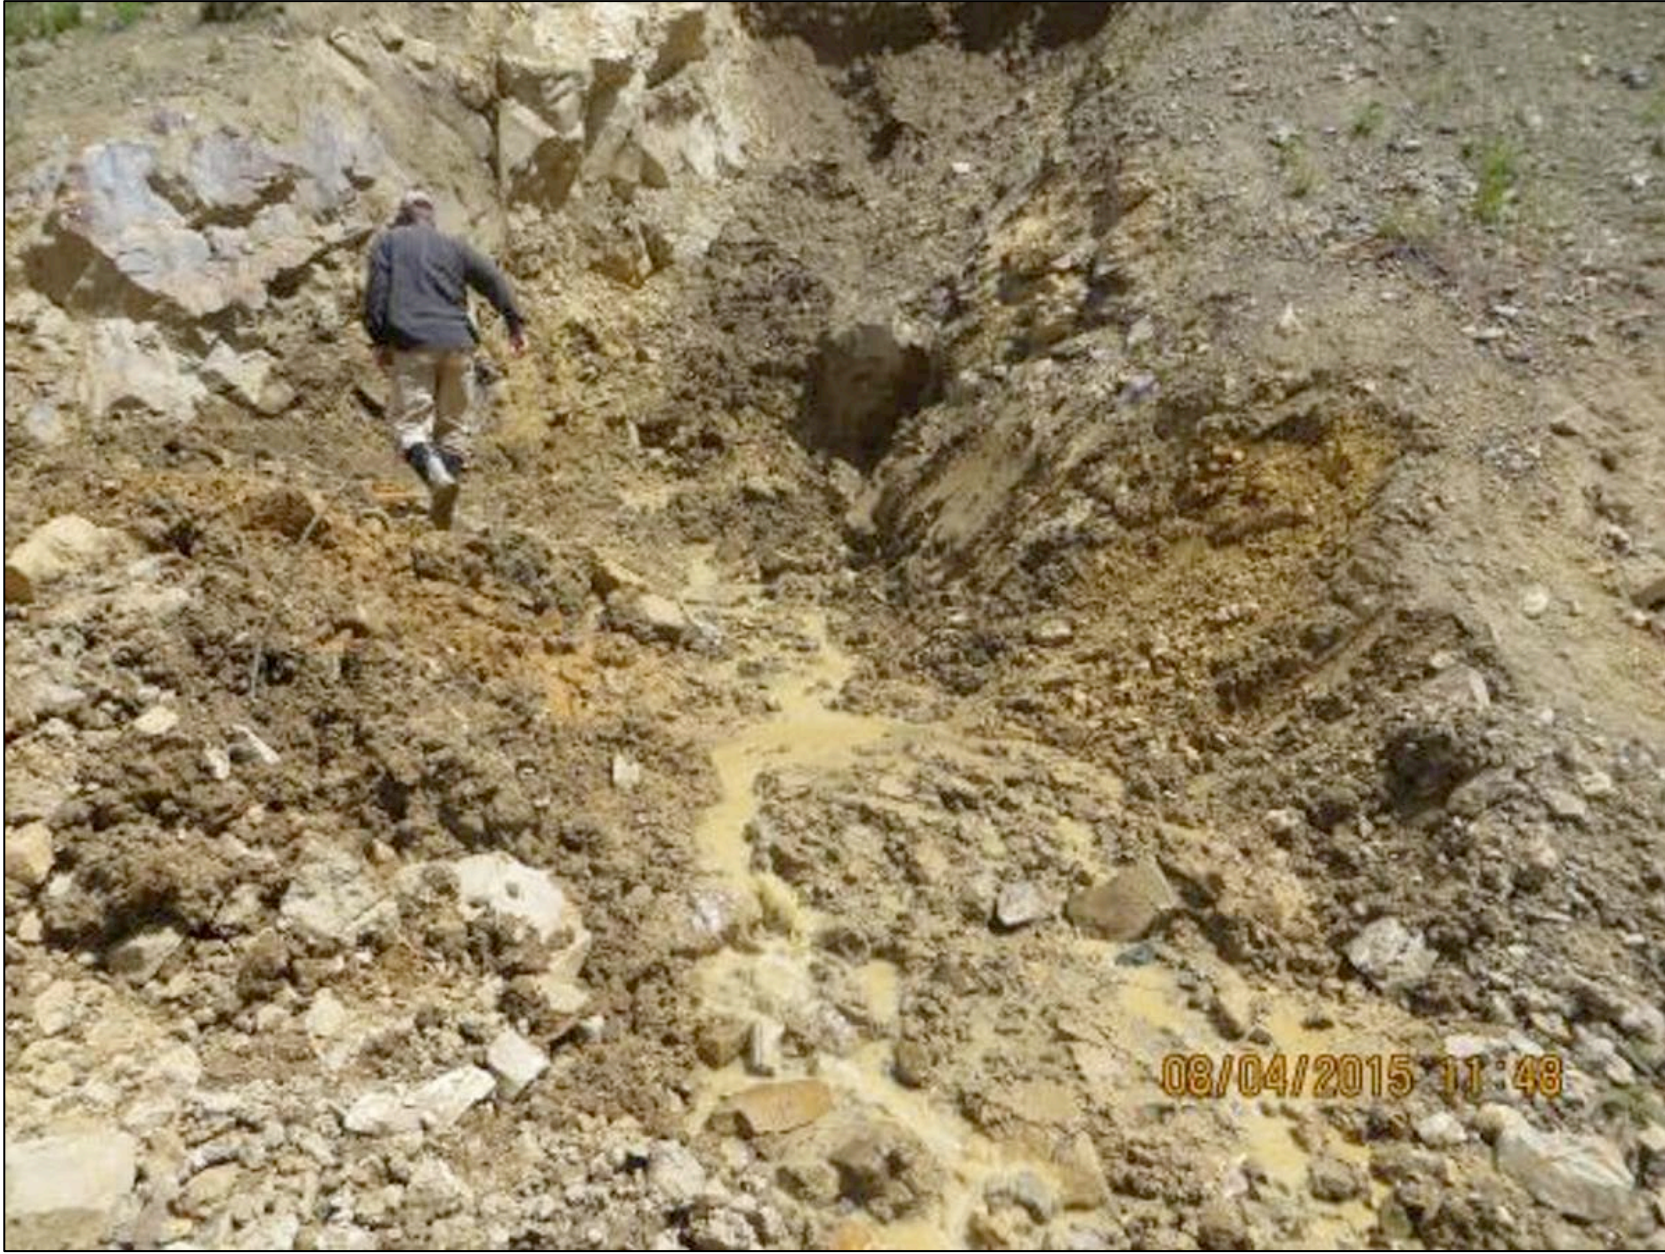
- EPA, DRMS, and the contractors reportedly believed they could use a similar plan to what was done at the Red and Bonita Mine in 2011
- This was because the seepage they were observing at that time in the excavation of the fill covering the mine portal was at an elevation corresponding to that of a partially full mine adit.

Figure 38.—Photograph showing seepage flow from the excavation at the Gold King Mine new portal at 11:48 a.m. on August 4, 2015. The flow is emerging approximately 5 to 6 feet above the floor of the adit (photograph from EPA project files).
