Gold King Mine Incident

CASE STUDY IN CRITICAL THINKING

CE 4200

Technical Evaluation of the Gold King Mine Incident

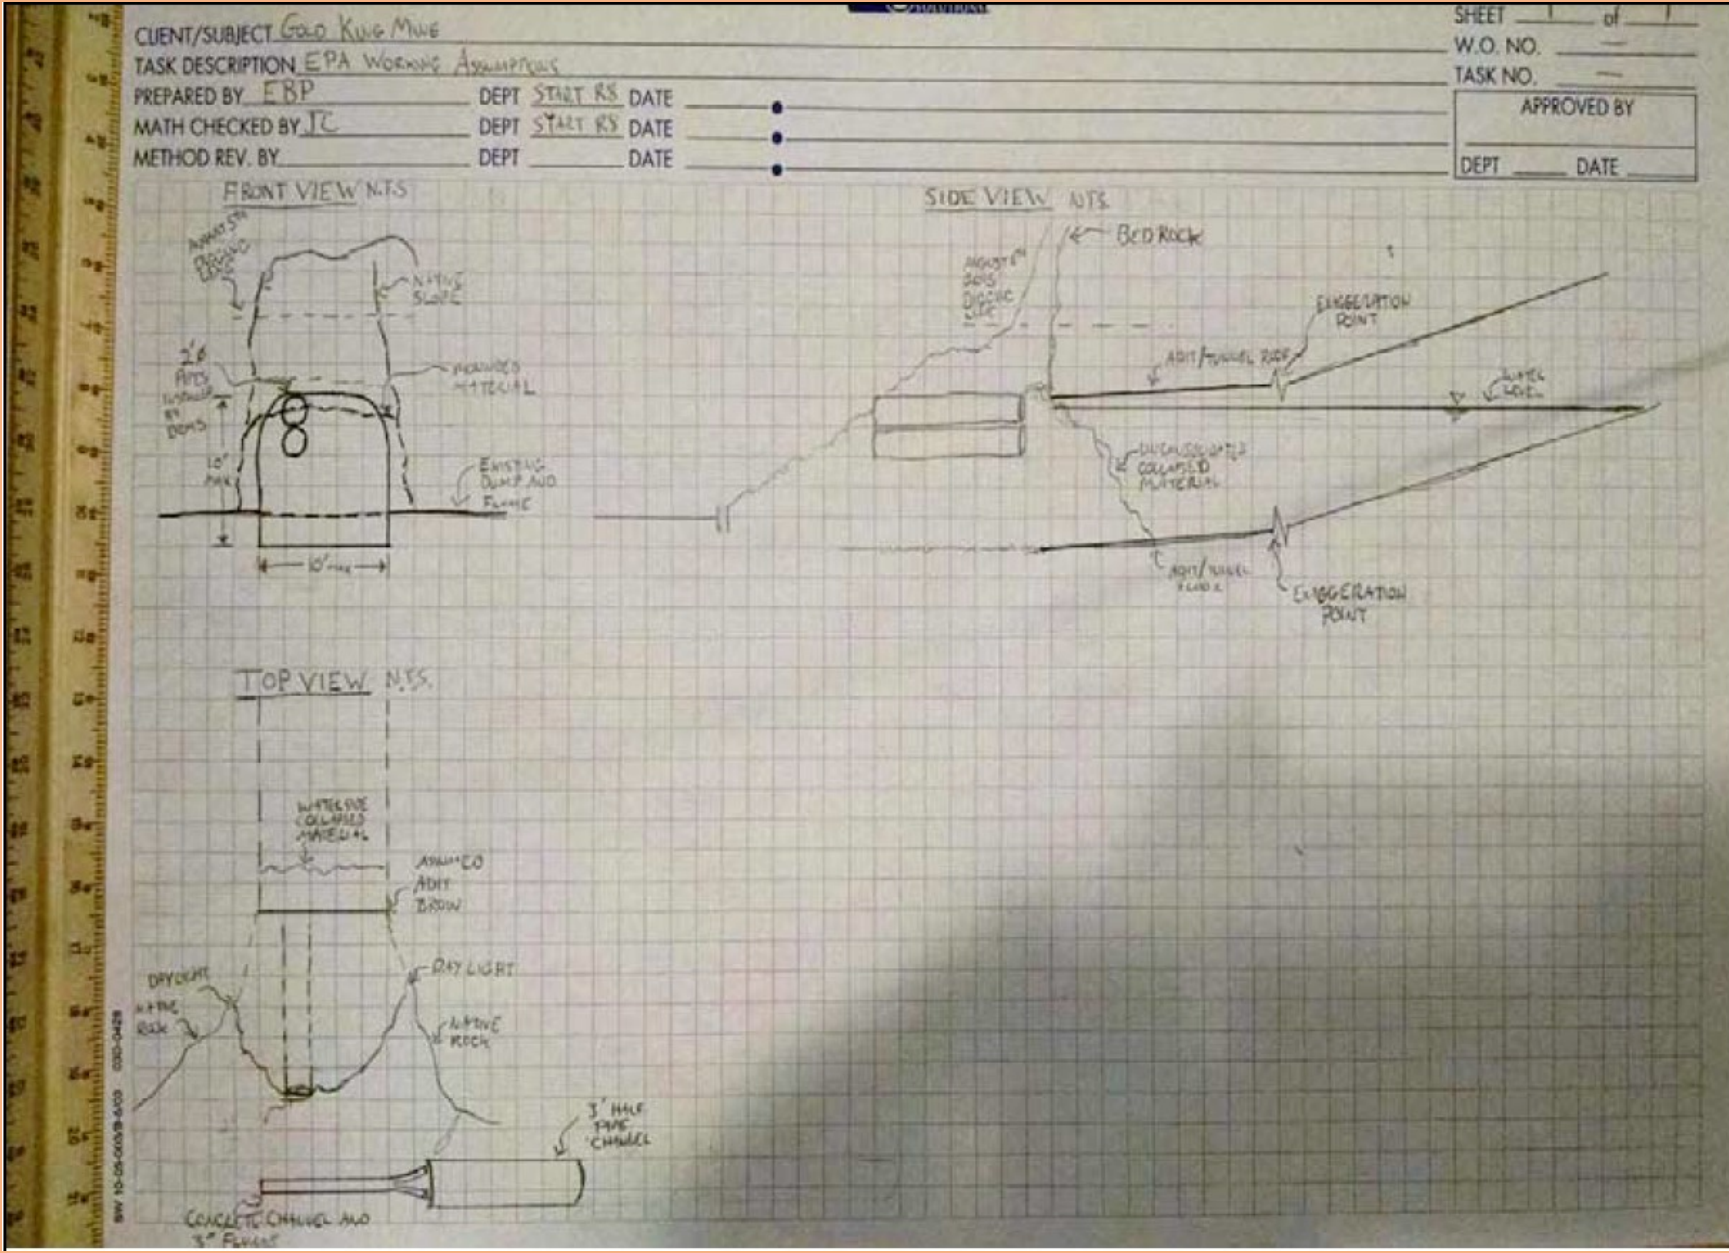
- Figure 39 shows a sketch of the plan to open the Gold King Mine Level 7 New Adit portal. To provide a margin of safety, the plan assumes the water was more than 5 feet deep on the upstream side of the blockage, but still below the adit roof
- The cross-section view from figure 39 was used as the basis for illustrating the steps that EPA was going to take to open the adit
- A key aspect of their plan was to only excavate fill lying above the assumed top of the water inside the adit. This method would leave in place the fill holding back the water
- The next step would push a steel pipe called a “stinger” through the top of the fill to gain access to the mine pool

Figure 39.—Photograph showing the sketch used by EPA to illustrate the conditions at the Gold King Mine Level 7 New Adit portal (photograph from EPA project files).

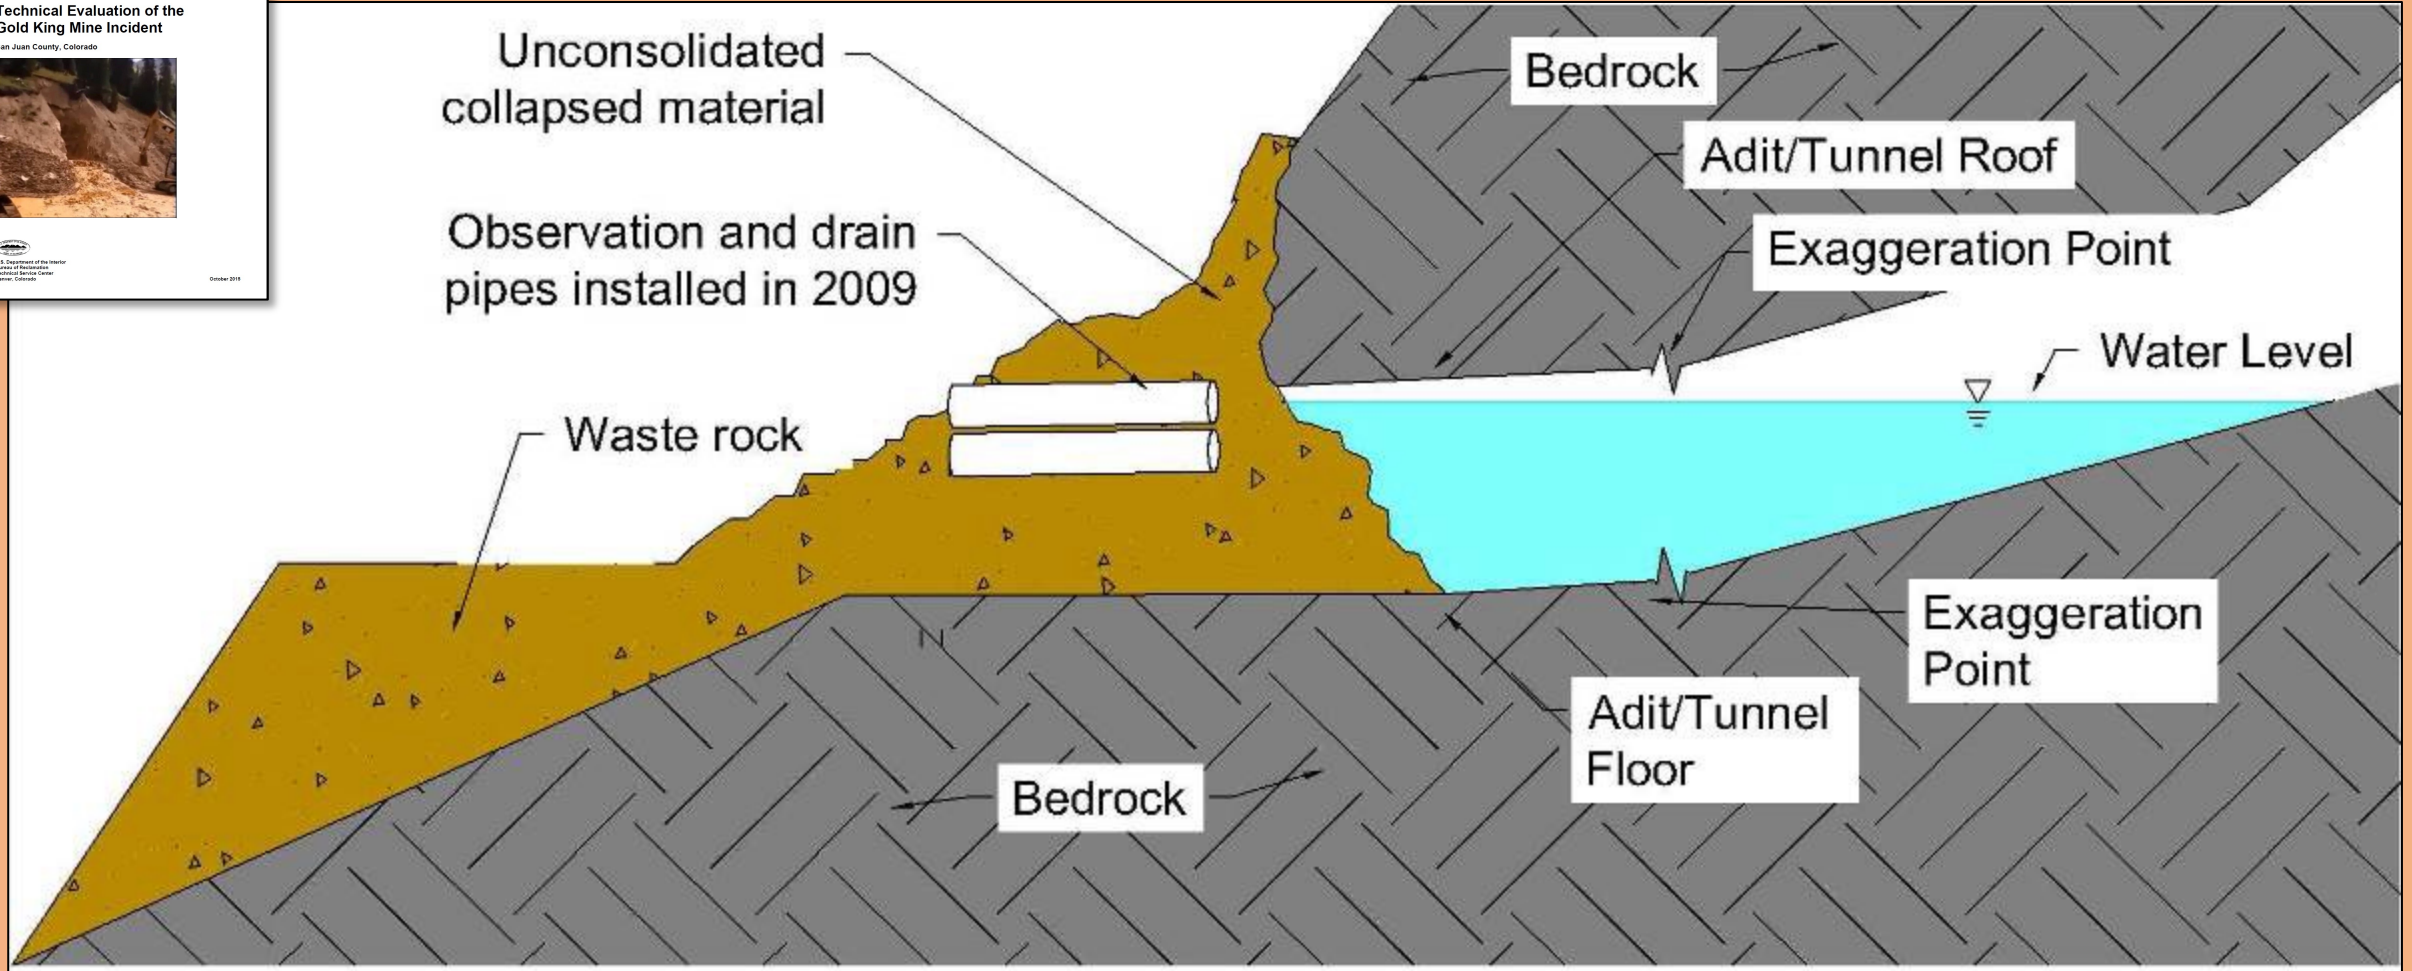
Figure 40.—Cross-section illustration showing the condition of the adit that was assumed by the EPA OSC and the abandoned mine experts from DRMS for use in planning to open the adit (not to scale). The “exaggeration point” means the right side of the drawing has an exaggerated vertical scale in order to show the 1% uphill slope of the adit. If drawn without exaggeration, the uphill slope of the adit would not be obvious on the drawing.

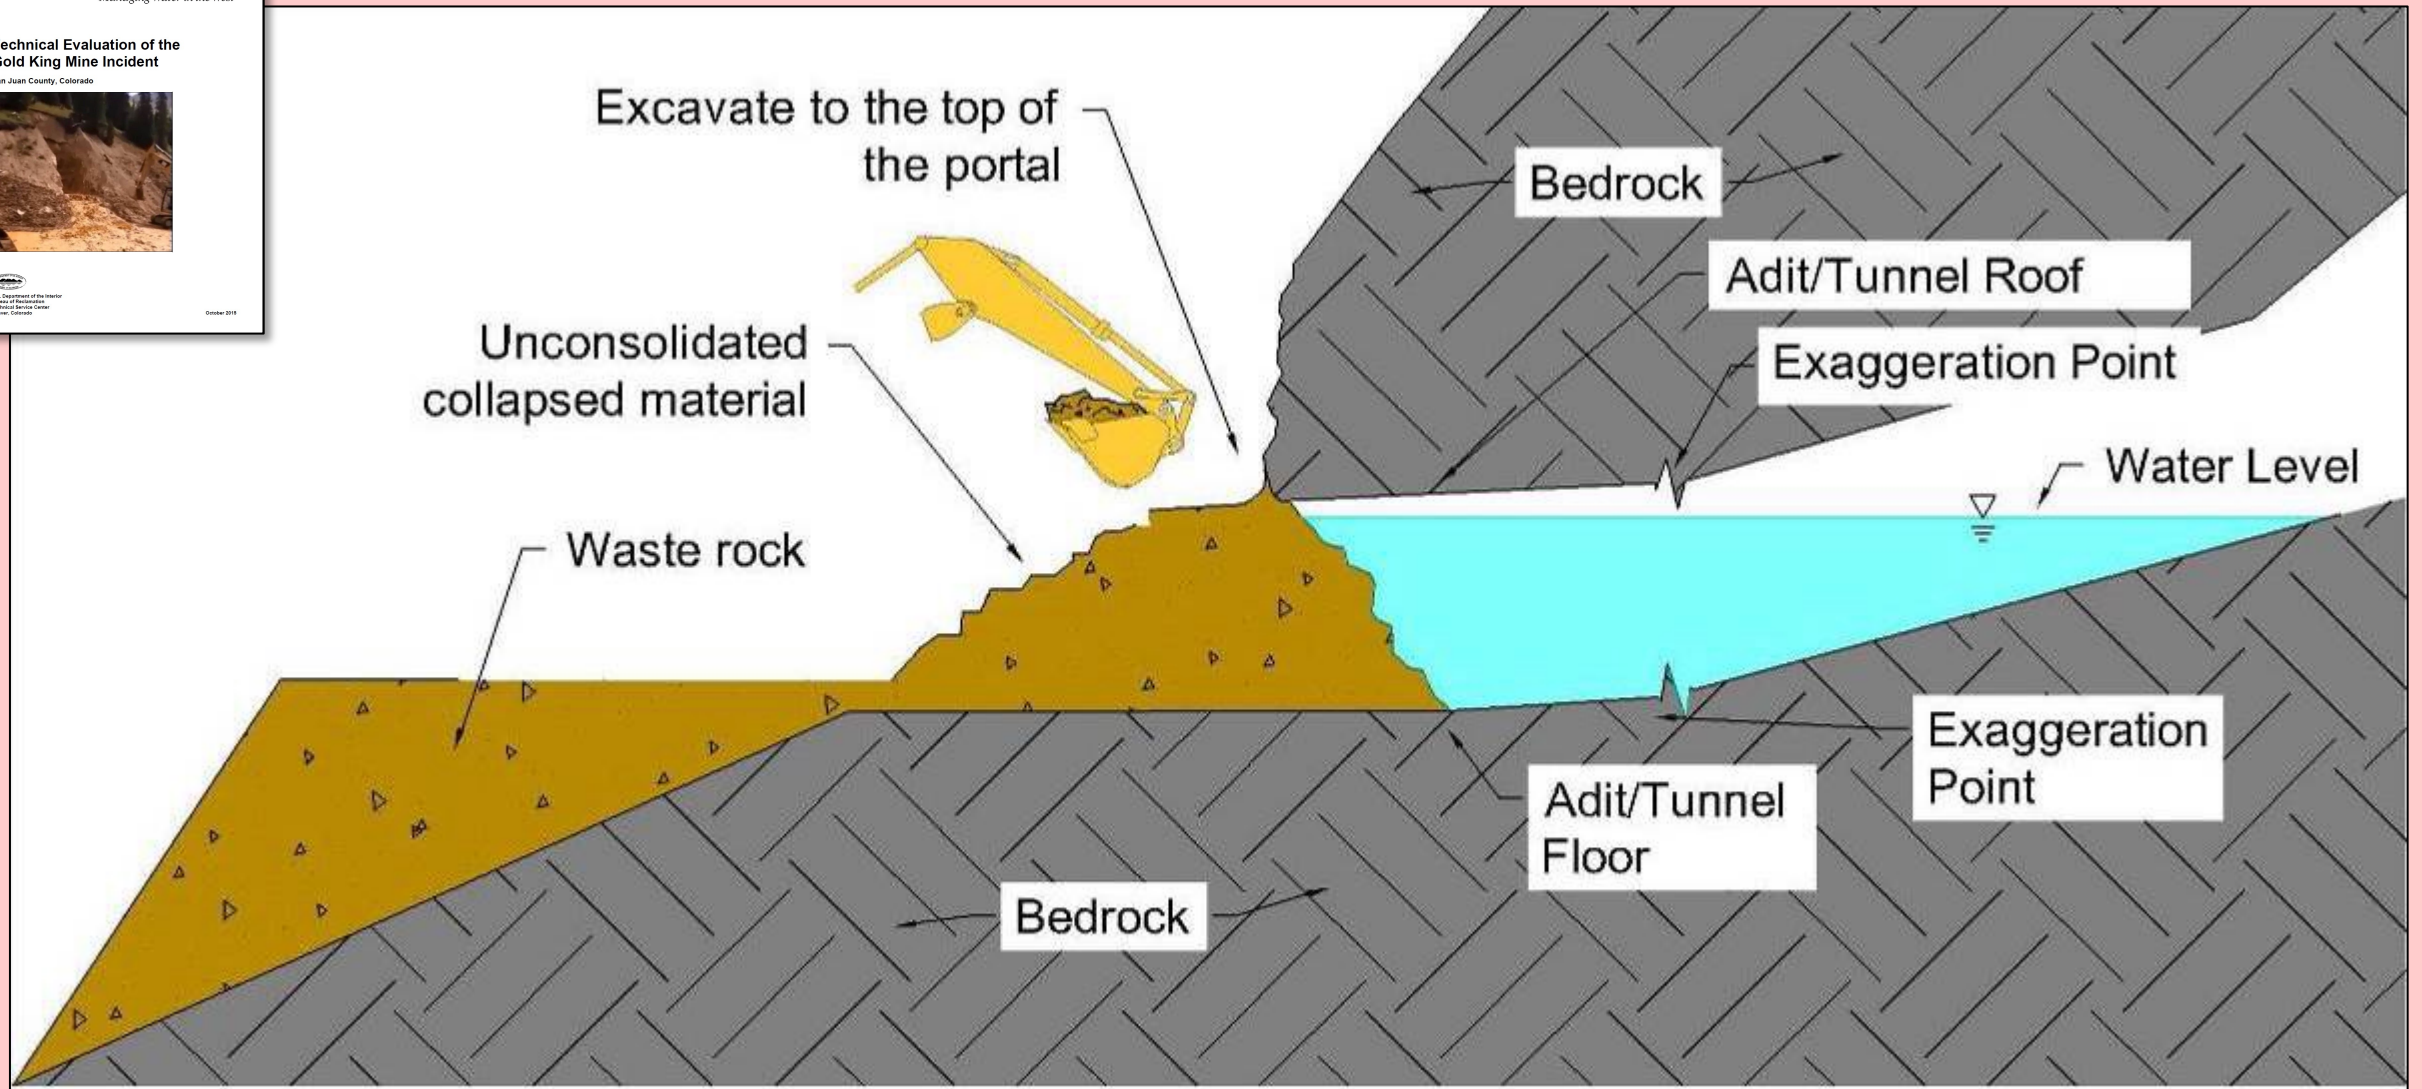
Figure 41.—Cross-section illustration showing step 1, the initial excavation to remove the drain pipes and backfill and then carefully excavate the collapsed material to expose the bedrock in the slope above the adit (not to scale).

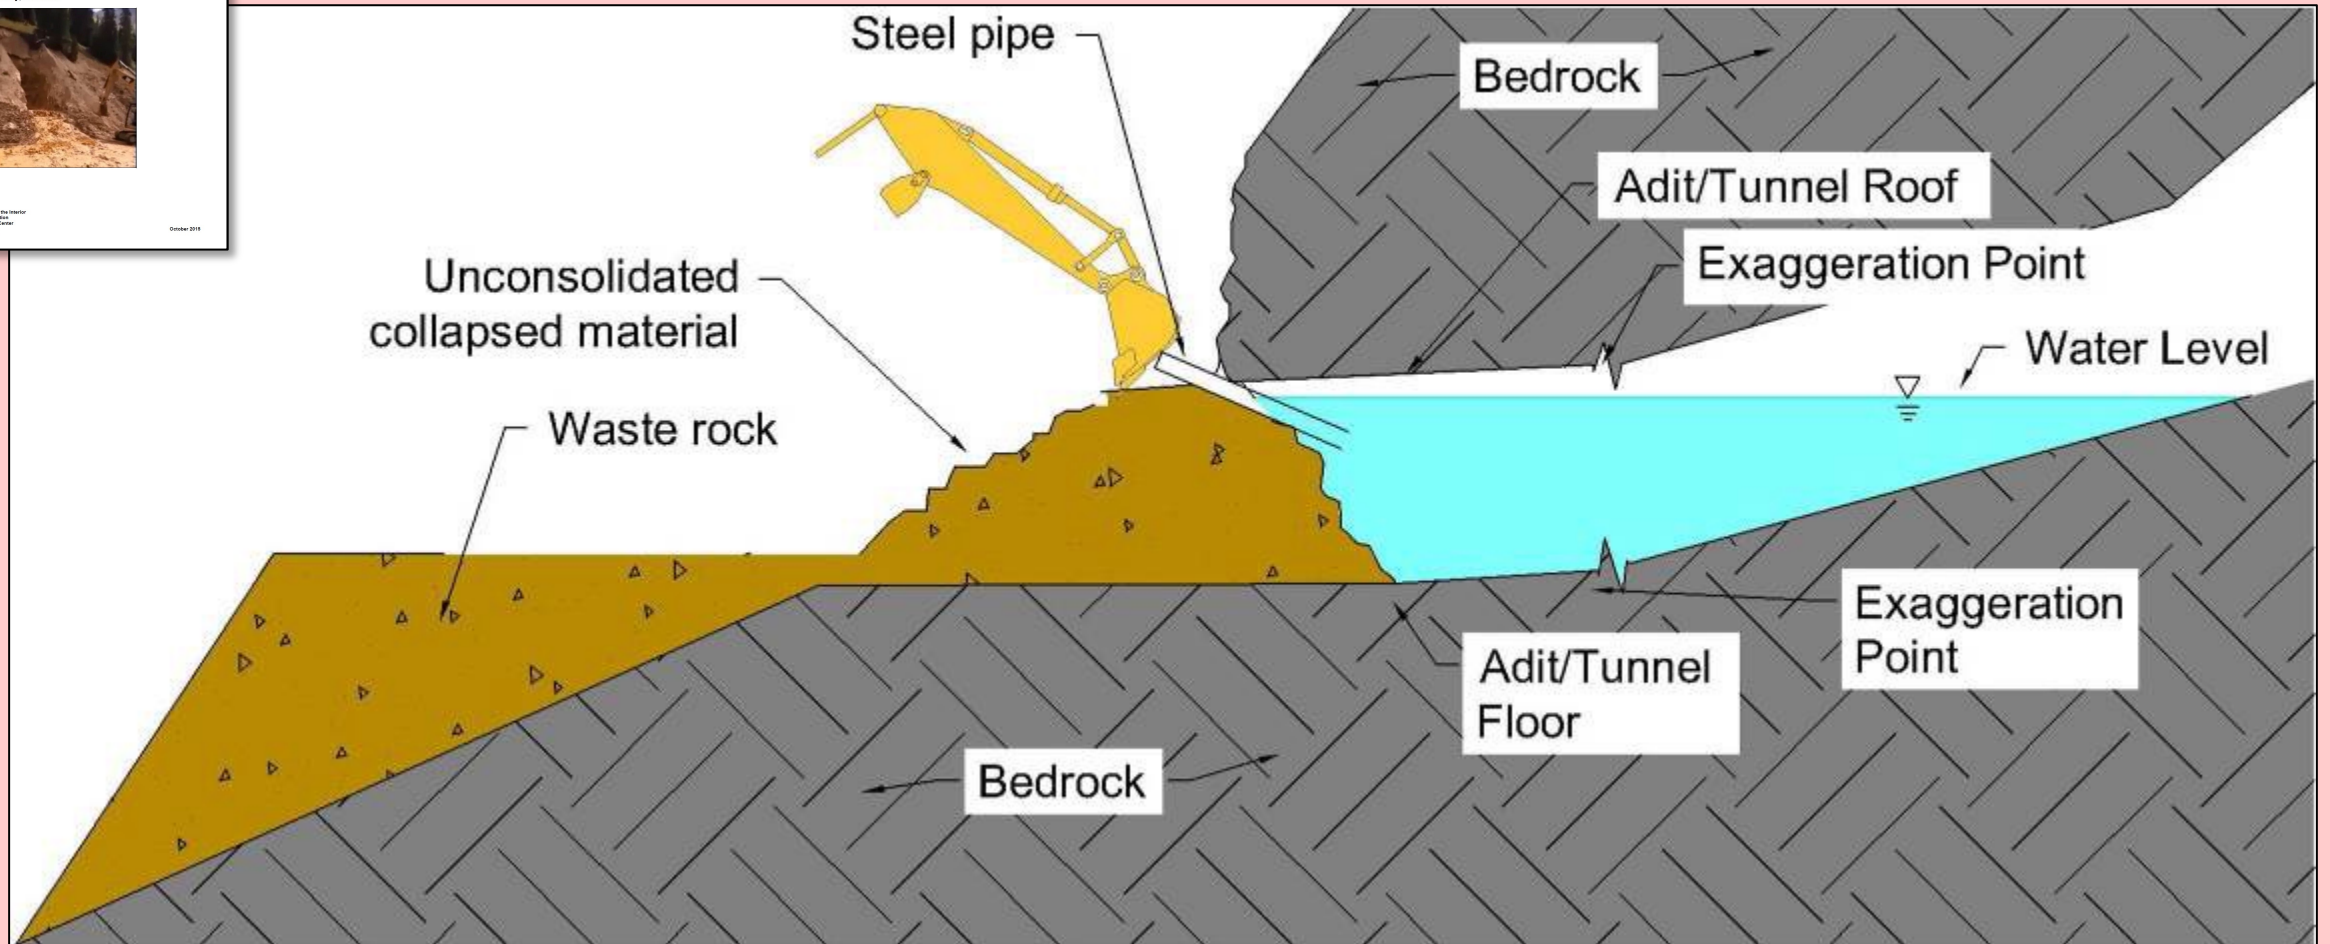
Figure 43.—Cross-section illustration showing step 3 of the plan (not to scale). With the bedrock above the crown of the adit exposed as a guide, a steel pipe called a “stinger” is positioned and pushed into the fill using the bucket of the hydraulic excavator. With the steel pipe fully inserted, contact is made with the water impounded inside the mine.

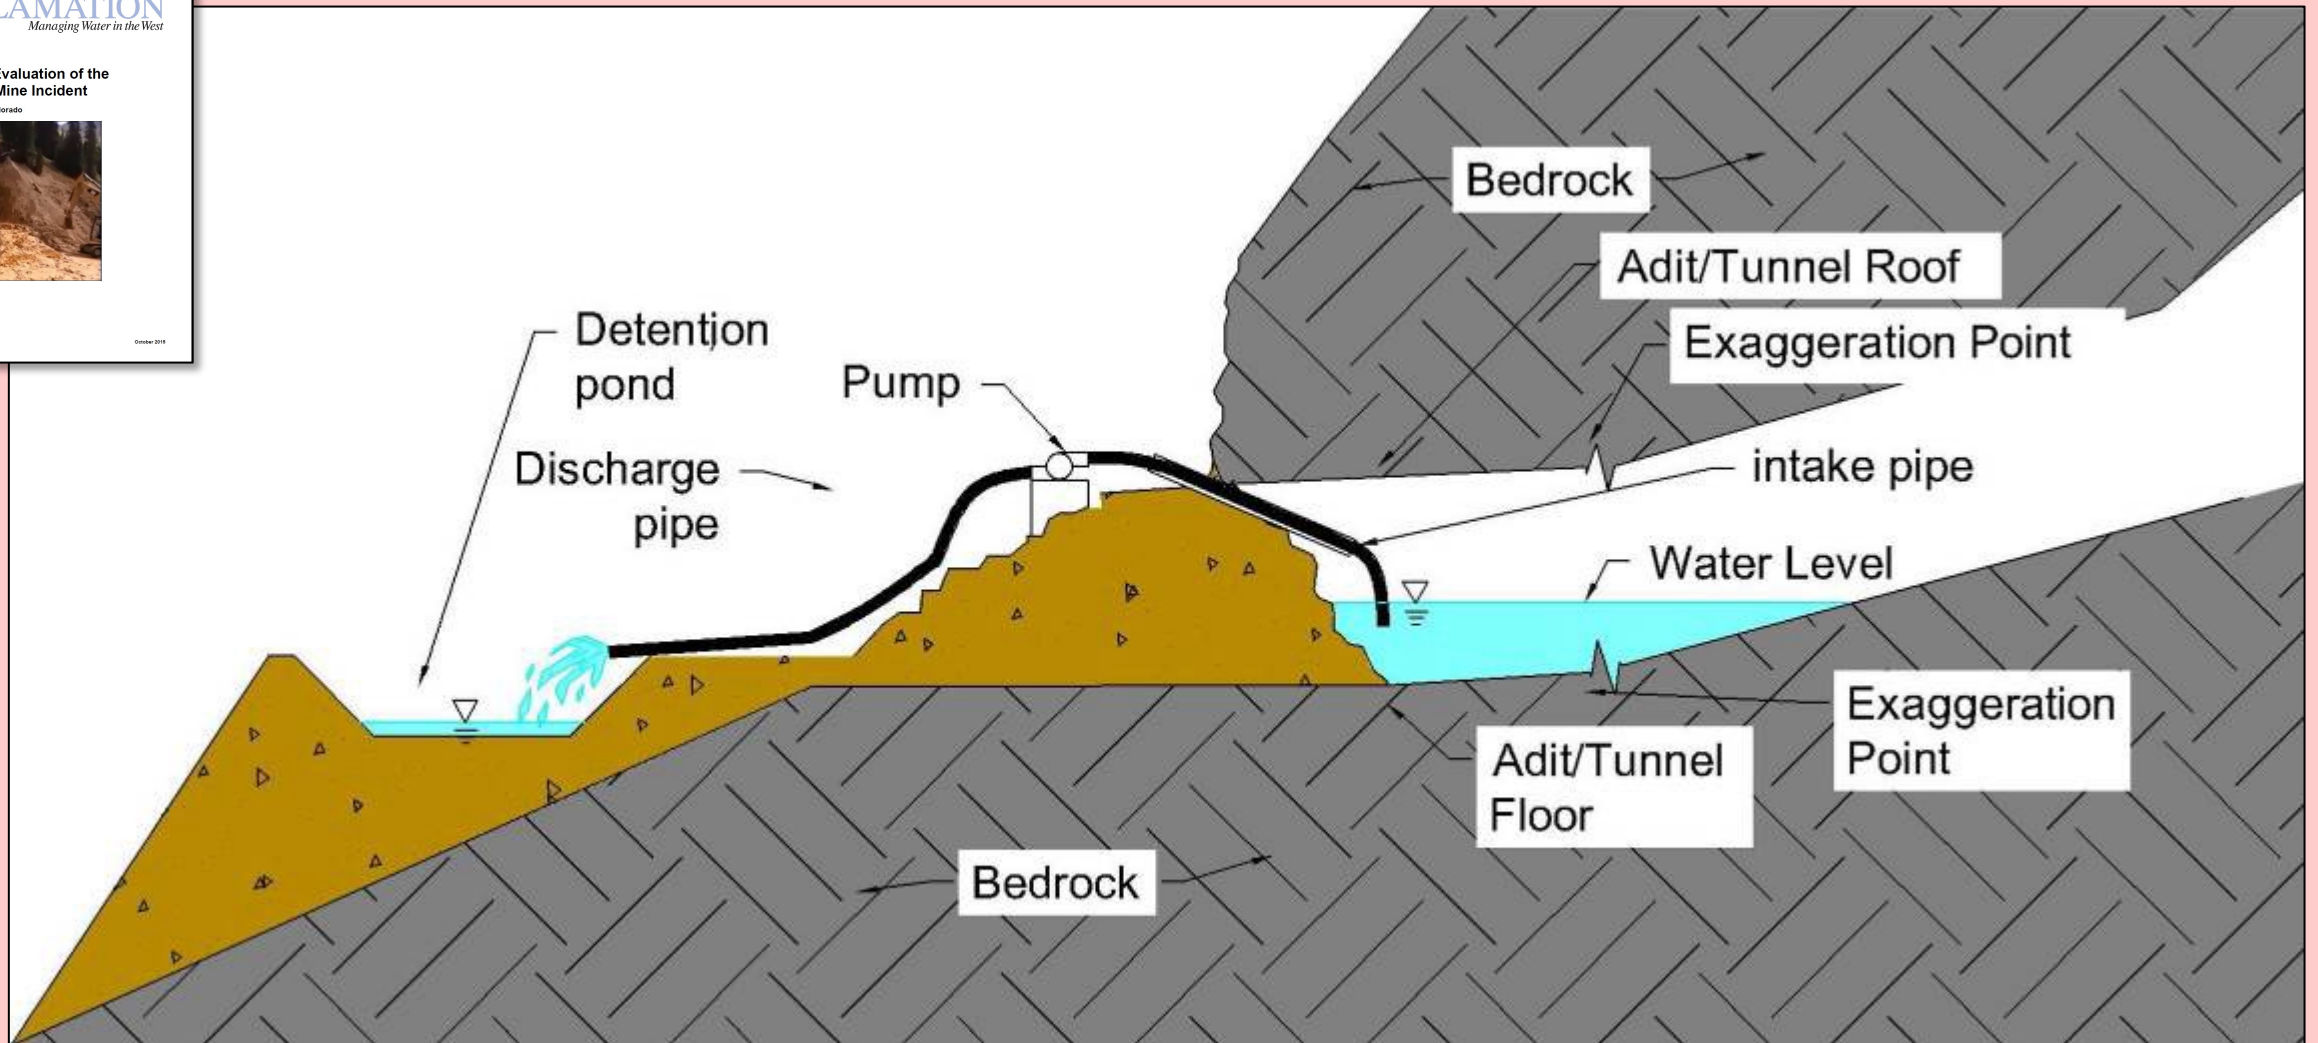
Figure 44.—Cross-section illustration showing step 4 of the plan (not to scale). An intake hose from a pump is inserted into the steel pipe. The pump discharge is taken to a small pond constructed on the waste rock dump. Water from the adit is pumped down. Not shown on this illustration is that the water in the small pond would be continuously removed by another pump and sent to treatment elsewhere on the site.

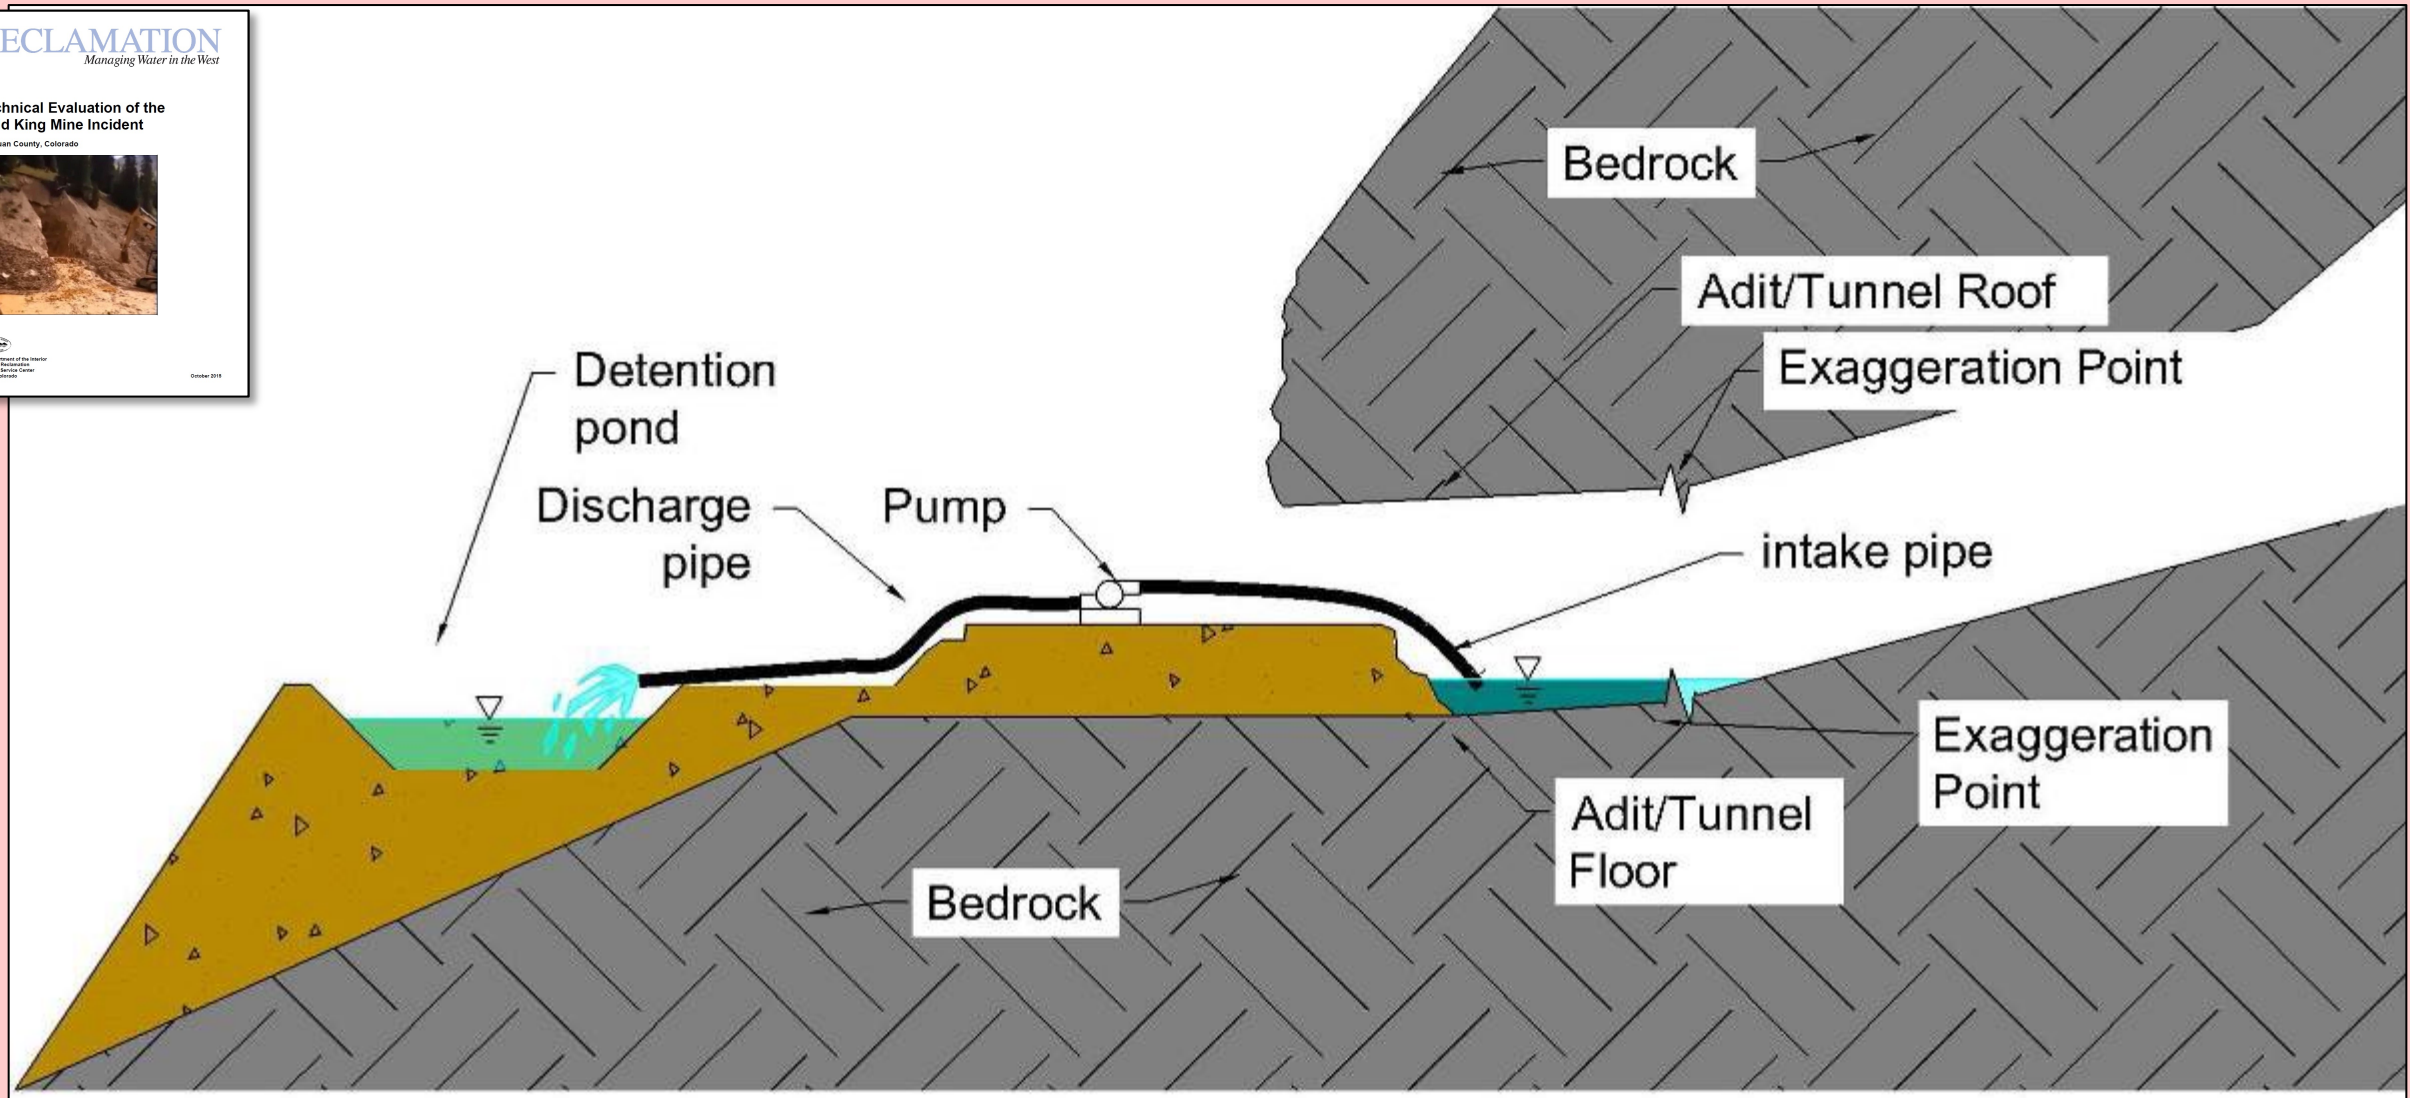
Figure 45.—Cross-section illustration showing step 5 of the plan (not to scale). As the water inside the mine is drawn down by pumping, additional fill from the blockage is excavated and the pump is repositioned to a lower level on the remaining fill. This step is repeated until all the impounded water and the remaining fill is removed; this will establish access to an open adit with the flow freely draining out.

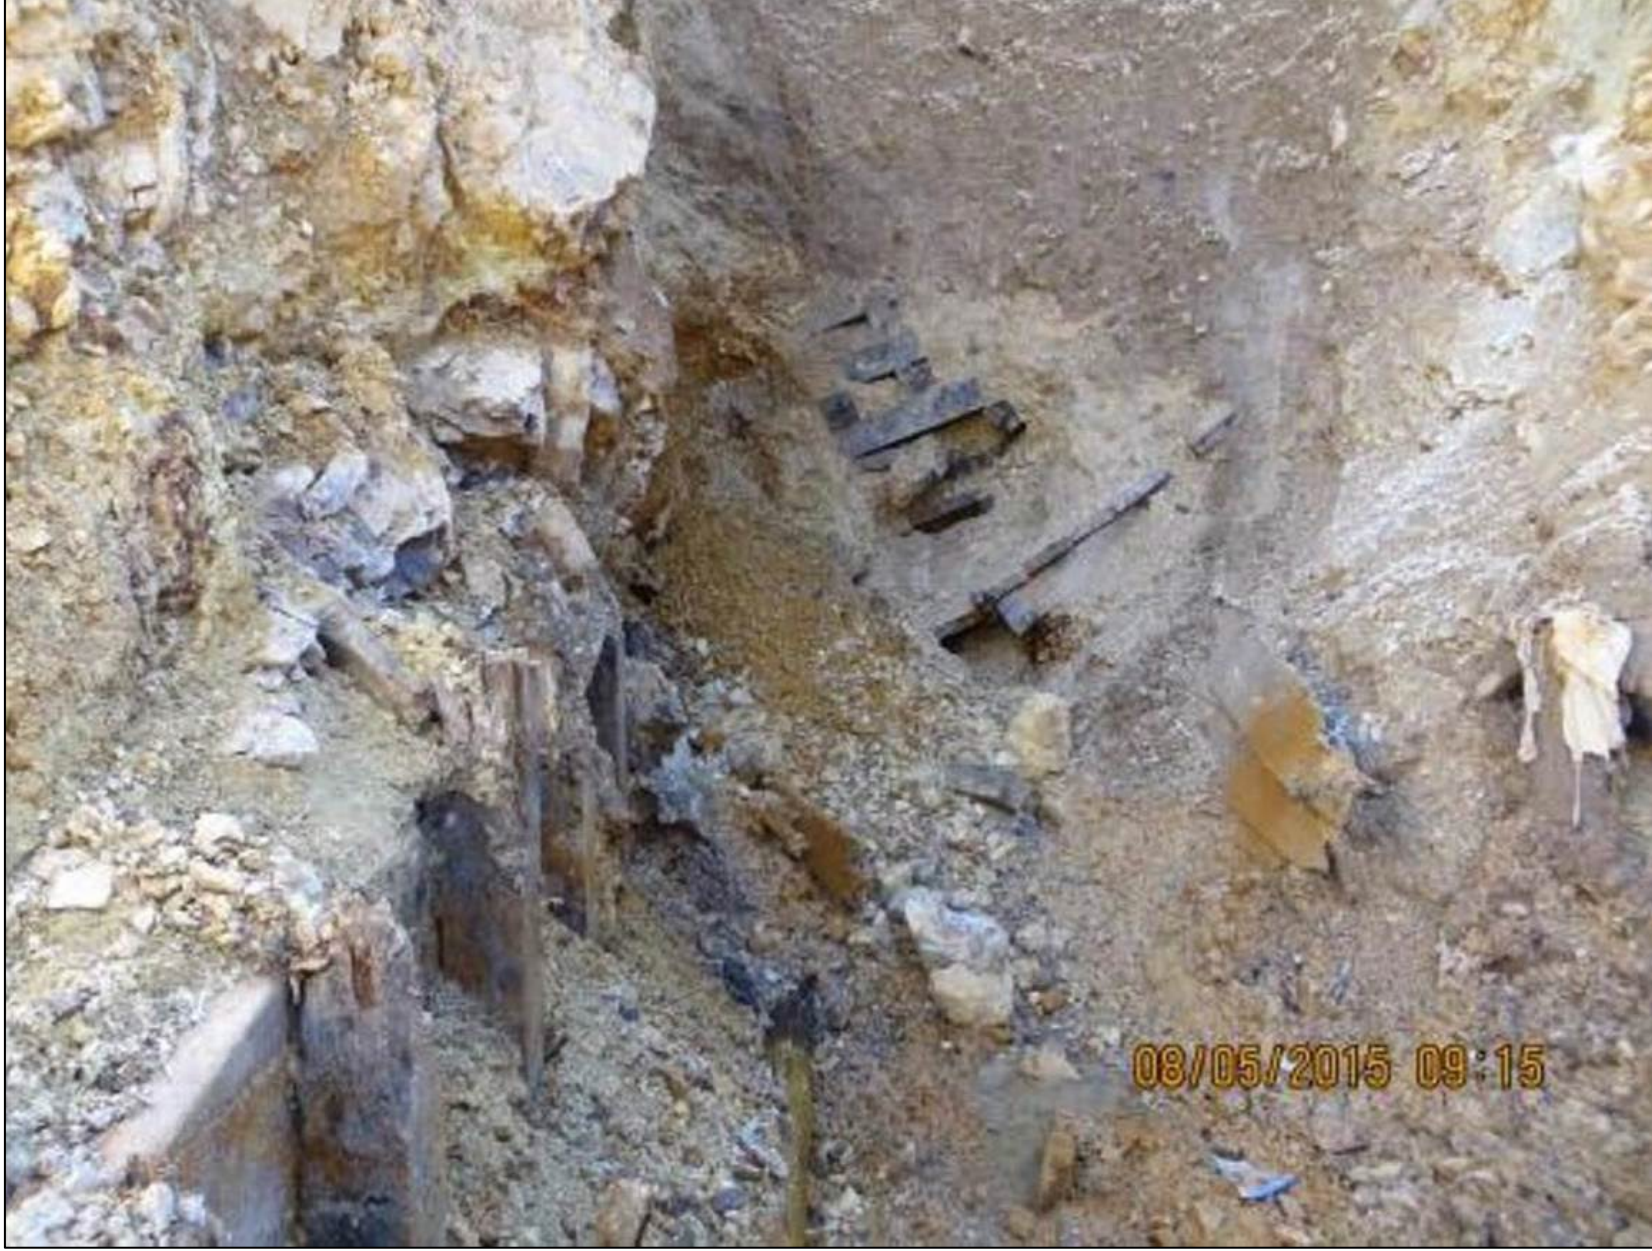
Figure 46.—Photograph taken at 9:15 a.m. August 5, 2015, showing the Gold King Mine Level 7 New Adit excavation uncovering mine timbers and lagging (photograph from EPA project files). Minor seepage is visible just to the left of the date stamp where a small puddle has formed. Note the soil in the upper end of the excavation above the timber lagging.

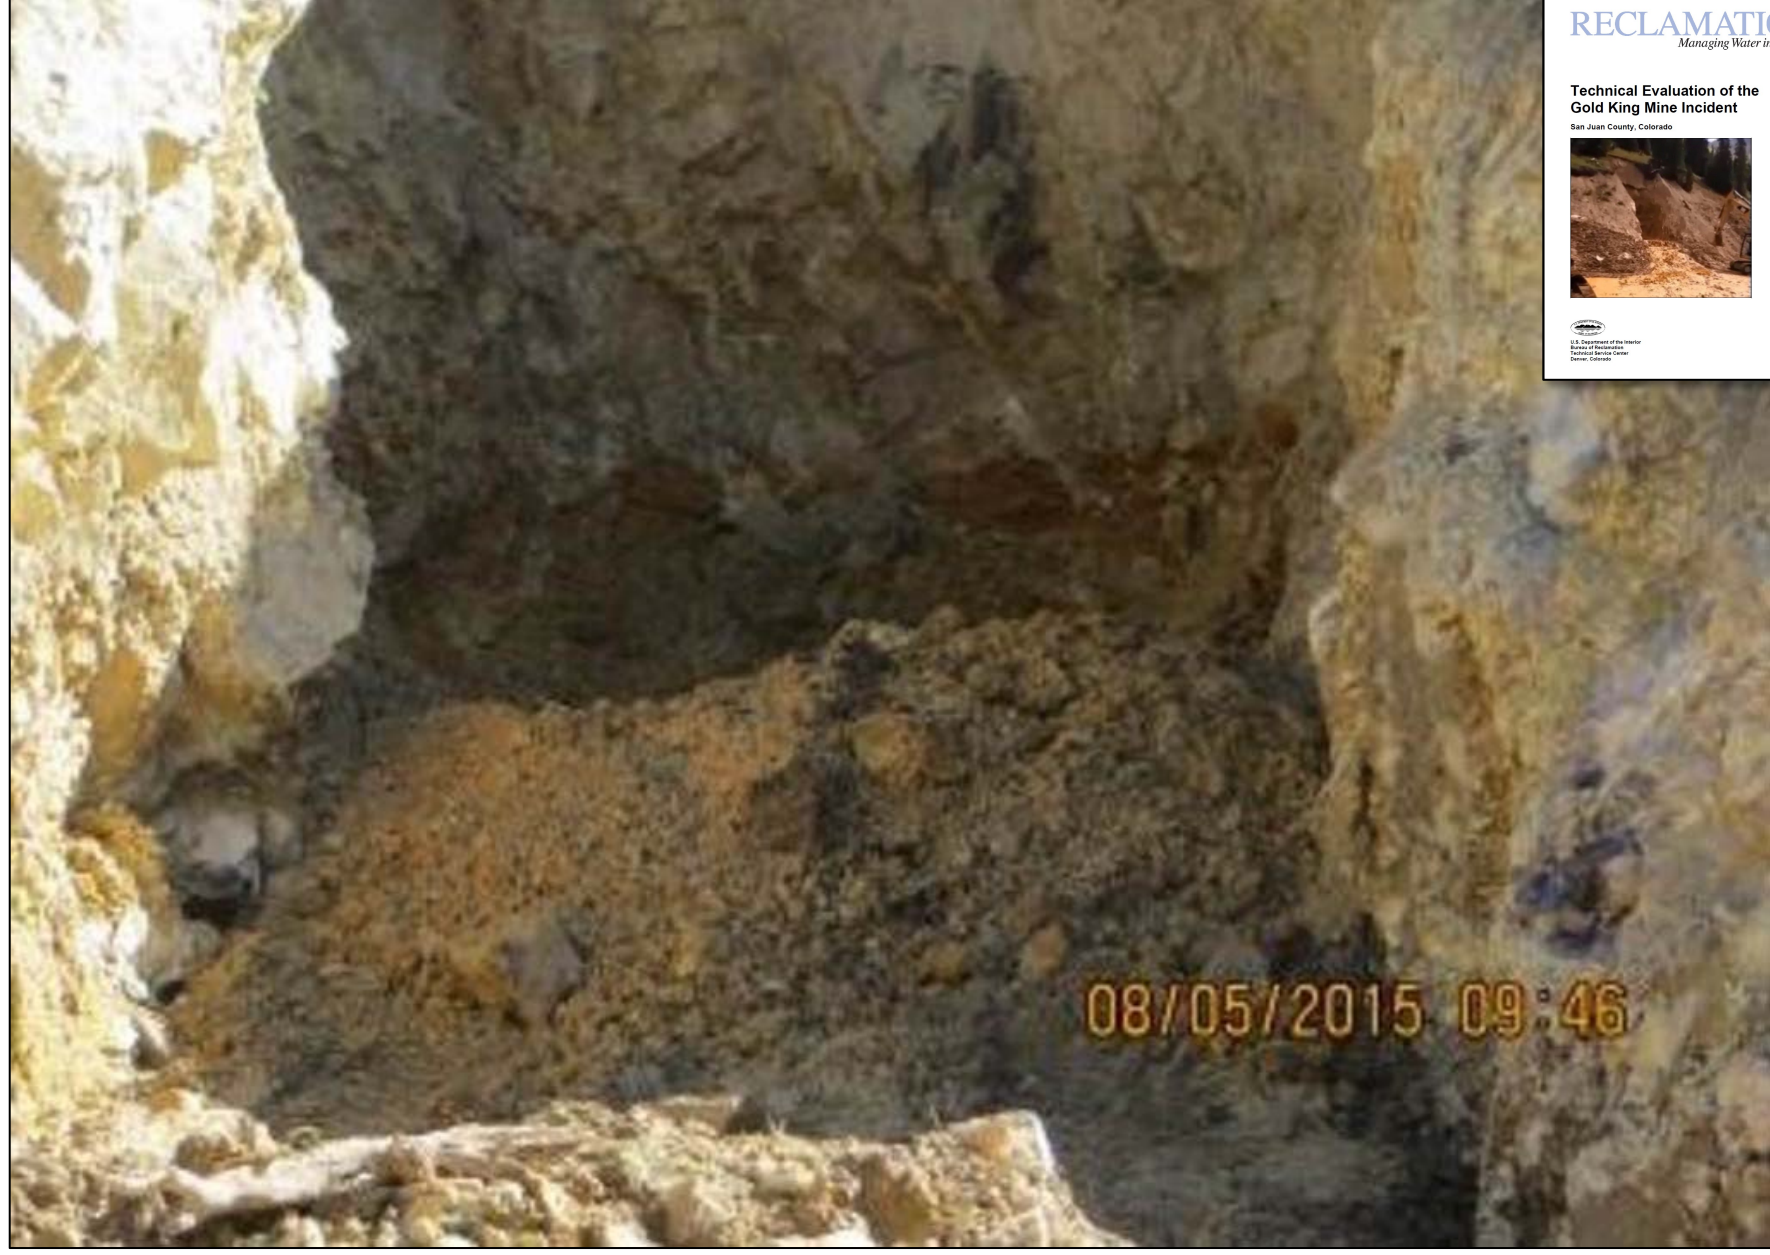
Figure 47.—Photograph taken at 9:46 a.m. August 5, 2015, showing that the loose soil from the upper end of the excavation had been removed exposing fractured and crumbly rock (photograph from EPA project files). The fill derived from the excavation had now covered the timbers, lagging, and seep visible in the previous photograph (figure 46). This indicates that the bottom of the excavation was about 10 feet above the level of the floor of the adit; this corroborates reports that they were digging high, trying to stay above the assumed water level in the adit.

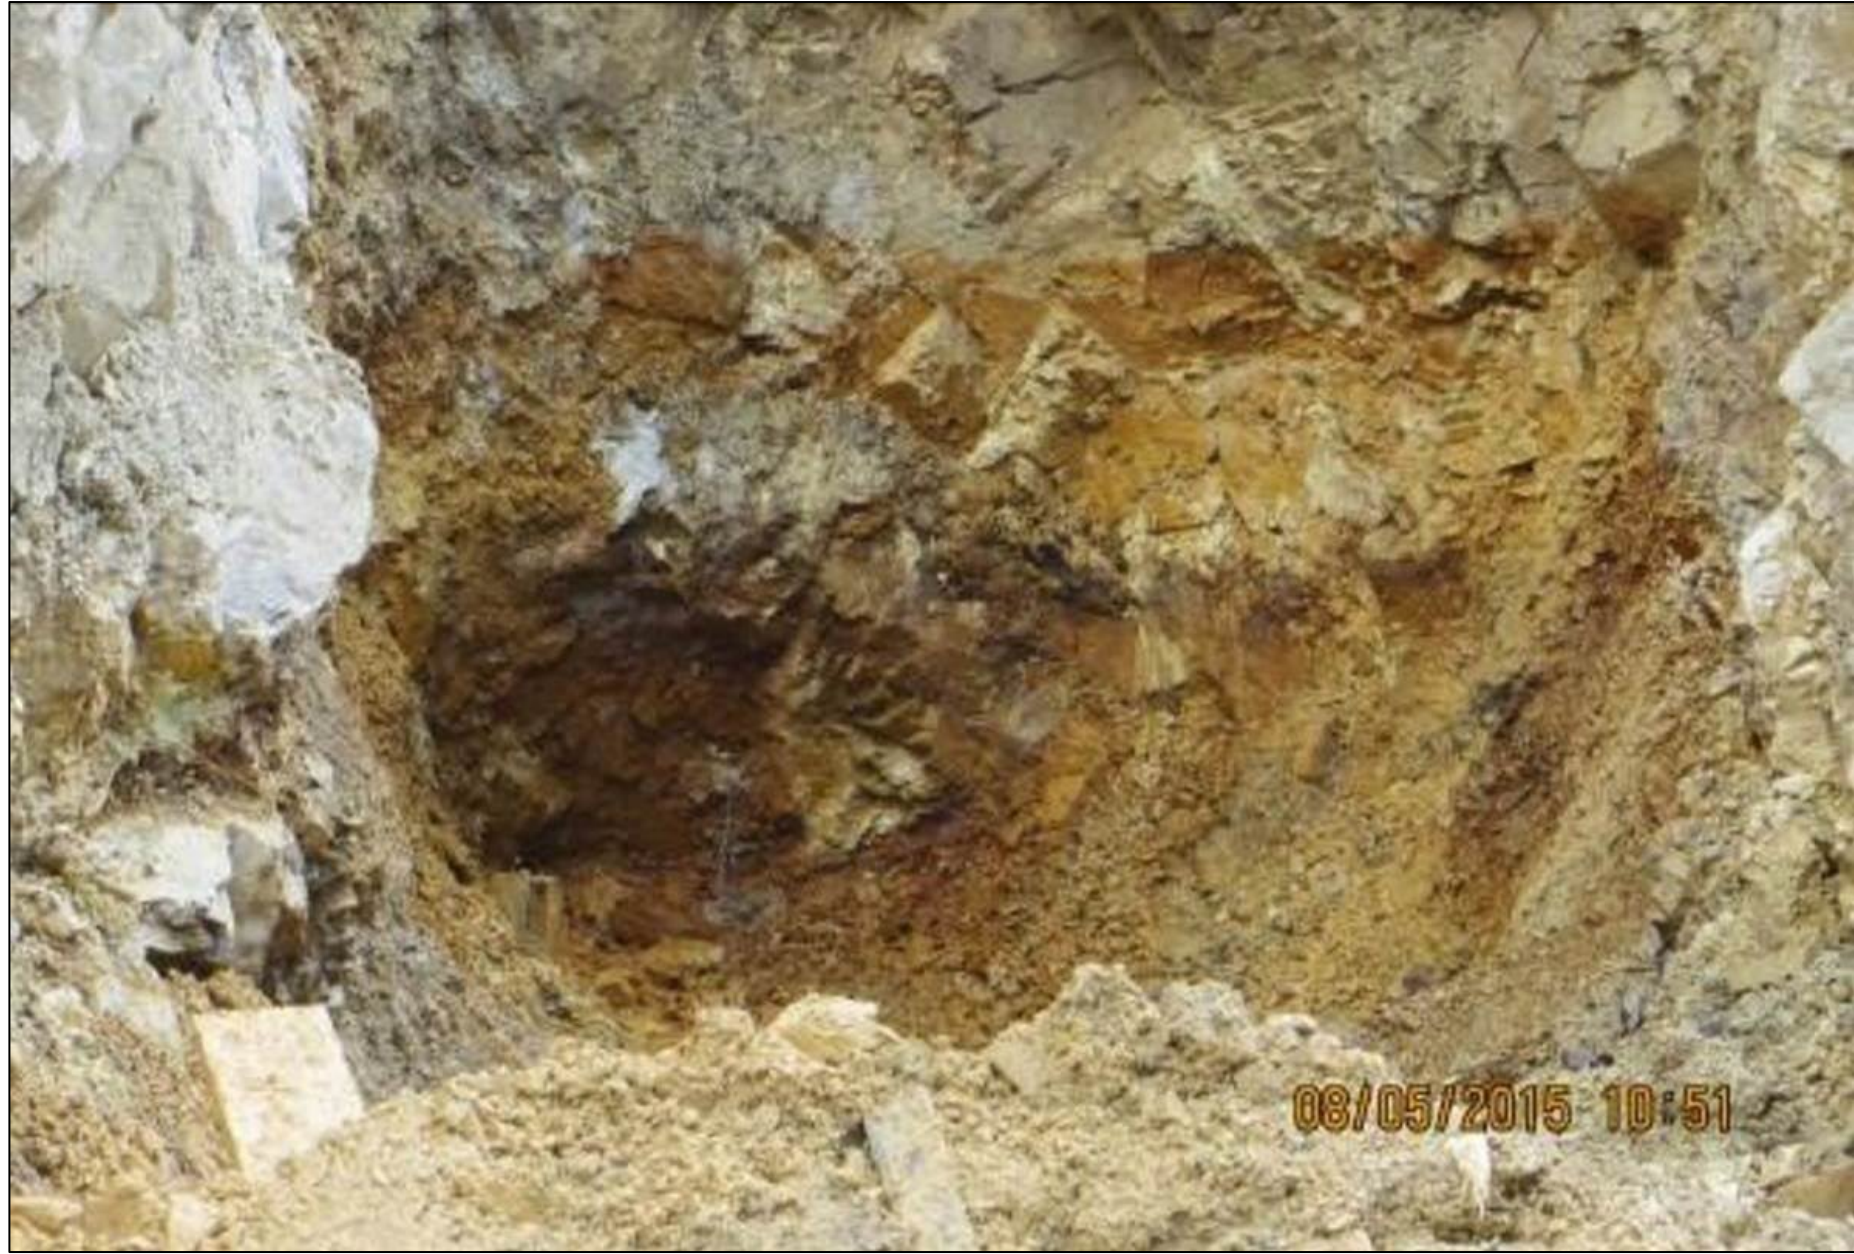
- As the excavator continued to dig on August 5, 2015, the operator reported hitting a “spring”
- He stopped, they removed the excavator, and the EPA OSC went up to look at the conditions
- Within moments, the “spring” began spurting upward 1.5 to 2 feet into the air
- The EPA OSC reported that the water was initially clear and then turned red; in about 3 minutes it turned orange and the flow increased rapidly

Figure 48.—Photograph taken at 10:51 a.m. on August 5, 2015, showing the initial spurt of clear water (photograph from EPA project files). The center of this photograph is shown enlarged in figure 49.
