Gold King Mine Incident

CASE STUDY IN CRITICAL THINKING

CE 4200

Technical Evaluation of the Gold King Mine Incident

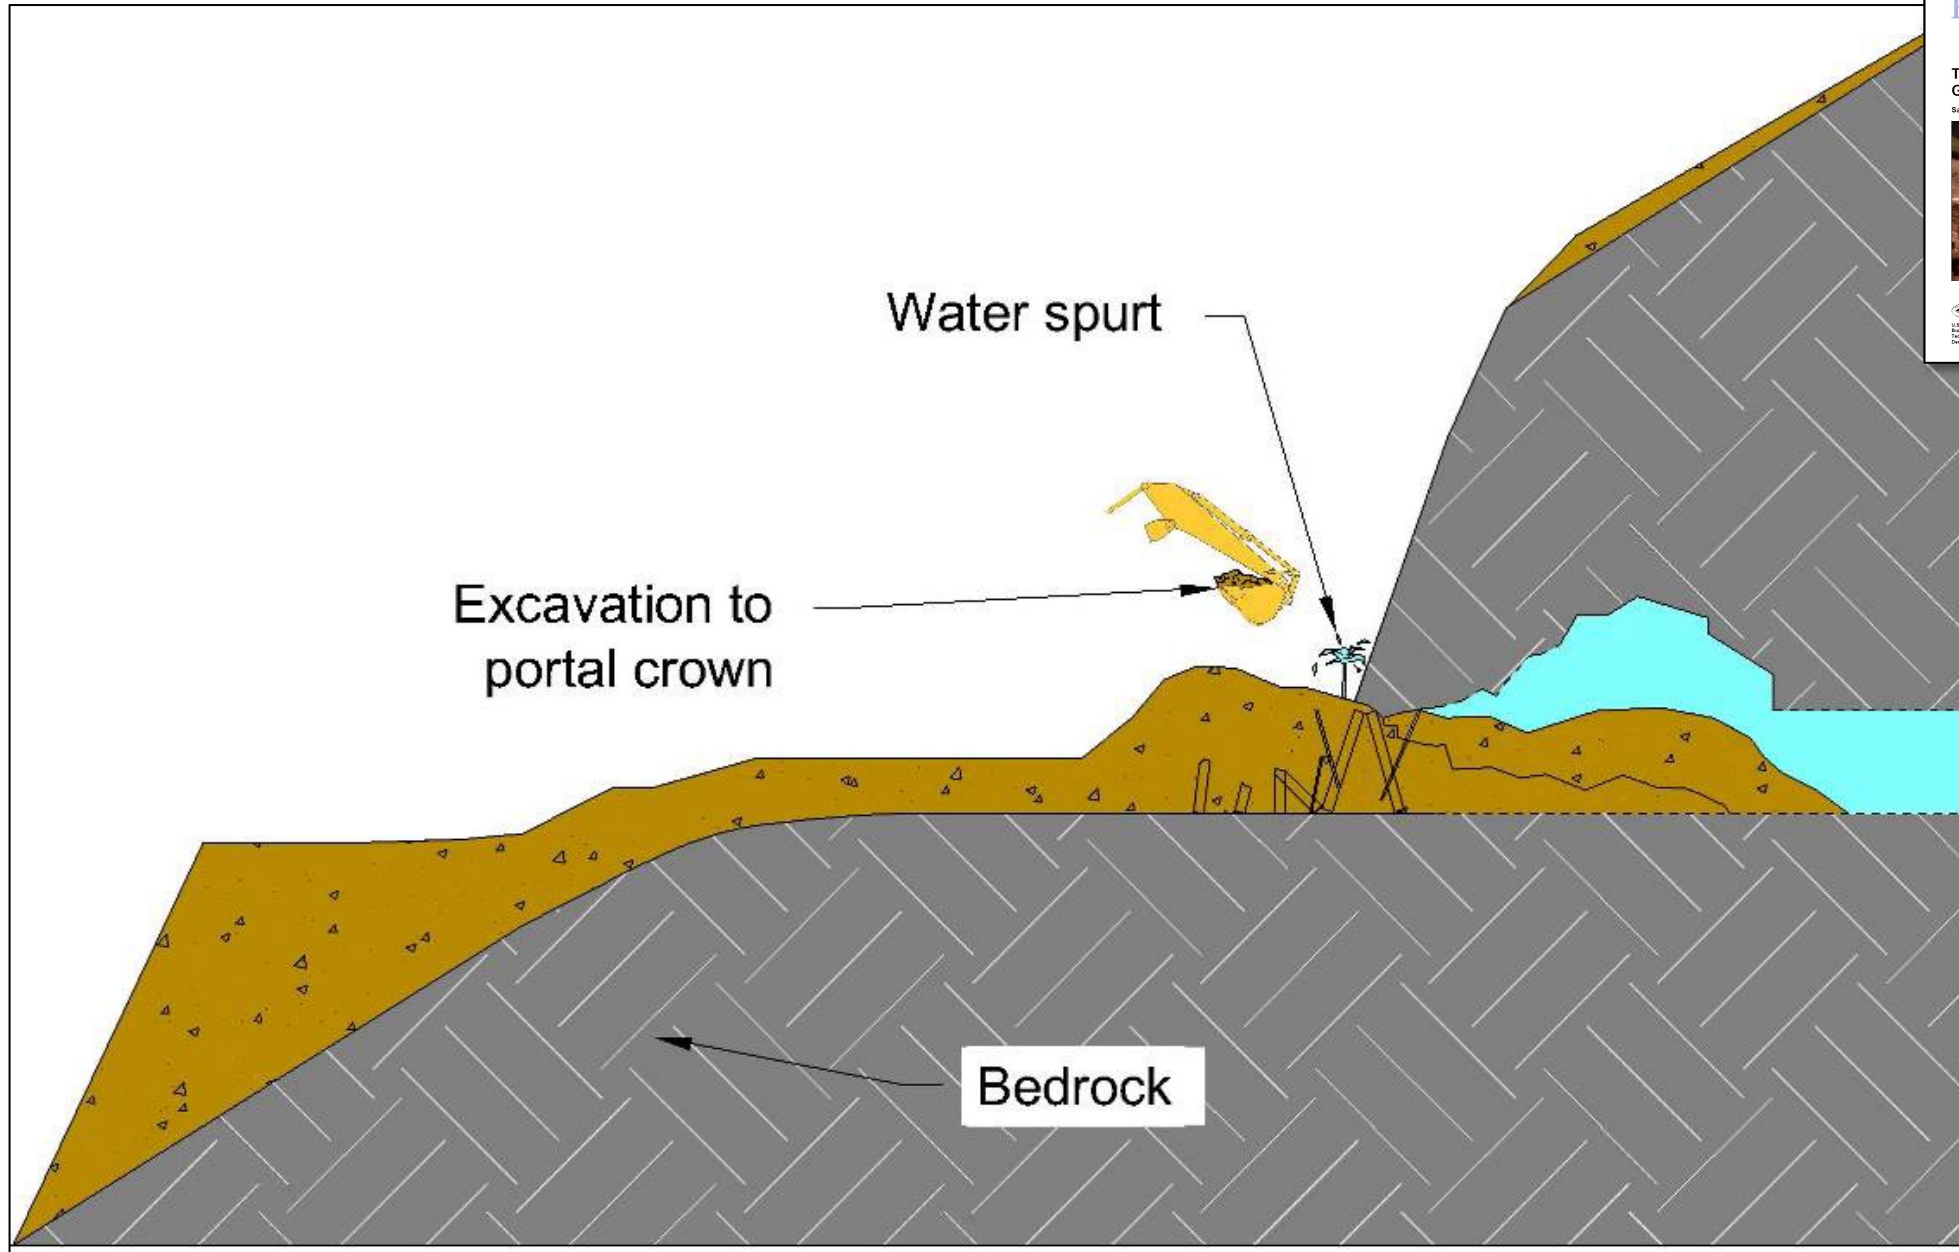
Figure 50.—Cross-section showing BOR's interpretation of the conditions immediately before the blowout as the spurt of water appeared indicating the adit was full and under pressure (not to scale).

- It is important to note that, in figure 50, BOR's interpretation of the water level inside the mine shows the adit full
- This is unlike the lower water levels previously depicted based on DRMS and EPA assumptions from 2009 to the occurrence of the blowout.

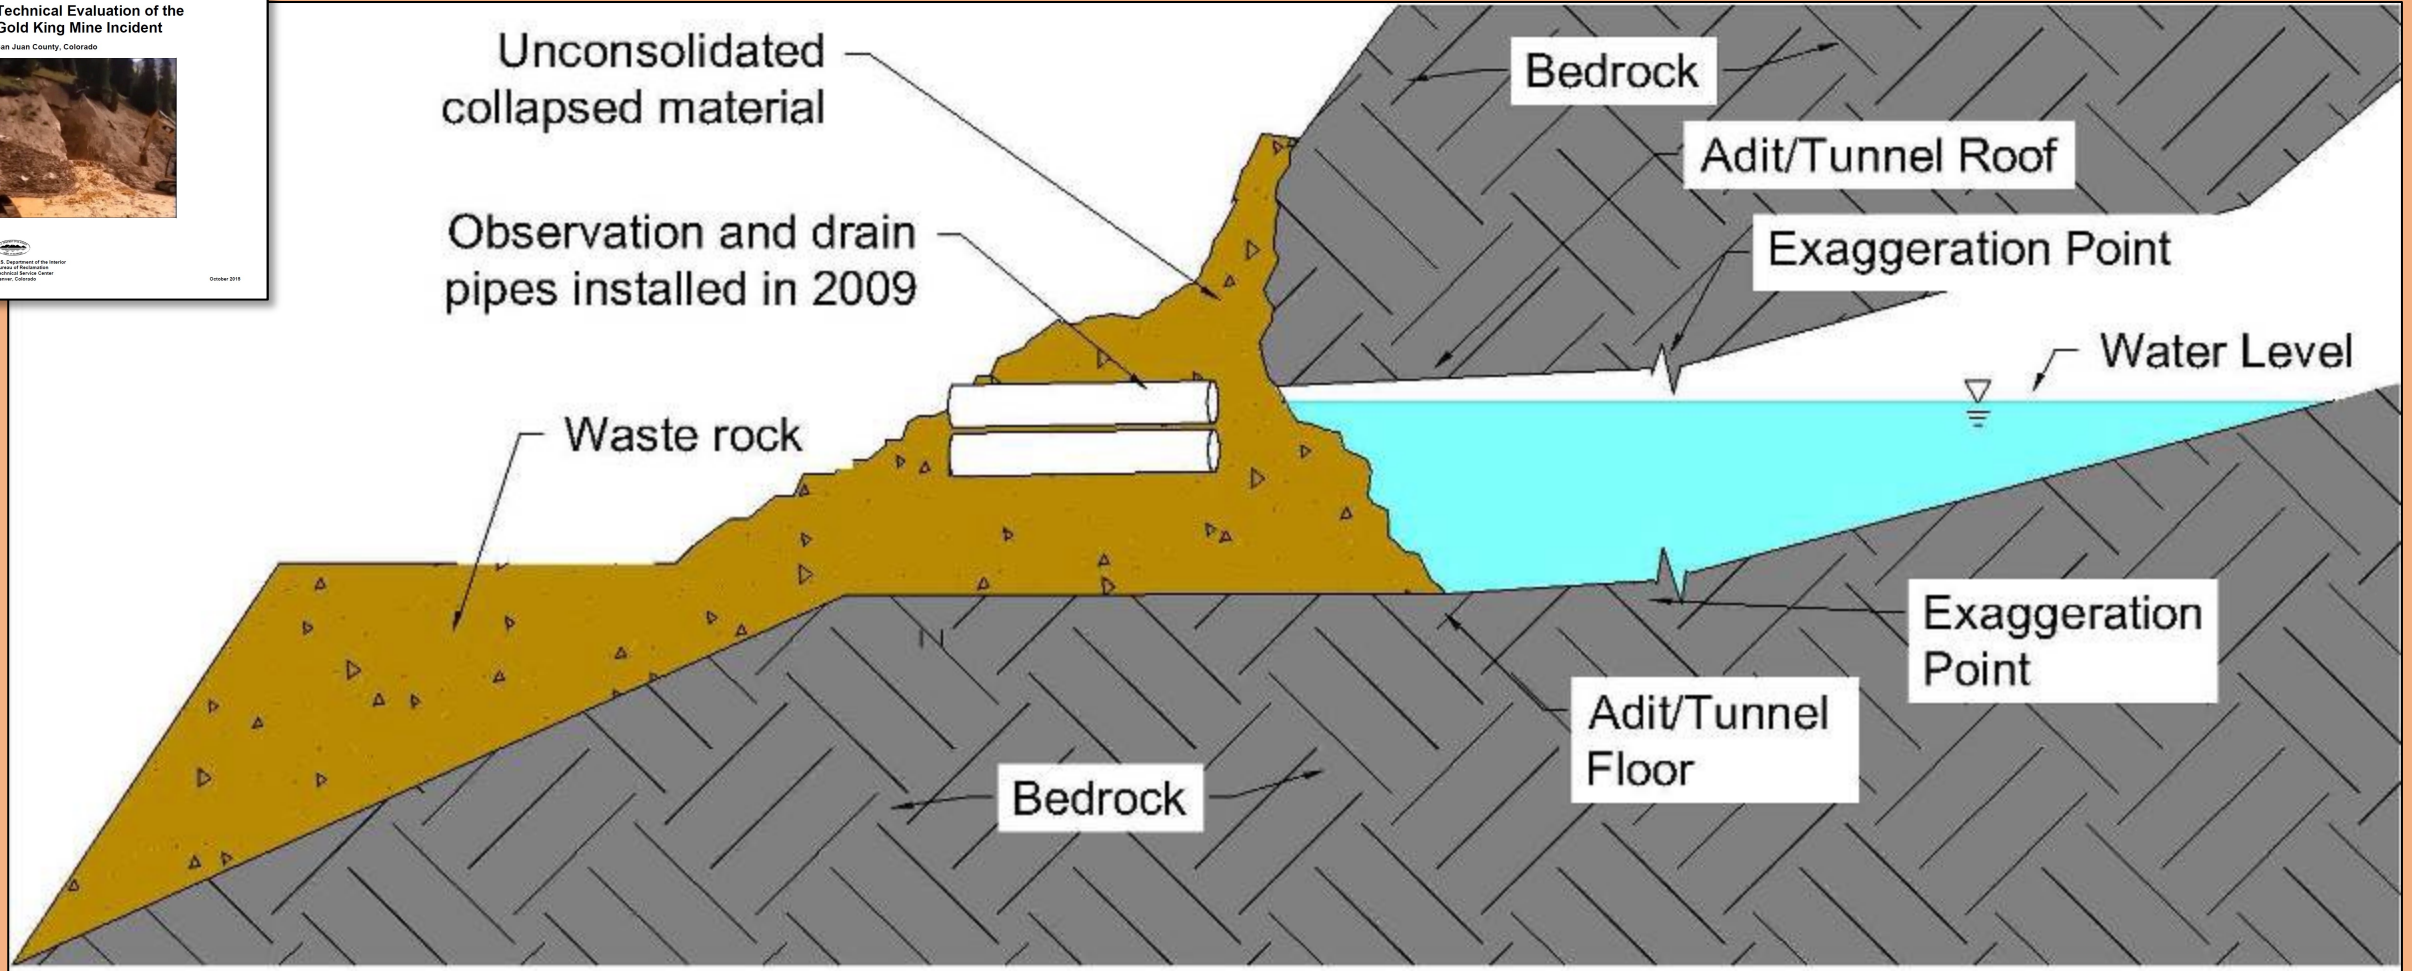
Figure 40.—Cross-section illustration showing the condition of the adit that was assumed by the EPA OSC and the abandoned mine experts from DRMS for use in planning to open the adit (not to scale). The “exaggeration point” means the right side of the drawing has an exaggerated vertical scale in order to show the 1% uphill slope of the adit. If drawn without exaggeration, the uphill slope of the adit would not be obvious on the drawing.

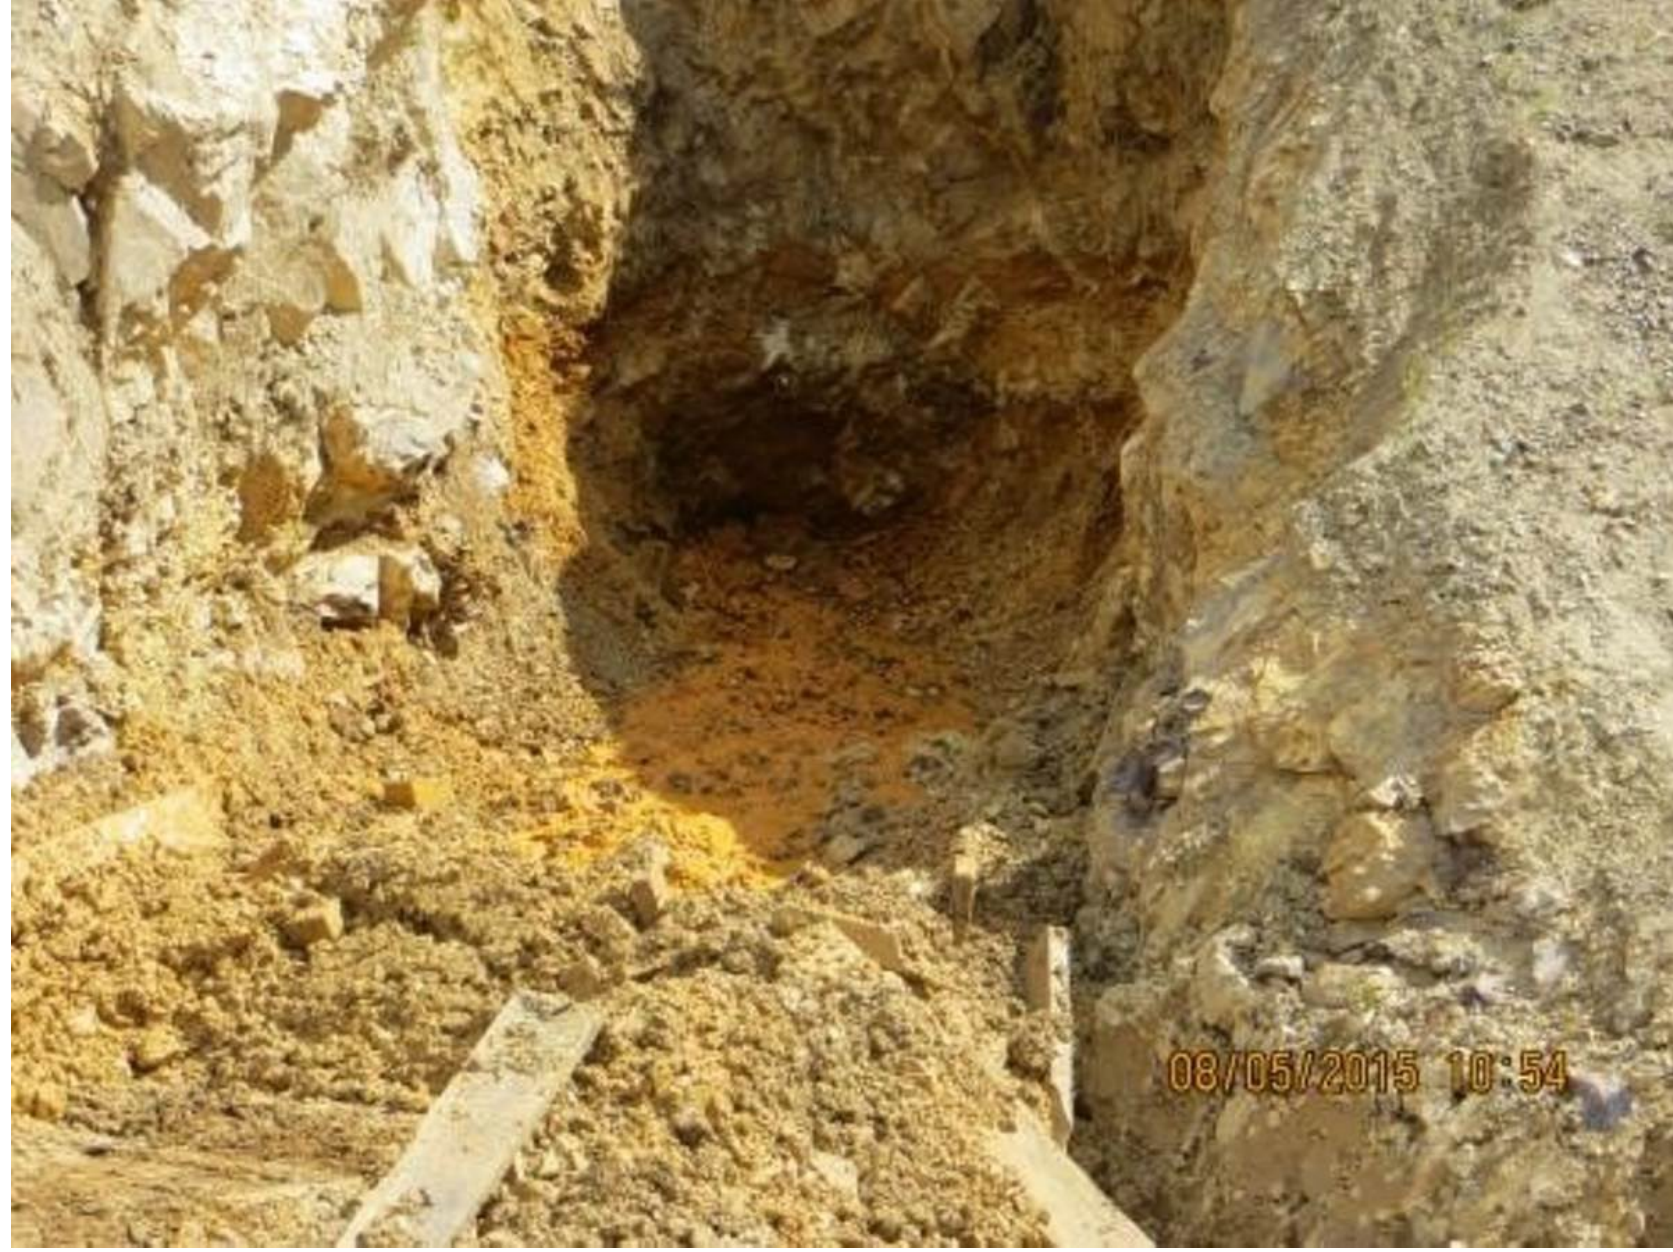
Figure 51.—Photograph of the uncontrolled flow taken at 10:54 a.m. on August 5, 2015. In 3 minutes, the flow progressed from a vertical spurt of water to the flow erosion evident in this photograph. The EPA OSC then made a decision to evacuate the portal opening to safeguard personnel onsite. A few moments later the flow erupted in an uncontrolled release (photograph from EPA project files).

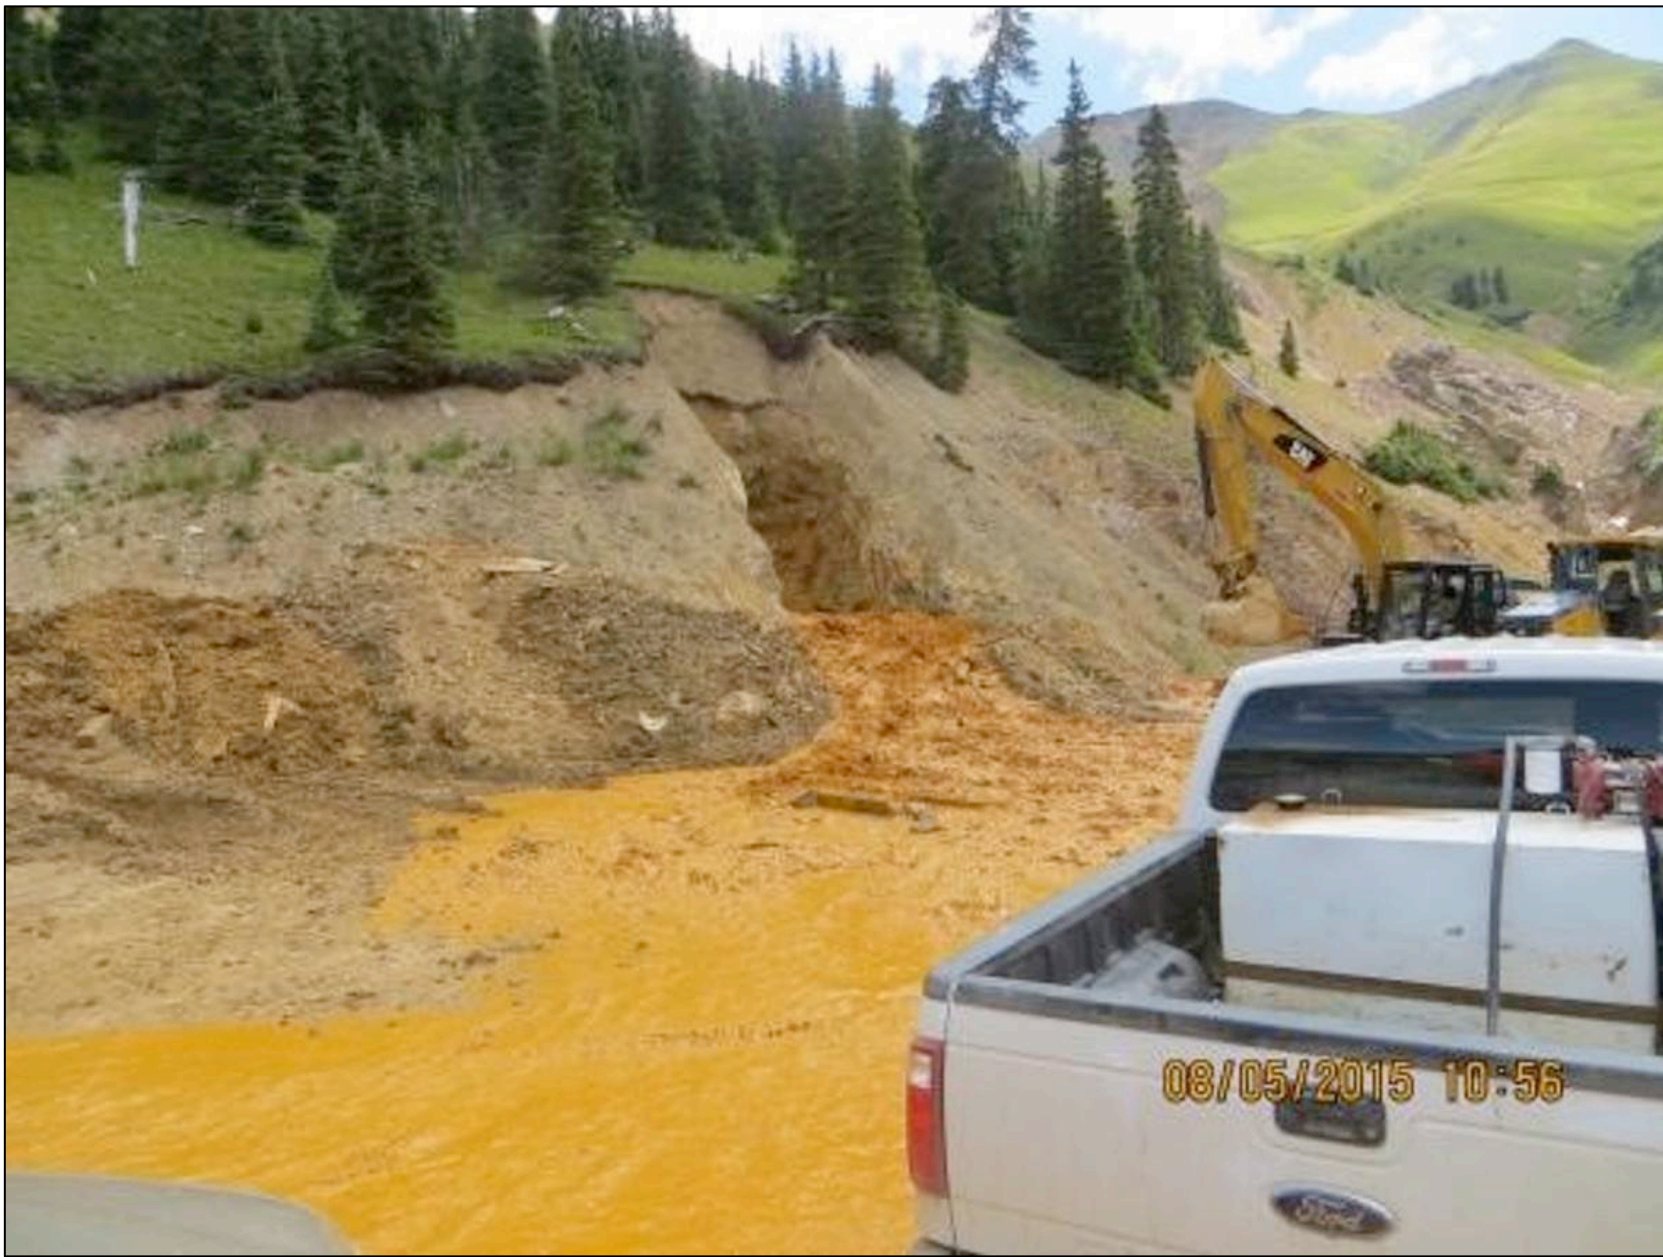
Figure 53.—Photograph showing the blowout at 10:56 a.m. on August 5, 2015 (photograph from EPA project files).

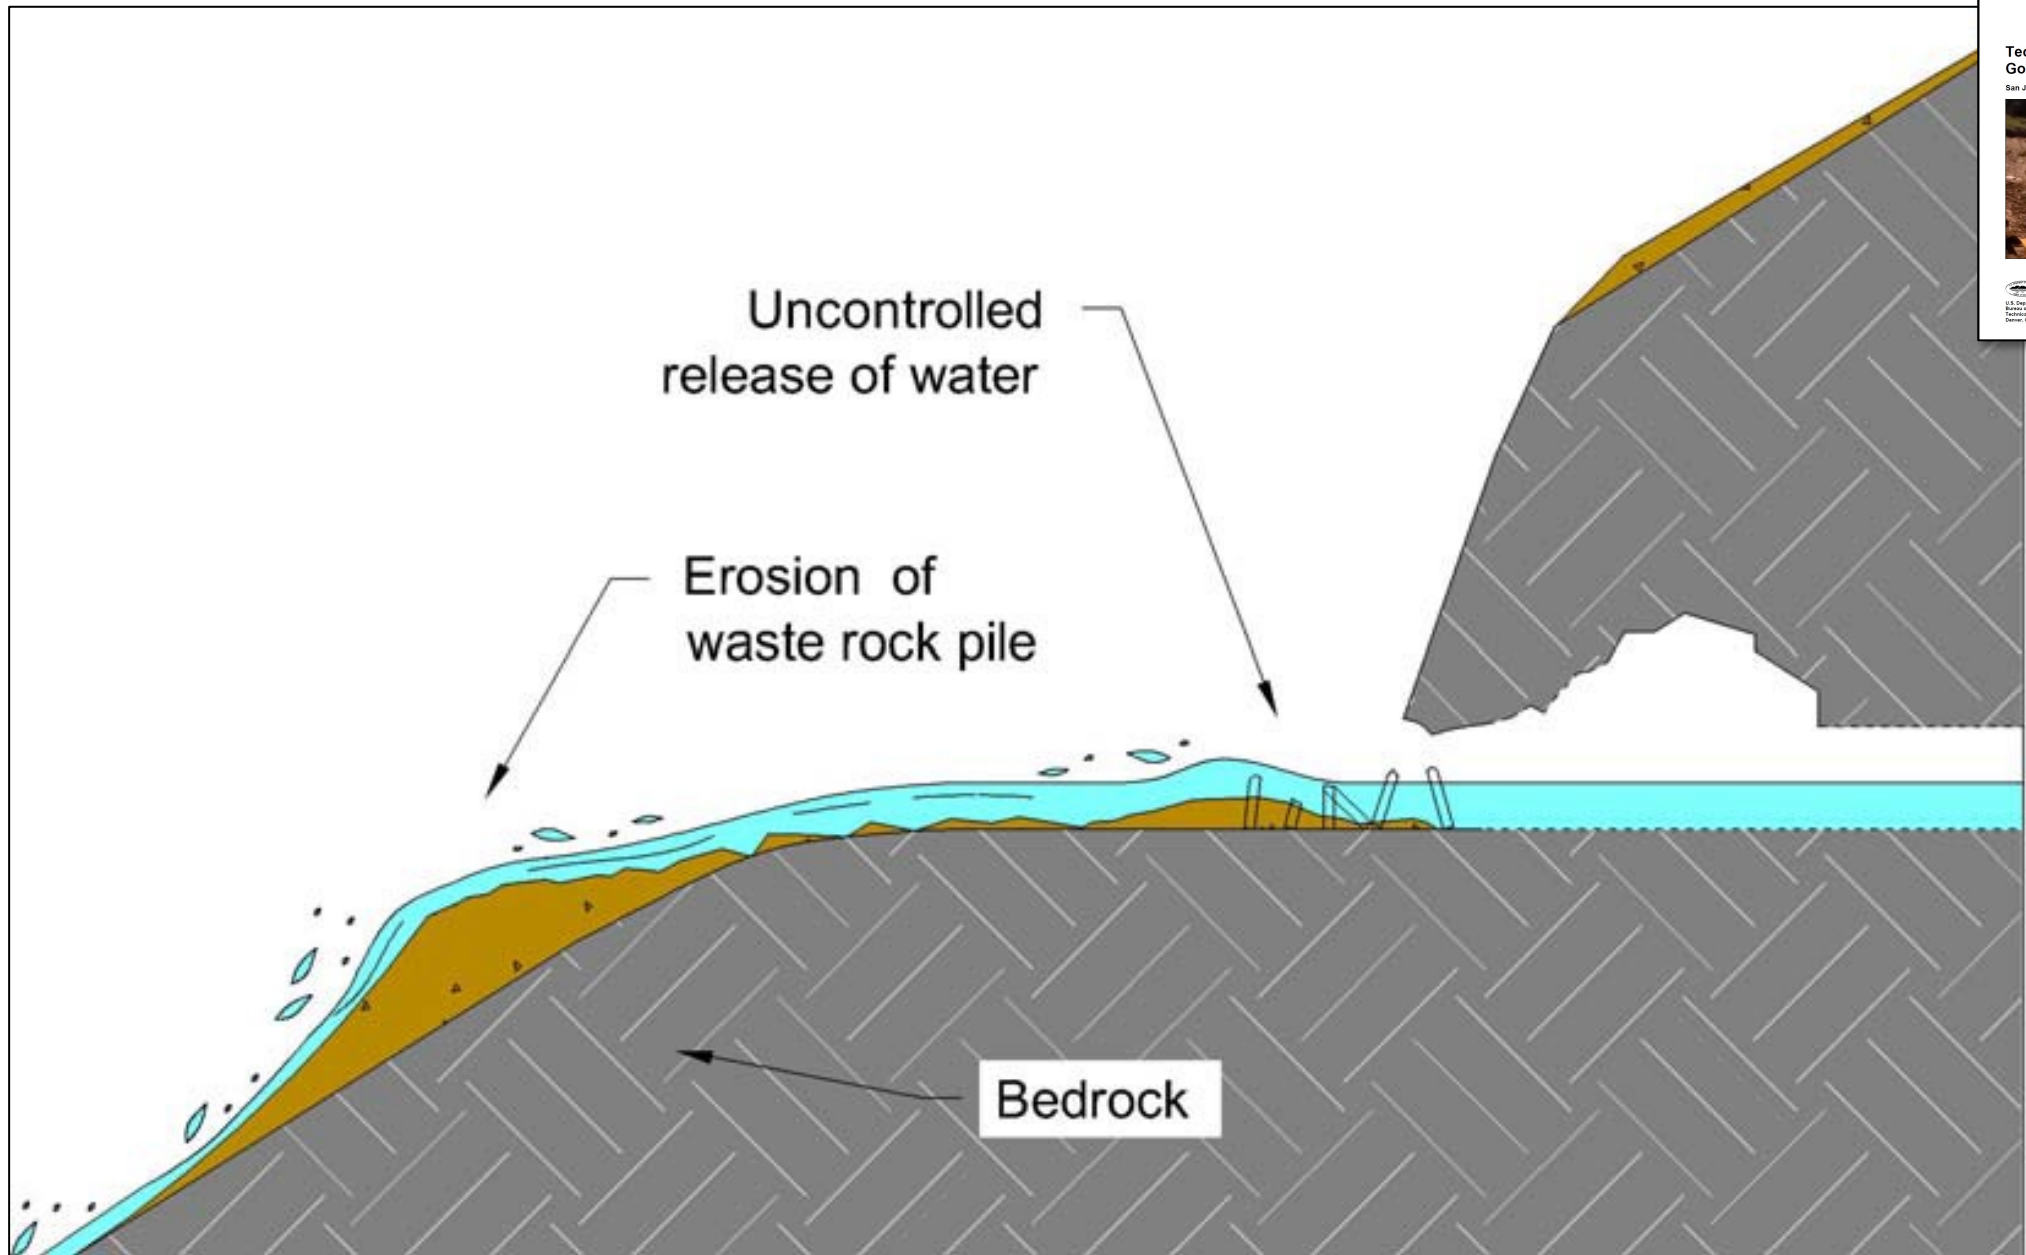
Figure 55.—Cross-section showing the blowout as it eroded (not to scale).

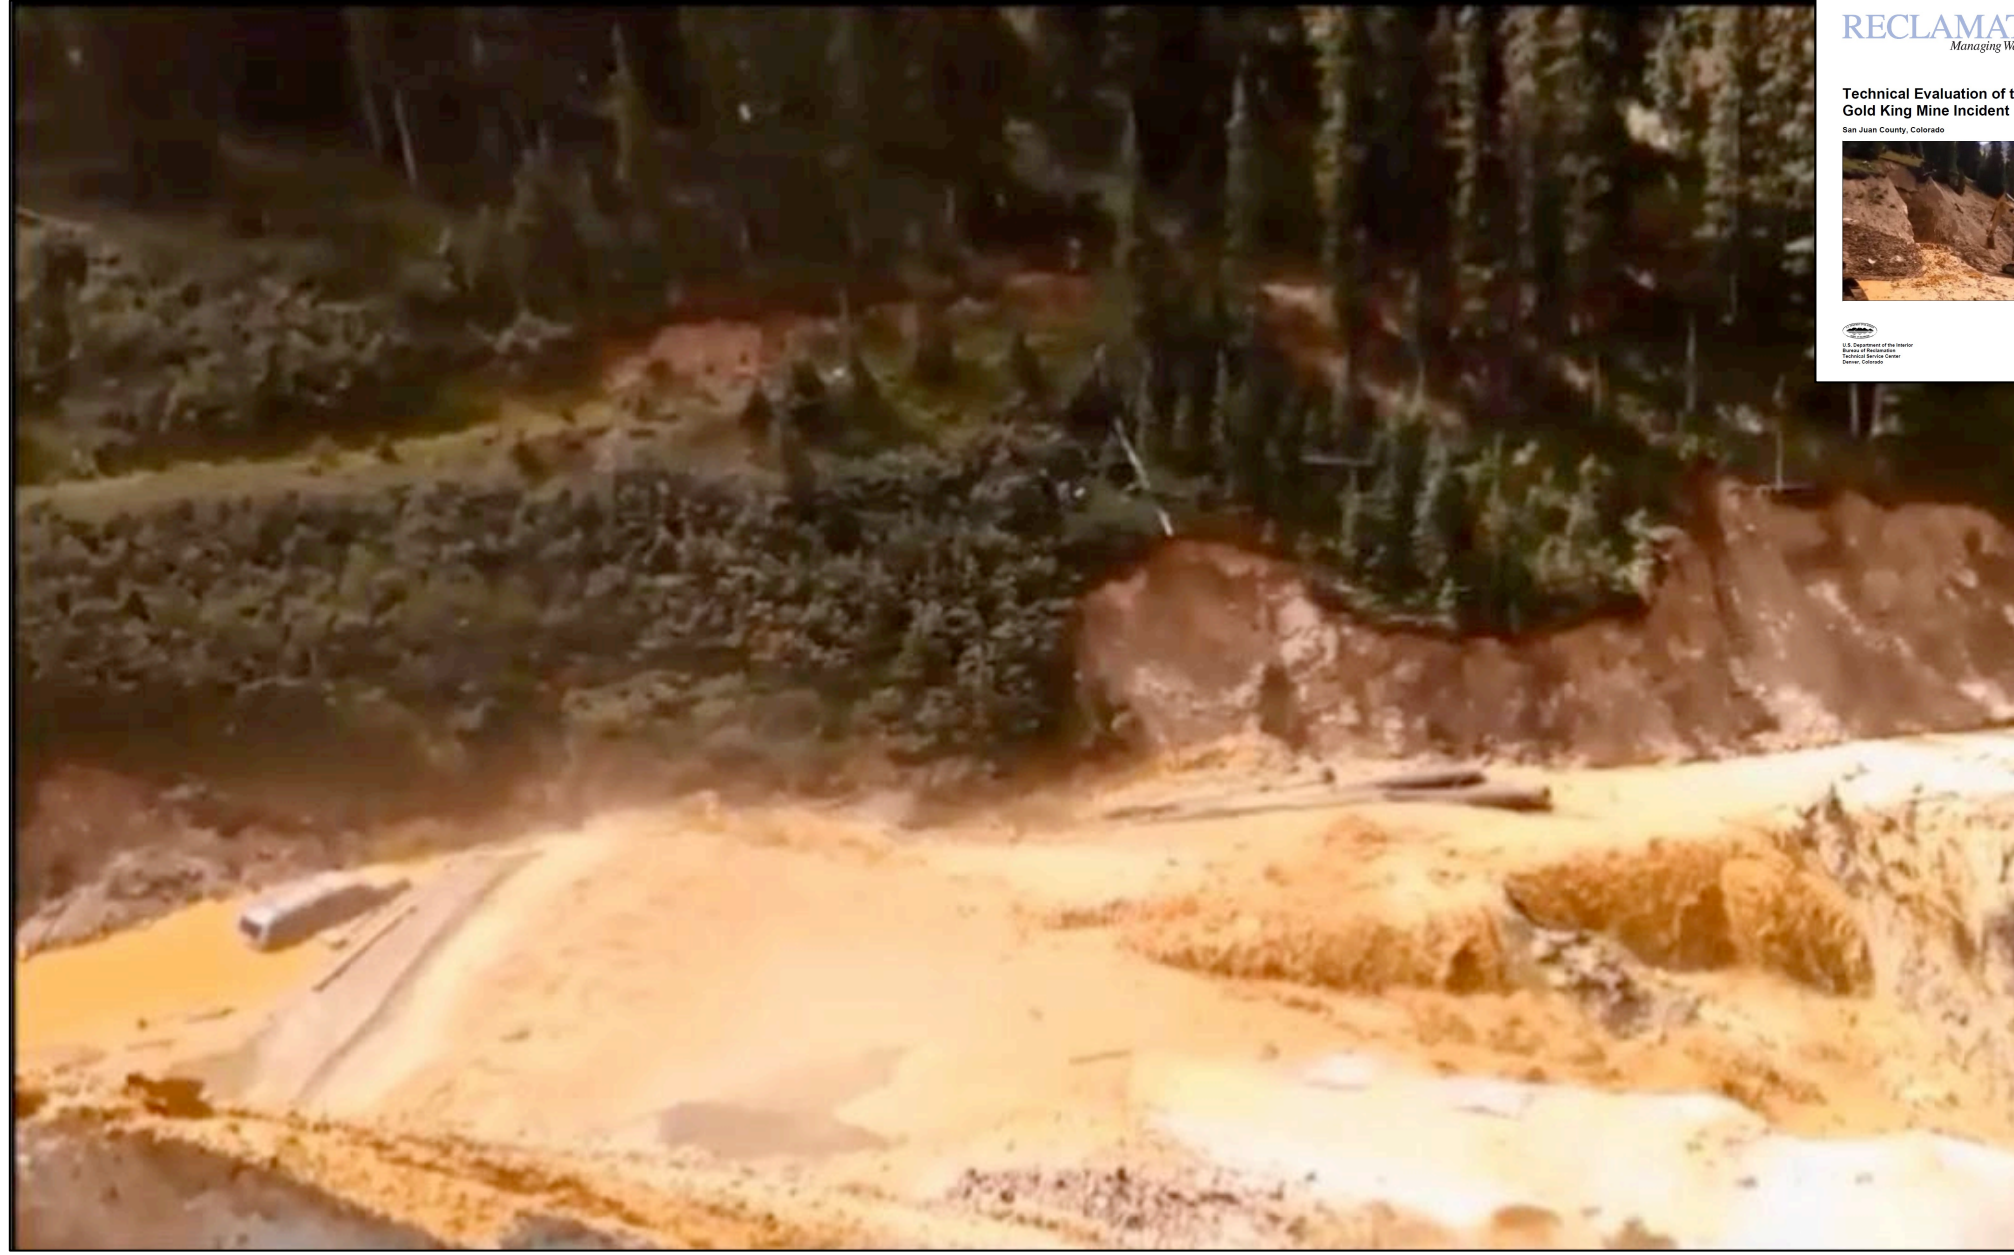
Figure 56.—Photograph showing at left, the inundation of a vehicle parked near the base of the waste-rock dump, and on the right water overwhelming the access road and cascading down into the North Fork of Cement Creek (still frame extracted from a video taken on August 5, 2015, at approximately 10:57 a.m.).

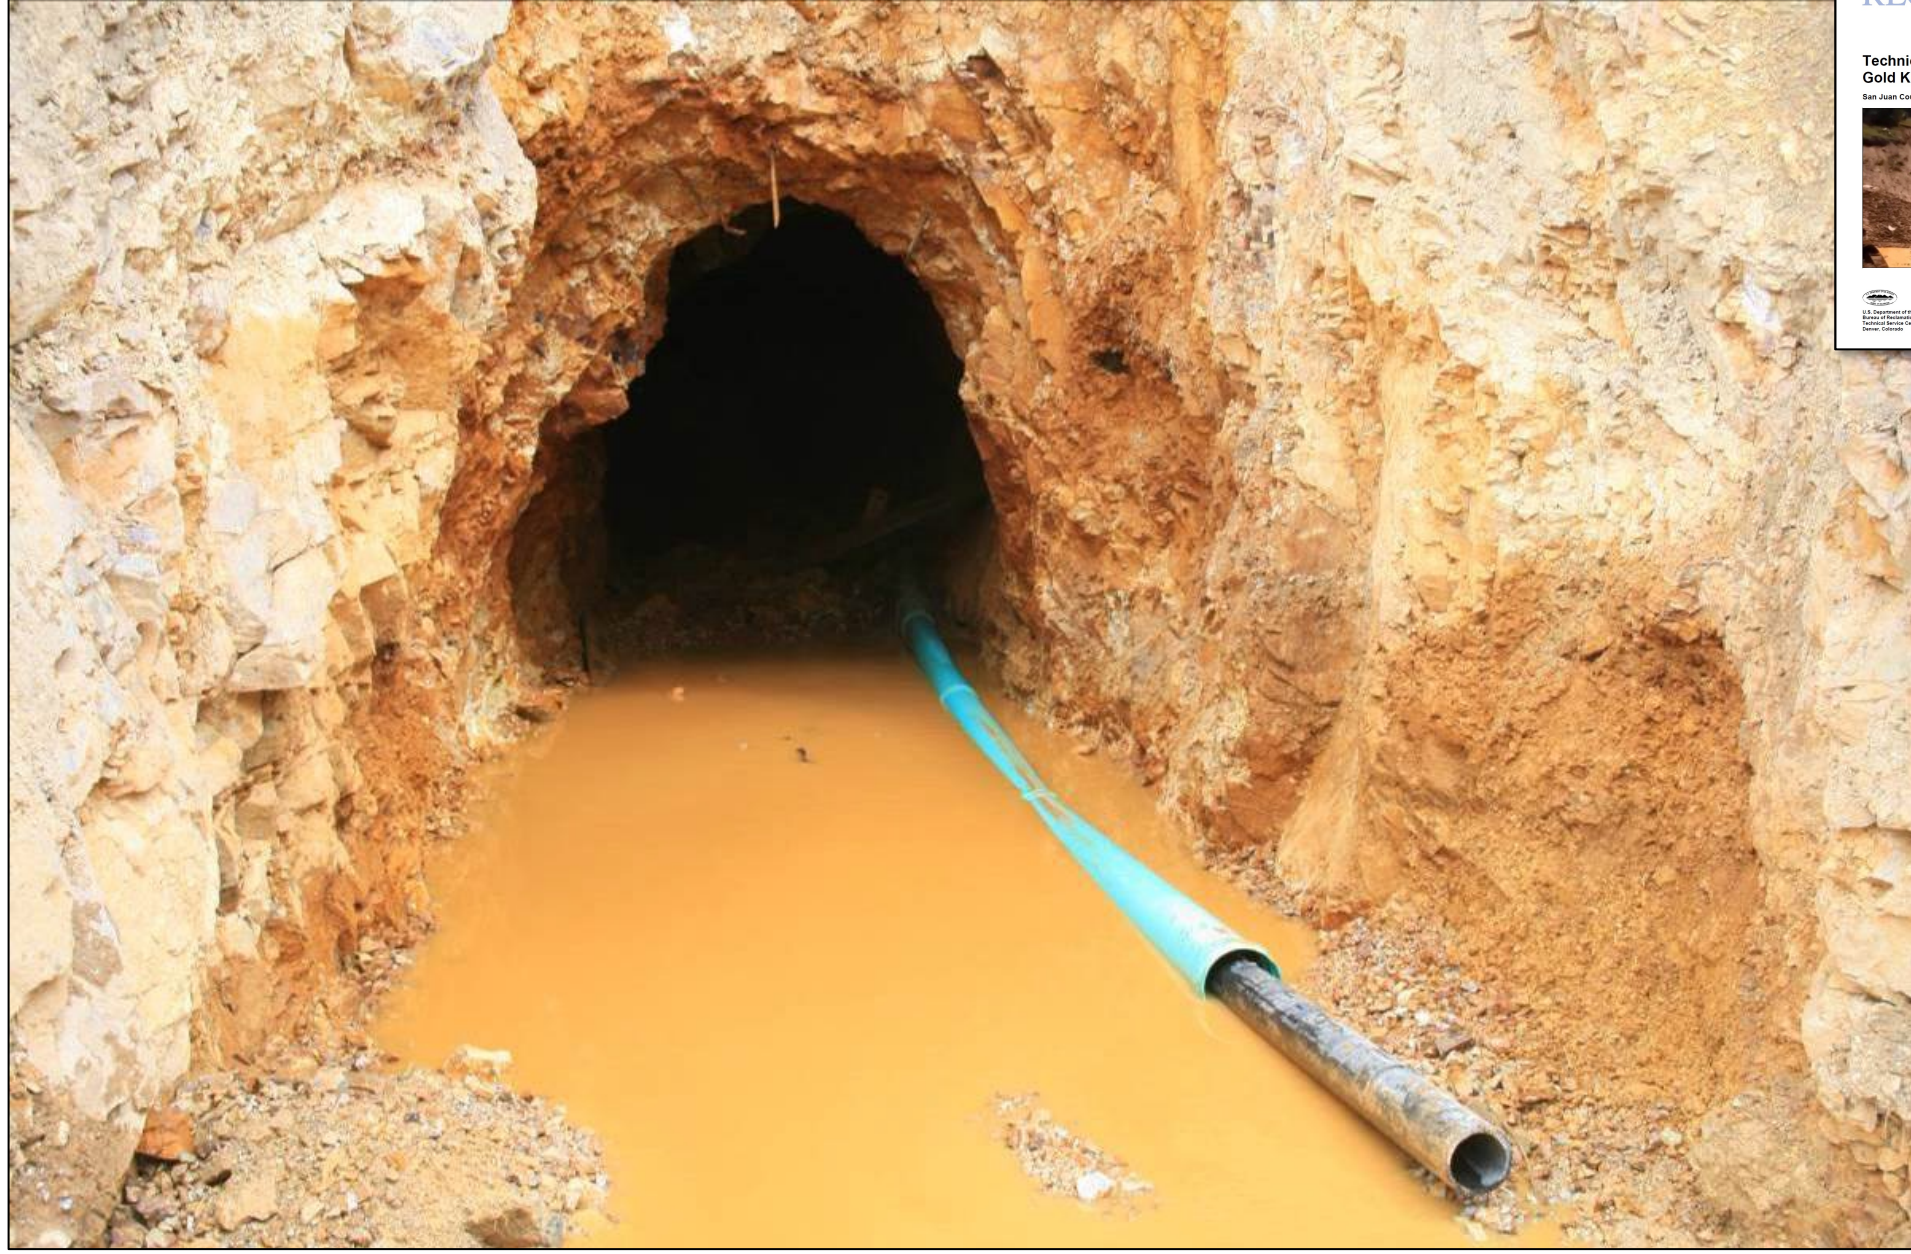
Figure 63.—Photograph showing the adit on August 16, 2015, with an 80-ft long (four 20-foot segments) turquoise-colored 24-inch outside-diameter drain pipe inserted into the adit opening. An 8-inch inside-diameter black HDPE pipe has been inserted into the 24-inch diameter pipe.

- EPA called down for the roads to be blocked where the stream crosses them, which was promptly accomplished.
- They also had word passed on to people in Silverton...
