Gold King Mine Incident

CASE STUDY IN CRITICAL THINKING

CE 4200

Technical Evaluation of the Gold King Mine Incident

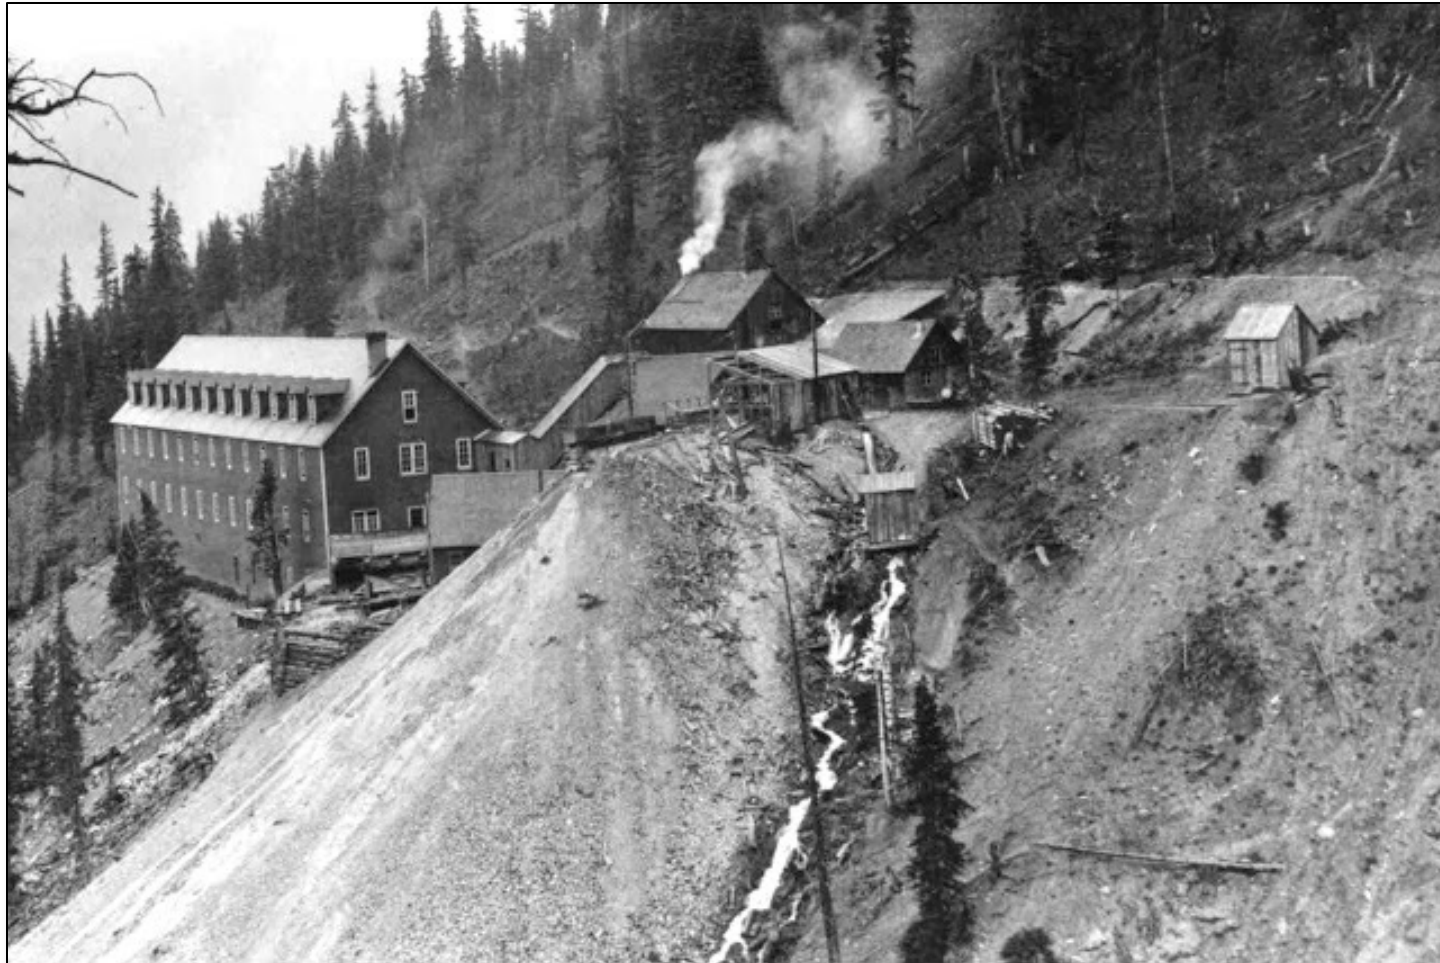
Photo from 1906 of boarding house and other structures at the mouth of **Gold King #7 Level** clearly shows a 200 to 300 gallon per minute water discharge from the portal.

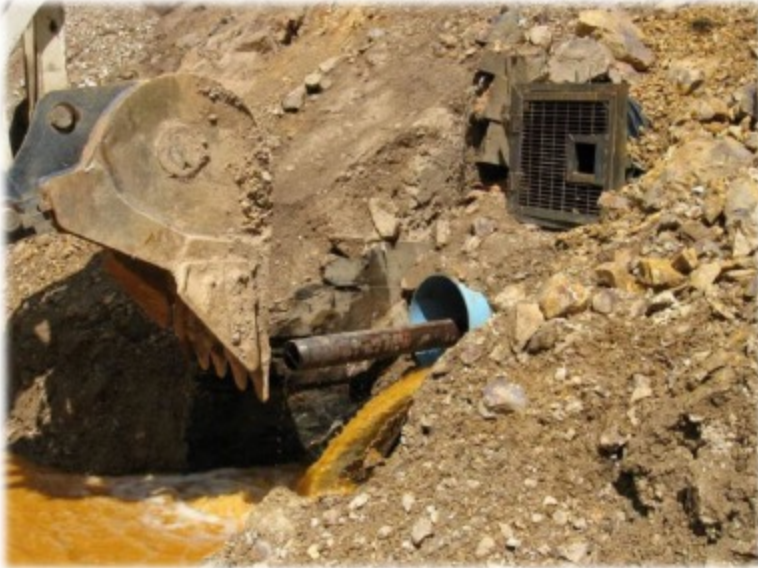
Gold King Level 7 Old Portal with well-point installed through the drain pipe. This point may be re-opened in a future project to help stabilize the mine drainage and prevent future increases in mine pool level.

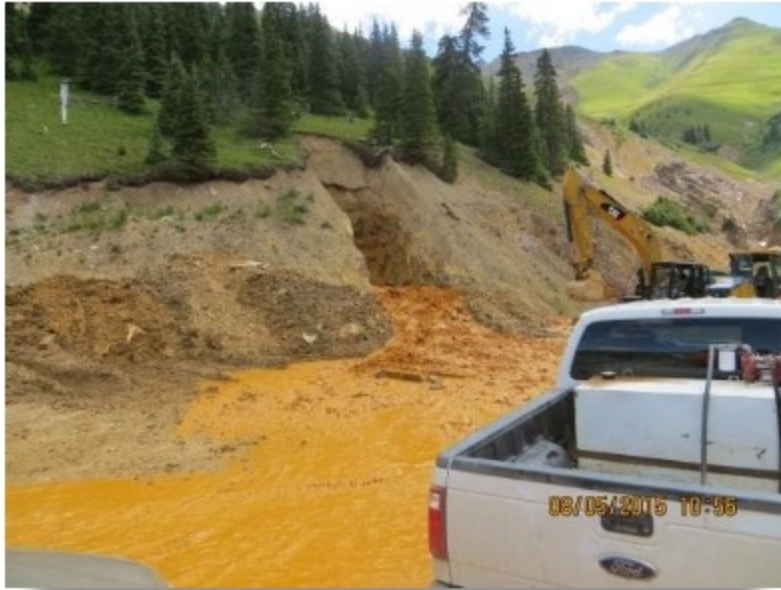
THE BLOWOUT

Excavation on the debris commences. Notably, the crew does not have the equipment on site to pump any mine pool water out. Digging continues until the operator notices a “spring” spurting from the dirt. Within minutes, the tiny fountain has grown to a 3-million gallon torrent of electric-orange, acidic, heavy metal-laden water pouring into the North Fork of Cement Creek far below.

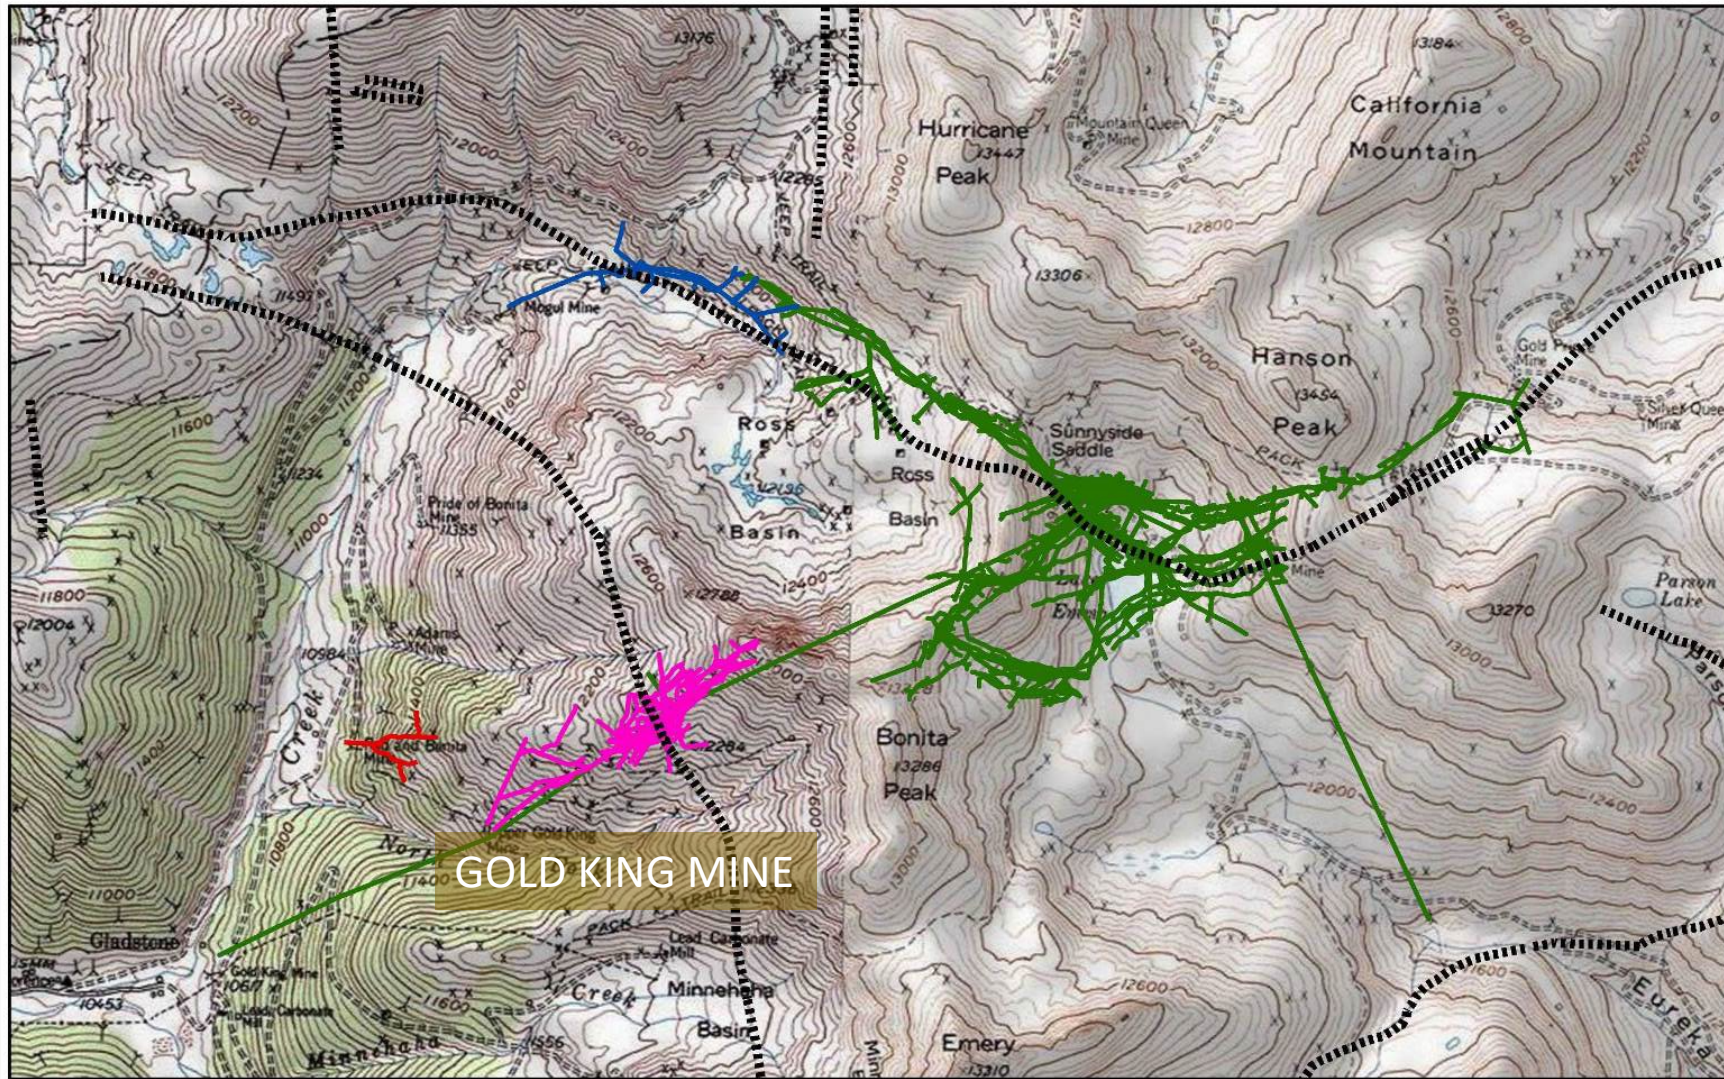
Figure 6.—Map showing topography and the location of the Sunnyside, Gold King, and Red and Bonita Mines workings in the Eureka mining district (graphic prepared by Kirstin Brown of the Colorado Division of Reclamation, Mining, and Safety on February 6, 2015).

RED AND BONITA
 Mine Workings past cave-ins are only projected to line of sight
 SUNNYSIDE MINE
 Most recent workings, needs more work
 GOLD KING MINE
 There is more data that needs to be added on 7 Level
 MOGUL AND GRAND MOGUL
 Separate mine workings that are connected to Sunnyside Mine

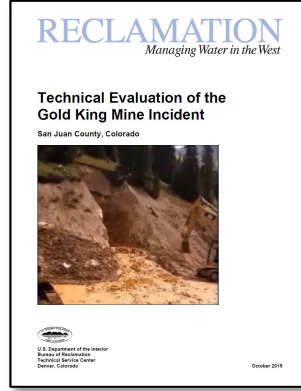
Figure 21.—Cross-section showing the installation of pipes by DRMS at the Gold King Mine Level 7 New Adit in 2009 (water level as assumed by DRMS) (not to scale).

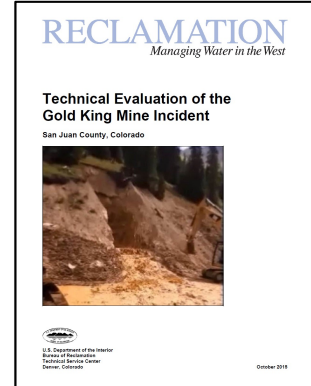
Figure 30.—Cross-section showing the condition of the Gold King Mine Level 7 New Adit in 2014 (water level as assumed by EPA and DRMS), after the installation of the two drain pipes and backfill cover (not to scale).

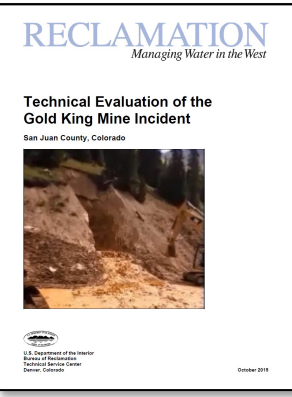
Figure 31.—Gold King Mine Level 7 OLD Adit (upper right) showing a small amount of seepage flow on September 11, 2014. At the portal, the floor of the old adit is approximately 2 feet higher than the floor of the old adit portal (photograph from EPA project files).

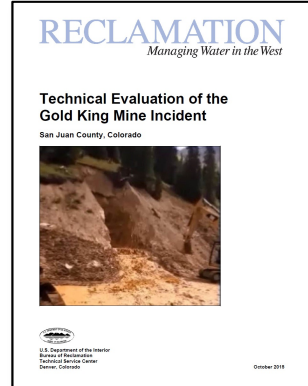
Figure 34.—Cross-section showing the condition of the Gold King Mine Old Adit on July 14, 2015 (water level as assumed by EPA and DRMS), when EPA returned to the site to begin work. More rock and soil and a tree had slid down onto the drains, and seepage was again saturating part of the waste-rock dump (not to scale).

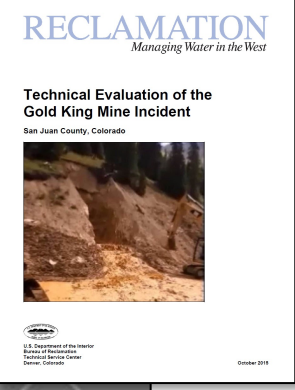
Figure 35.—Photograph showing the condition of the Gold King Mine Level 7 New Adit portal area on July 28, 2015. Note the soil and a tree that has slid downslope onto the portal area; at this time the seepage had been returned to the concrete trough, and the dump was drying out (photograph from EPA project files).

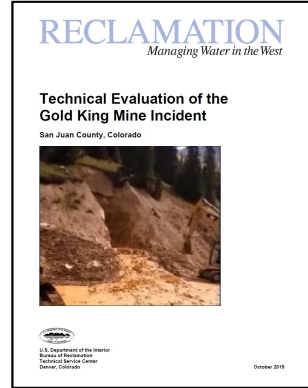
Figure 37.—Photograph showing additional excavation at the Gold King Mine Level 7 New Adit at 10:28 a.m. August 4, 2015 (photograph from EPA project files).

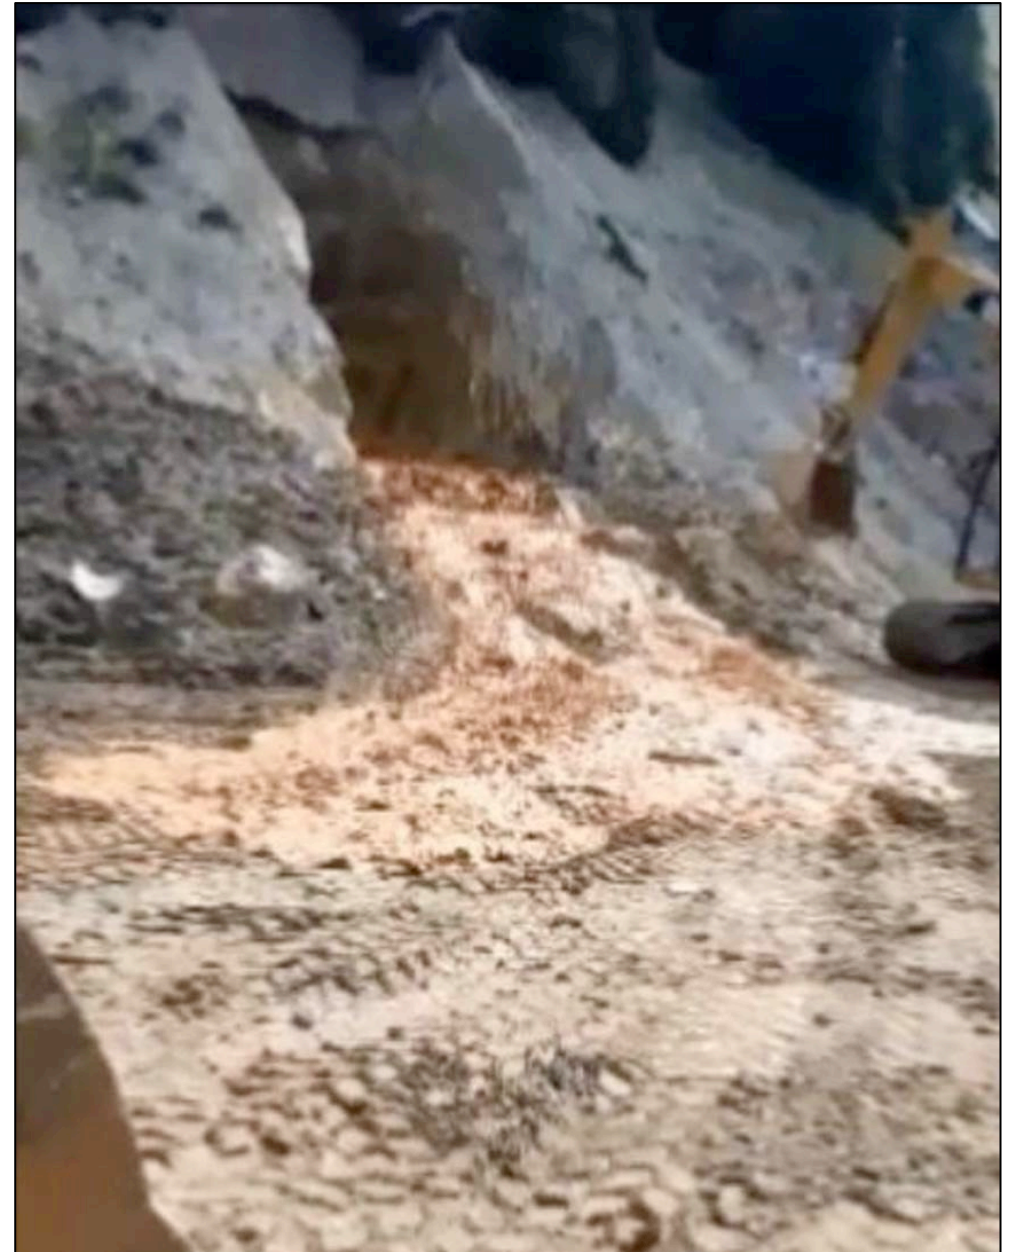
Figure 53.—Photograph showing the blowout at 10:56 a.m. on August 5, 2015 (photograph from EPA project files).
